Case Study 1: Barrabool Hills tunnel erosion

Landscape zone:	Bellarine
Shire:	City of Greater Geelong
Investors:	CMIS (CCMA)
Works dates:	Begun August 2005, signed off 9 November 2005
Site inspected by:	Shari Wallis, Greg Peters (CCMA), Joel Tyndal (CCMA), Paul Whinney
<p>Topographical Map: Map showing catchment area for unnamed tributary leading into the Barwon River.</p> <p>Catchment area approx. 130.5 ha</p> <p>Catchment area above tunnel erosion site (yellow line) approx. 63ha</p> <p>Tunnel erosion site approx. 0.8 ha</p>	
<p>Type and extent of threat: (erosion type, area covered, land holders involved, risk to assets)</p> <ul style="list-style-type: none"> • Tunnel erosion is the main threat along with associated sheet and rill erosion. The main tunnelling occurs around a dam on the landholders property. Two landholders are involved as the tunnels have caused a small landslip which cuts under the boundary fence into the neighbours • Extensive tunnel, sheet and rill erosion around dam covers approx. 0.8ha • The run off from the site impacts directly on the Barwon River as sediment and weed seeds can be washed into the River • A small landslip has occurred under the boundary fe

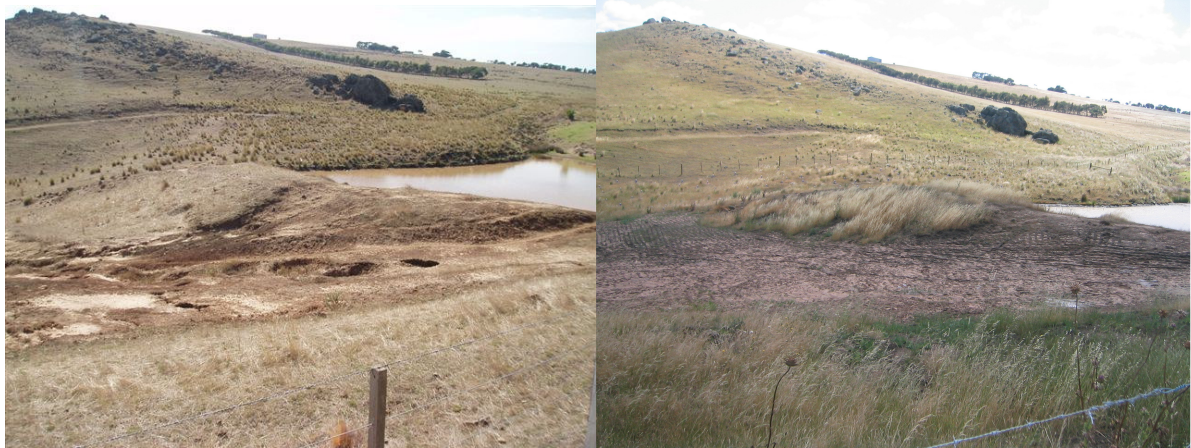
Photo set 1: Photo of tunnel erosion site before and after works, looking south east

- Deep rip and compact tunnel erosion area
- Fill in and compact slump site on Richards property
- Fence out the dam and whole ground works site
- Tree belt planted along Richards boundary to intercept any watering entering soil profile up slope of site
- Trees and grasses planted throughout works site to help in stabilisation

- Site was successfully deep ripped and compacted down, a small area (approx. 10x20m) was not deep ripped or compacted due to slope.
- Landslide site was filled however a new tunnel (approx. 40cm diameter) has reappeared in filled in site. The landholder filled in a compacted the hole and will monitor the tunnel.
- Grass seed had not been applied as of Nov. 2006, small rills were beginning to show after significant rainfall event but no major damage, seed to be applied early autumn.

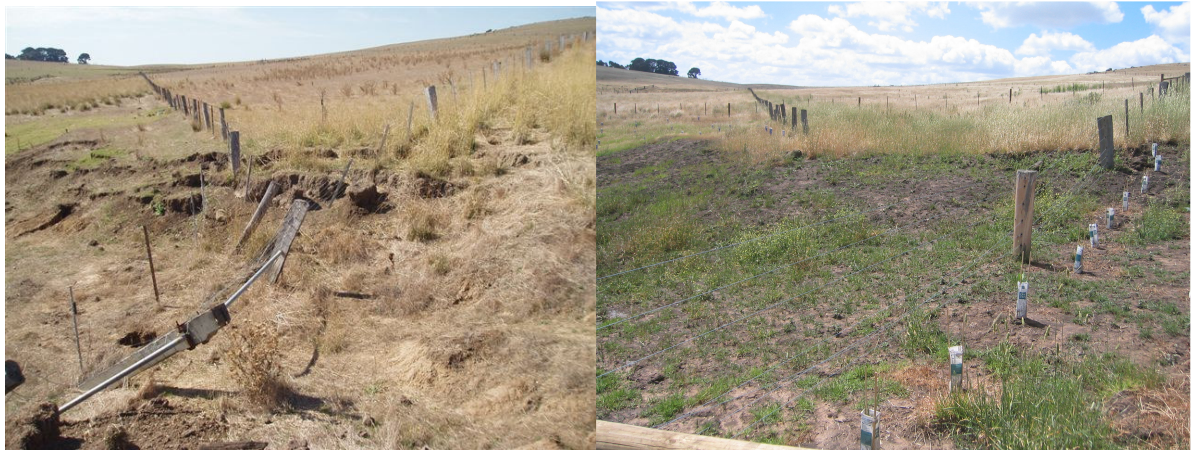
Photo set 2: Before and after photos of the landslide creeping under the boundary fence of the neighbours. After photo also one row of the tree belt planted along the new boundary fence to reduce sub-surface water entering the sensitive works area below. Photo taken looking south, south east.
