## Case Study 2: Deans Marsh Gully/Tunnel Erosion

<b>Landscape zone:</b>	Upper Barwon
<b>Works dates:</b>	Feb. 2005 – May 2005
<b>Site inspected by:</b>	Shari Wallis, Neil McInnes (UBLCN), John Turner (CCMA), Simone Wilkinson (CCMA)
<b>What did grant cover?</b>	CMIS grant covered approx. 60% of earthworks (contract hire, rubbish removal, clay backfill, top soil and sowing down)

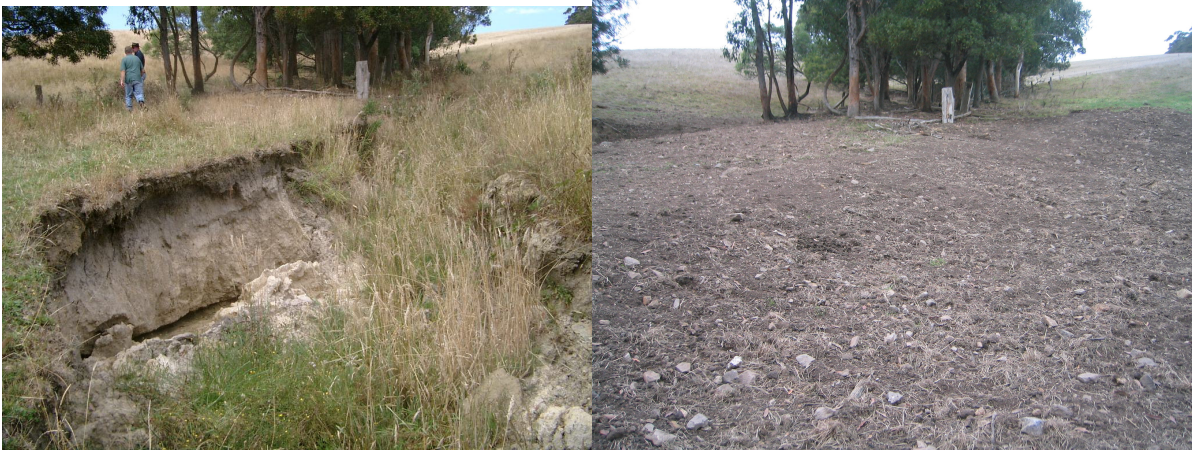
**Photo set 1:**

Looking east up the collapsed tunnel/gully area with the PRV road behind and the planted out gully ahead. The rubbish site and possible entry point of the tunnelling is up amongst the trees.

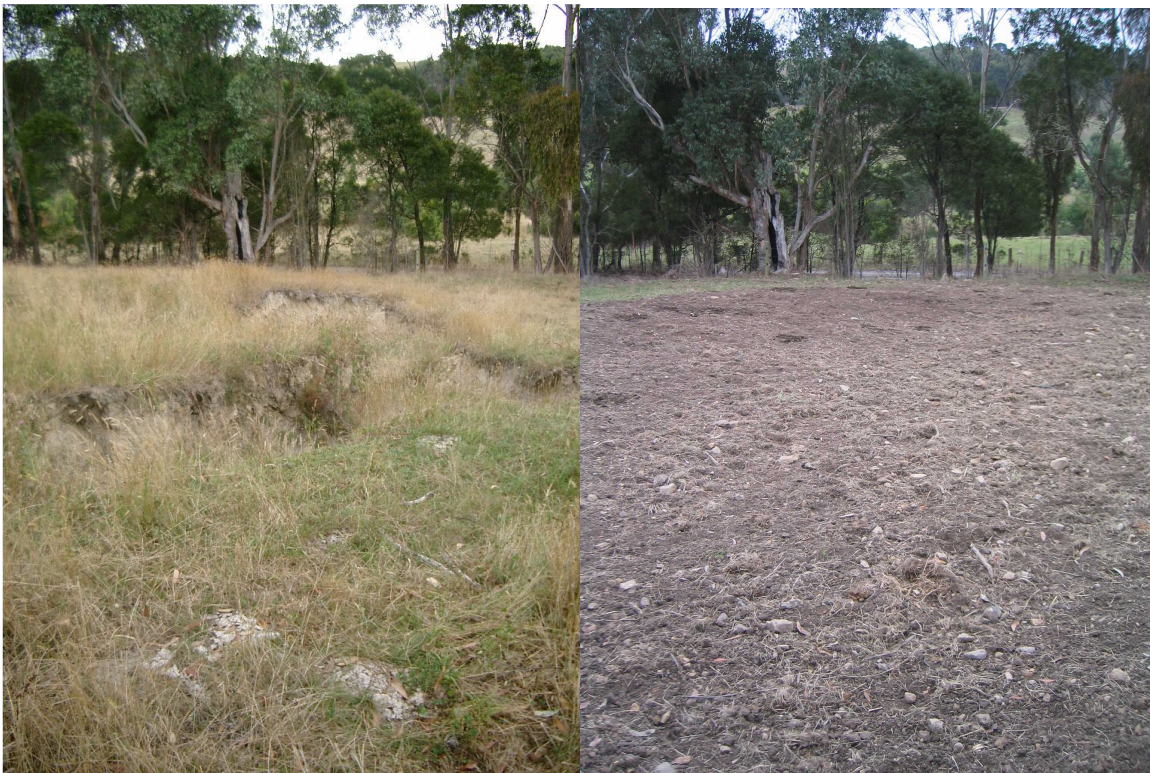
**Photo set 2:**

Looking west down the gully towards PRV road and after topsoil and seed had been applied.

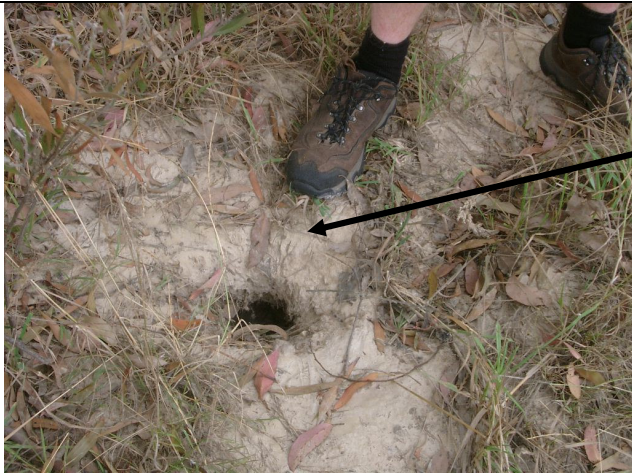
Sediment deposited on the side of Penny Royal Valley Rd at the exit point of the tunnel erosion

**Photo 3:** Tunnel exit hole on side of PRV road

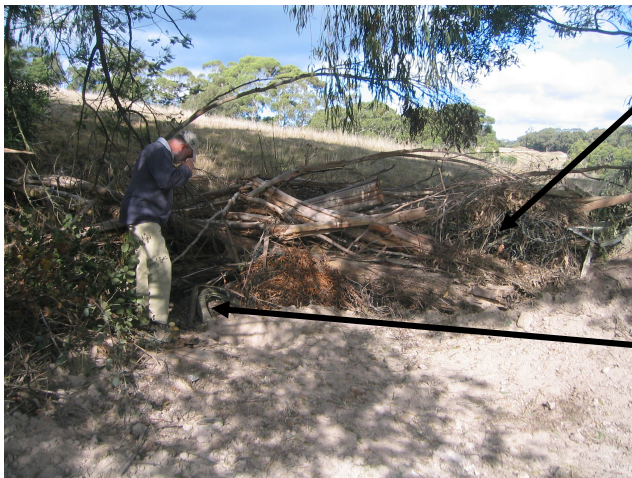
Wire, tires, corrugated iron and trees left at the works site by contractors. There was more buried.

**Photo 4:** Rubbish not completely removed from the site and partially buried.

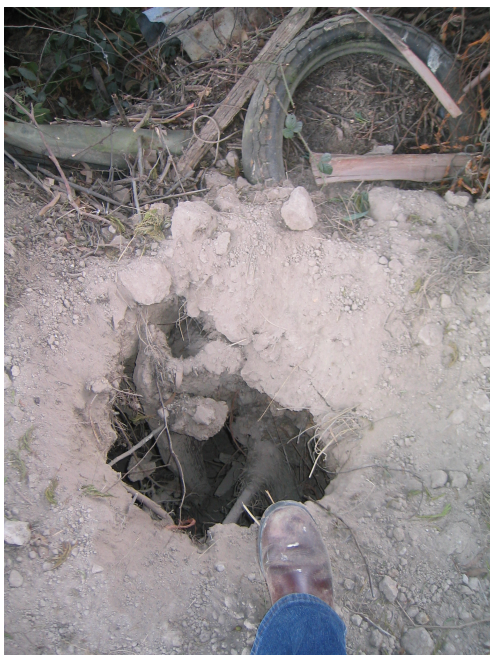
- The fragile part has been fenced and planted out, leaving a wide enough gap for a track to be put through
- A month or two after works were completed a new tunnel hole appeared where the rubbish had not been removed and was partly buried (Photo 5). The landholder had rung Neil McInnes to report the hole.
- Neil and Greg Turner visited the site again and Greg suggested more earth works. Neville was going to monitor the size of the hole.

Neil looking at the new tunnel which appeared at the site of the unremoved rubbish

**Photo 5:** New tunnel appears next to buried rubbish after completion of works

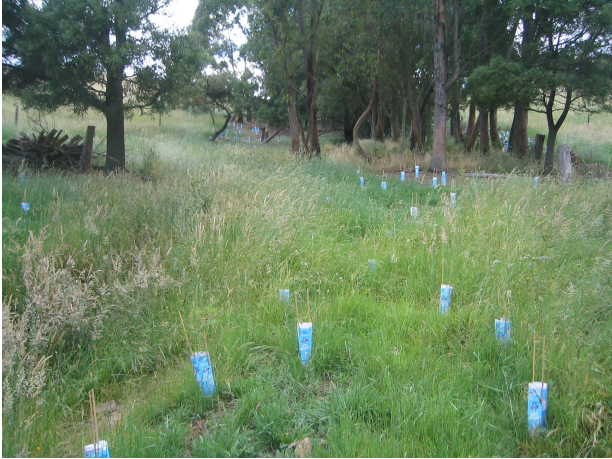
**Photo 6:** The site had good grass cover by December 2005 and the trees had been planted the previous autumn. The gully area was stable with no sign of any further movement.

The half buried rubbish was still there but the tunnel which appeared after works were completed had not enlarged

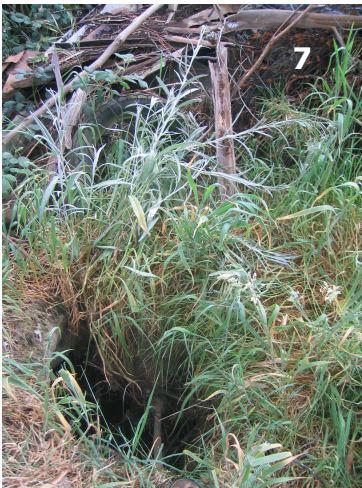
**Photo 7:** Tunnel which appeared after completion of works is still active. (same site as photo 5)

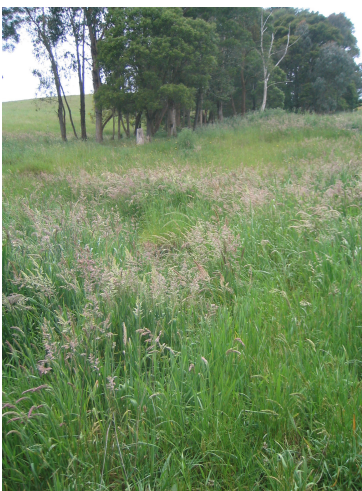
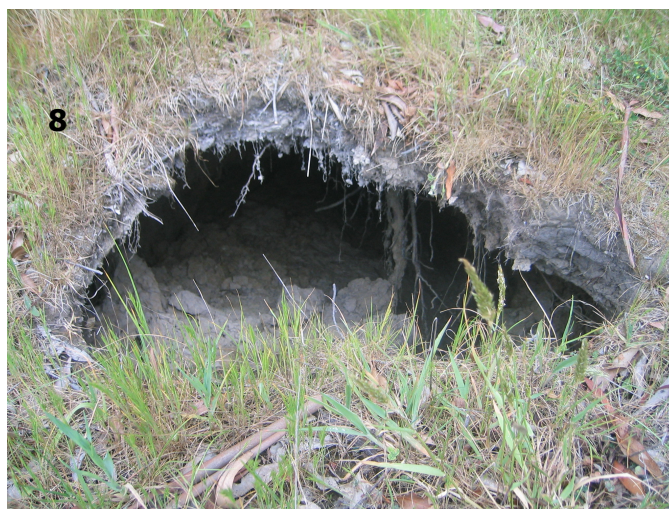
**Photo 8:** Collapsed tunnel erosion right on the access track. Opens up to a cave approx. 2m x 2m under the track. Sediment is still being deposited on the side of Penny Royal Valley Rd.
