## Case Study 3: Deans Marsh Stream bank erosion

<b>Landscape zone:</b>	Upper Barwon
<b>Works dates:</b>	30 <sup>th</sup> May – 2 <sup>nd</sup> June 2005
<b>Site inspected by:</b>	Shari Wallis & Greg Bell

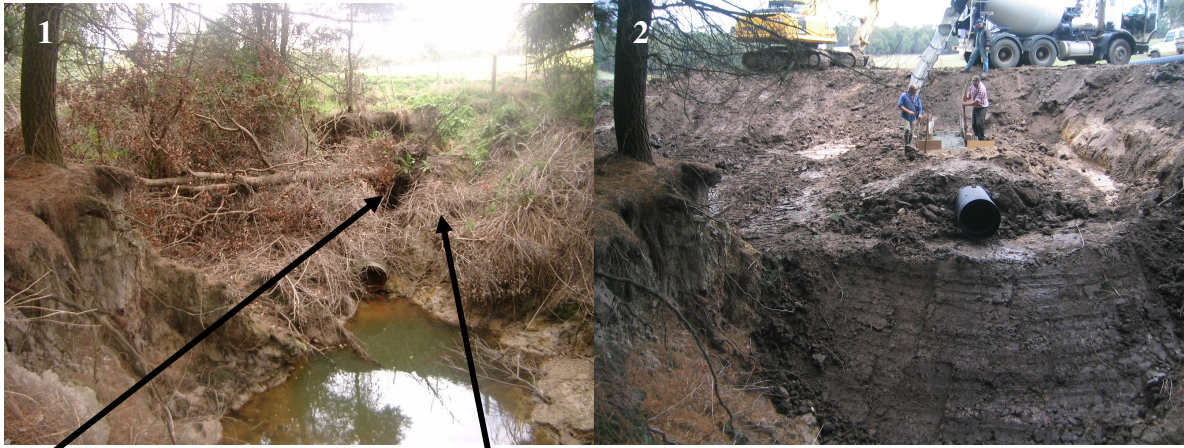
### Photo set 1:

- The erosion is occurring at the site of a 20 year old soil conservation structure, put in when erosion began after the Ash Wednesday fires.
- The corrugated iron pipe has corroded in the middle causing water to run out at a point under the track and eroded away the stream bank edge and under the track. This is continuing at a rapid rate, especially after big rainfall events, and is taking back the creek edge and removing trees.
- The pipe has rusted in the middle, while the top half of the pipe under the track is in tact, the lower half, below the erosion, has broken off and fallen down into the erosion below (See before photo 1)

Original height of pipe before it rusted through and broke off

Erosion was occurring back under the pipe and cutting under the track above. The area under the fallen tree and blackberries was eroded out

Photo 1 on the left shows the site in its original condition before earthworks began. The trees fallen across the erosion site have occurred as a result of the erosion undermining them. This only occurred in the months before our first inspection on 24<sup>th</sup> May 2005.

Photo 2 on the right was taken during works after clay had been imported and compacted. The pipe was then layed level into the existing pipe and joined and stabilised with concrete around the join.

- The pipe structure needed to be replaced but removing the whole corrugated iron pipe would require digging up the whole causeway. Instead it was decided to feed a new plastic pipe up into the original pipe to reduce the earthworks required.
- This was successful and the join of the old pipe with the new pipe was sealed with meters of concrete (both down and across) to prevent any movement.
- The area under and around the new pipe was filled with heavy black clay brought over from a dam on the farm. This clay was fully compacted before the pipe was layed.
- The Smiths staked in carpet underlay at the end of the pipe where water will trickle out to prevent erosion from occurring while the ground was still bear. Grass seed was going to be spread.

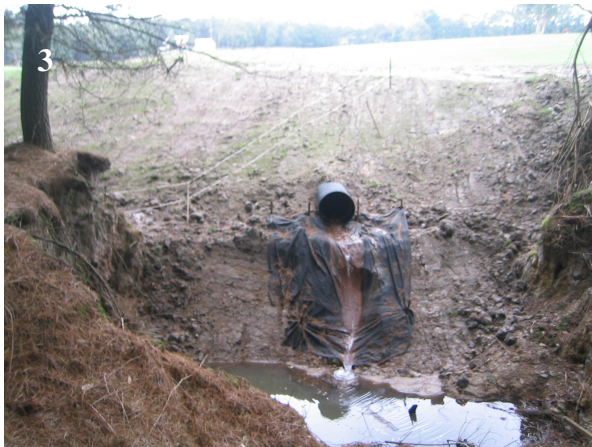
### Photo set 3:

This photo shows the new pipe structure after works were completed and after the landholders had staked the carpet underlay underneath the pipe. Grass was also beginning to cover the area. This photo was taken 2 months after works completion.

- Works were completed on time and only took 3 days.
- Max put in a lot of work with the contractors while laying the pipe
- On completion, the site looked stable and I was happy with the job done.
- Max staked in some carpet underlay at the pipe end to take the water flow while the site stabilised and until vegetation took over.

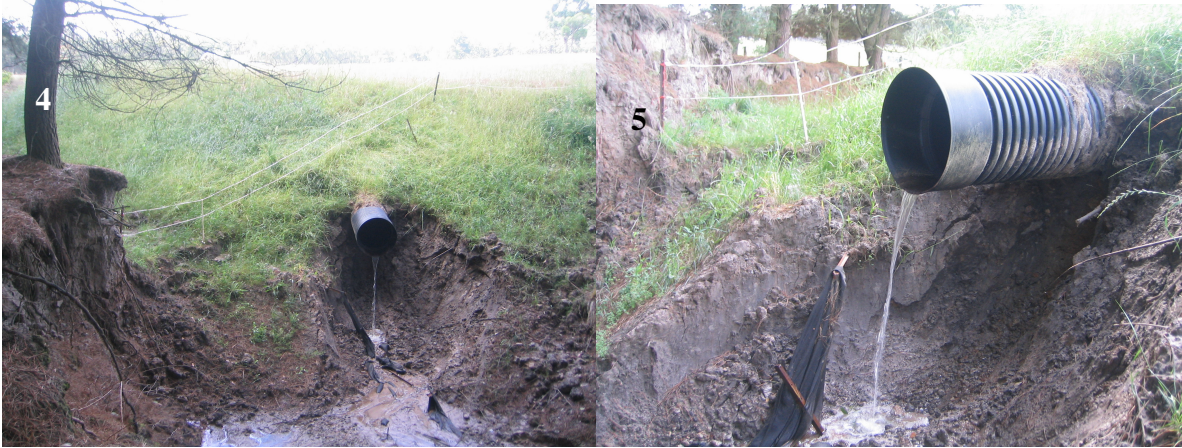
Photo 4 and 5:

- The site was inspected 2 months after completion and was looking excellent (Photo 3). The carpet underlay was in place and the pipe and earthworks were taking the flow of water well.
- The site was inspected again on 7/12/2005 to take GPS points and the earthworks had failed. The carpet had slipped away, causing water to swirl back under the pipe and erode away the soil under the end of the pipe.
- Spoke to Greg Bell re: the issue, rocks or tires were the suggested solution by Greg. Spoke the landholders and said we will follow up the issue with another visit again in early 2006.
- The grass had grown well on the area above the pipe

The above photos show the new erosion occurring around the pipe exit as seen on 7/12/05. While water was flowing out of the pipe there seemed to be a trickle of water coming out from under the pipe which would have caused the erosion around the base of the pipe. The carpet underlay has also been washed away.

This new issue is to be followed up by Shari and Greg in early 2006.

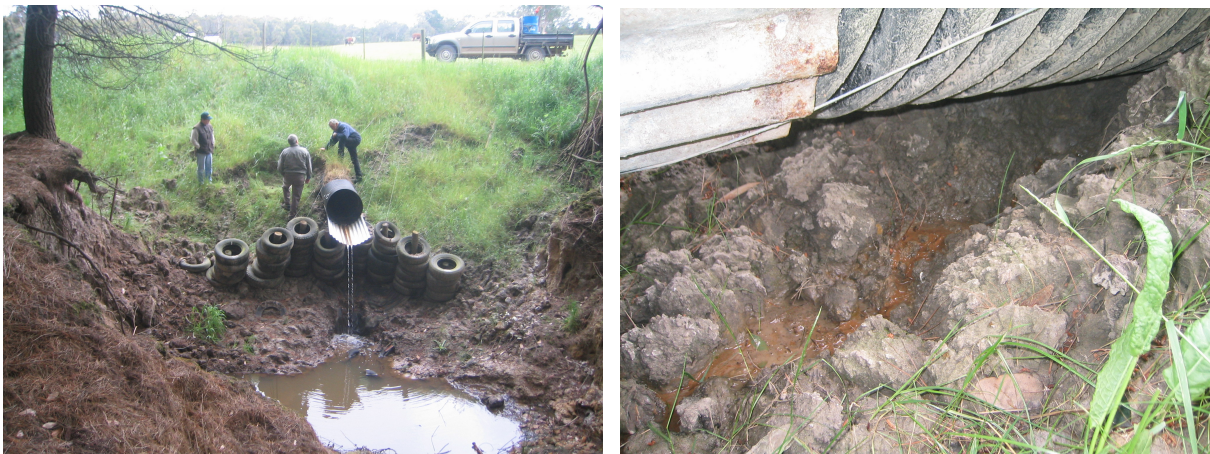
Returned to site with Greg Bell to see further attempts at stabilisation the Smiths had tried (deep posts with straining wire and tires to hold the bank up). Stan Armstead (contractor) also visited with us. The thought was that water was seeping along the outside of the pipe either from a poor seal at the pipe entrance or because of a natural spring underneath. When diluted paint was added to the pit at the pipe entrance the paint flowed through the pipe, not than along the outside, indicating that it was not a leak around the seal but more likely a spring under the pipe.

Photos 6 and 7: Further attempts at stabilisation of the overhanging pipe which has been undercut by erosion. Photo 7 shows the water leaking along the outside of the pipe causing the erosion around the pipe.
