Case Study 4 – Gully erosion in Eclipse Creek, tributary of the Moorabool River

Landscape zone:	Moorabool
Priority area in CSHS?	Eclipse Creek
CAMS work project no.	Output ID no
Works dates:	May 2007 – September 2007
Site inspected by:	Ralph Cotter & Shari Wallis, DPI Geelong
<p>Type and extent of threat: (erosion type, area covered, land holders involved, risk to assets) Sever gully erosion, approximately 700m in length had formed in a direct tributary of the Eclipse Creek. The property is owned by an elderly couple who considered it of high importance to ameliorate the gully and revegetate the site. The erosion was presenting considerable risk to asset in the form of direct sedimentation into the Eclipse creek which joins the Moorabool River only 2km from the gully site. The Moorabool River contributes water to water supply reservoirs managed by Central Highlands Water and Barwon Water.</p>	
<p>Site description: (soils, climate, landscape/topography, catchment area, dominant veg/land use)</p> <ul style="list-style-type: none"> The gully has formed on the dispersive sedimentary soils which have a very thin topsoil lay to protect the poorly structured subsoil. The area receives a

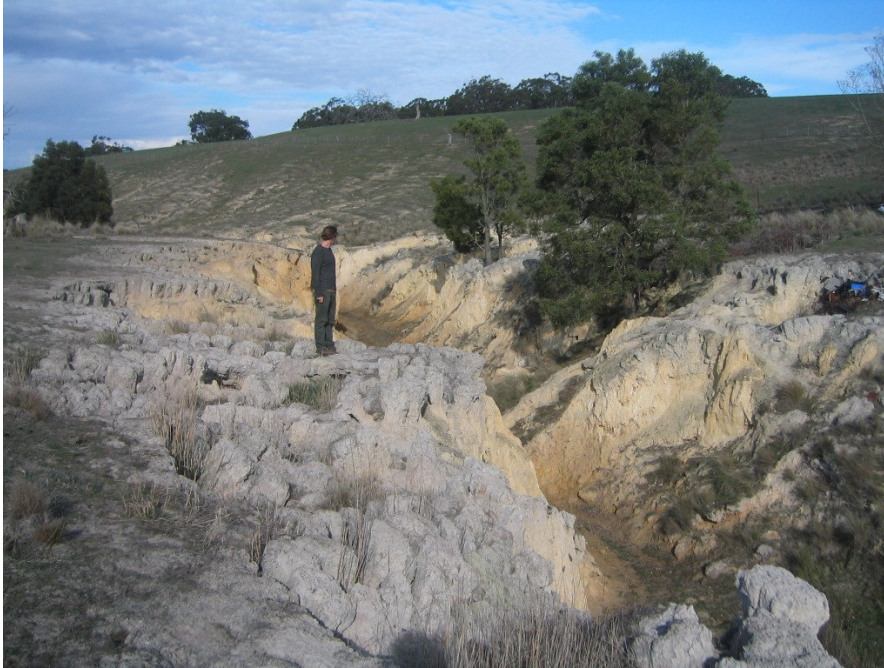
May 2007, main gully, note blackwood tree for positioning

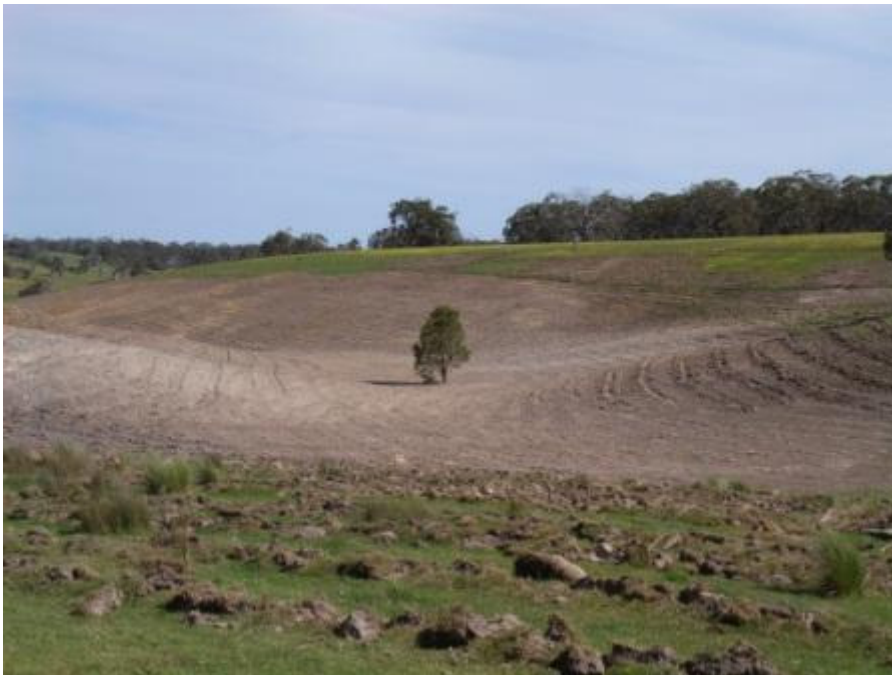
September 2007: After photo showing entire gully works completed and using the blackwood tree for positioning. Note surrounding slopes have been ripped ready for planning.

<p>Comments on completed works:</p> <ul style="list-style-type: none"> 1 month after the works were completed the area received around 80 – 90mm of rain over 3 days. On inspection of the site after this down pour the works have held up well with only minor channels scouring out. The own has since put a few rocks in places in these channels to slow any further water movement. However that was most likely the last big rain for the season.
