Case Study for Erosion and Landslides.

Western Freeway Bacchus Marsh

Report No: 356.3/04/06

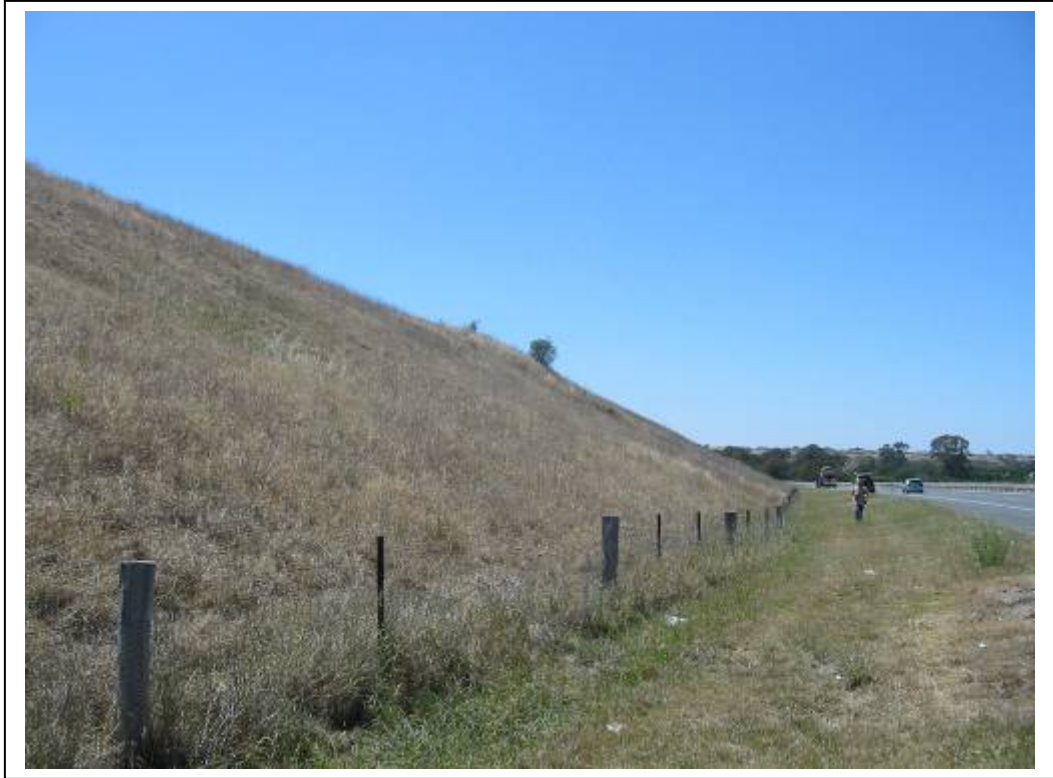
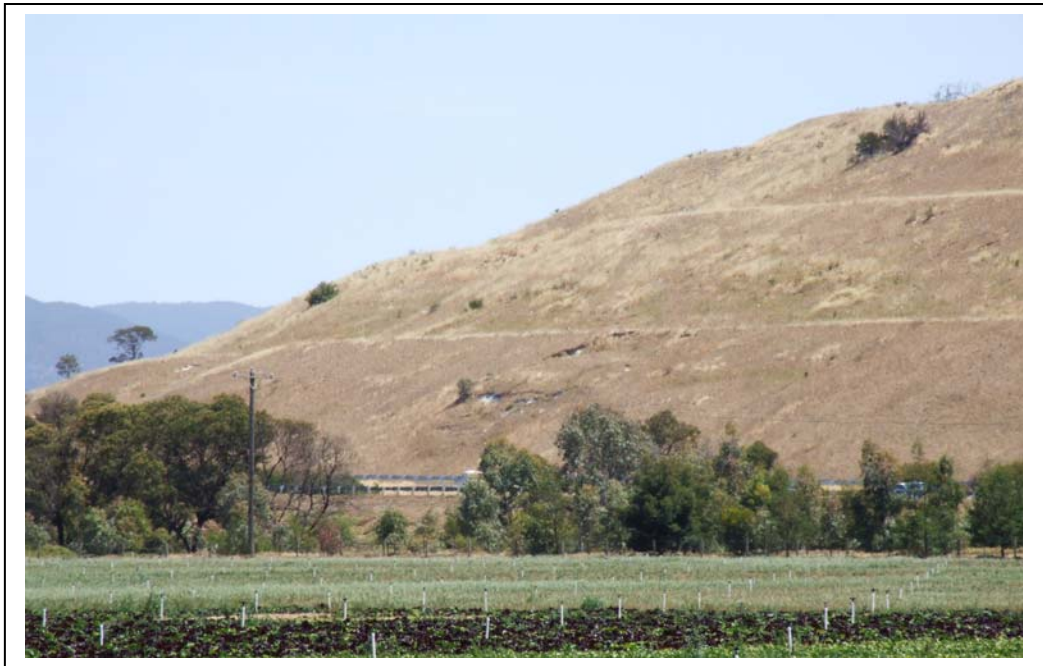
Photos

The site is located in a cutting on the northern side of the Western Freeway heading into Melbourne. A landslide has occurred in an extensive cutting and has travelled down the face of the cut slope but has not reached the road shoulder

A small rotational landslide is located approximately 20 metres upslope on an embankment adjacent to the Western highway. The slide has moved only a few meters but could continue to fail in wet weather and may have enough potential to travel onto the road.

Approximately 20 m (W) x 20 m (L) x ??m depth . However the depth appears to be not more than a metre or two.

The slide only appears to have moved cms to less than a metre and the rate of travel has probably been slow

Removal of failed materials and surface protection using a geotextile (possibly biodegradable) to assist vegetation growth
