Case Study for Erosion and Landslides.

Melba Parade, Anglesea

Report No: 356.3/22/06

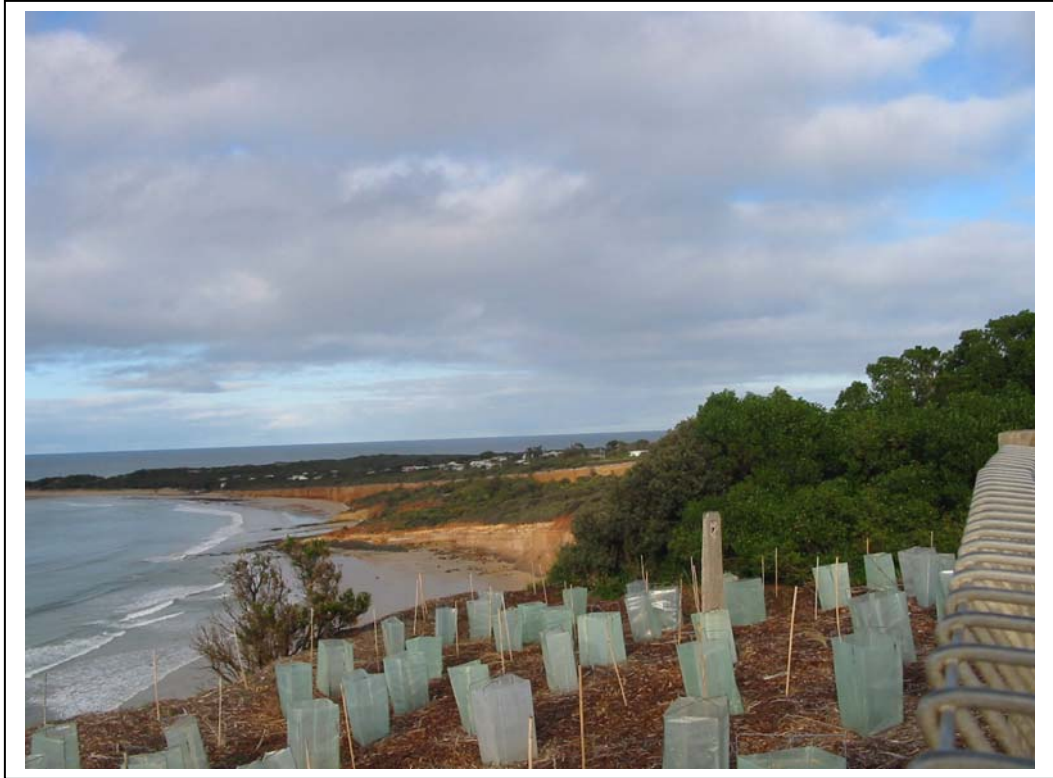
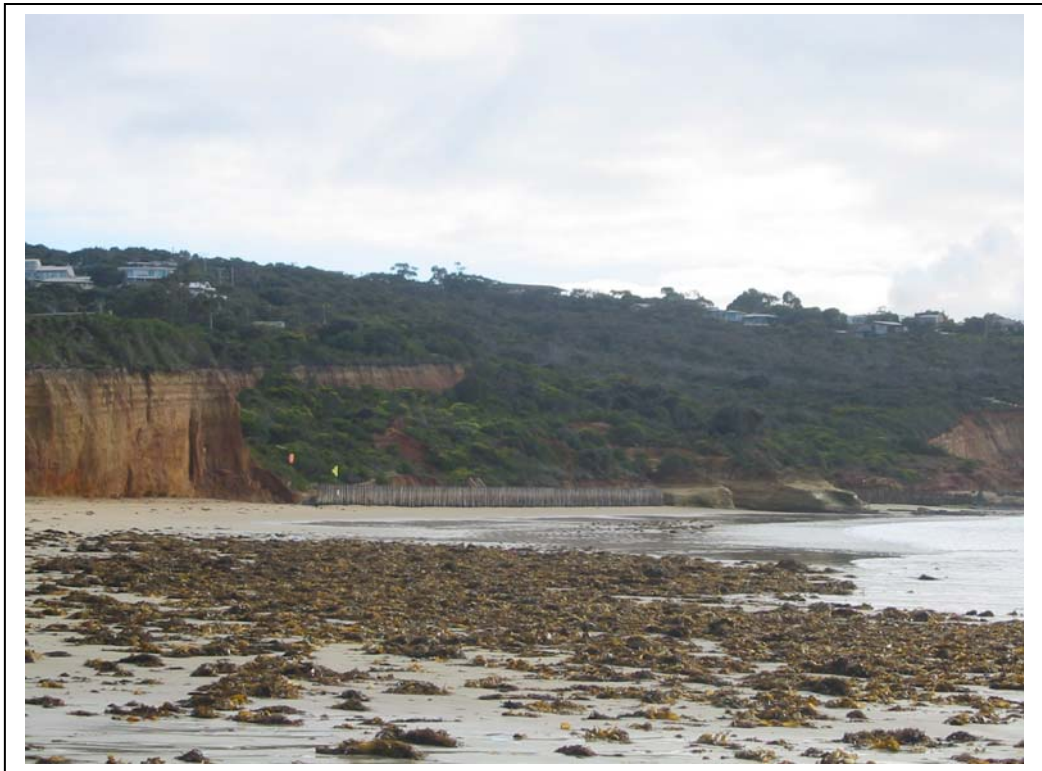
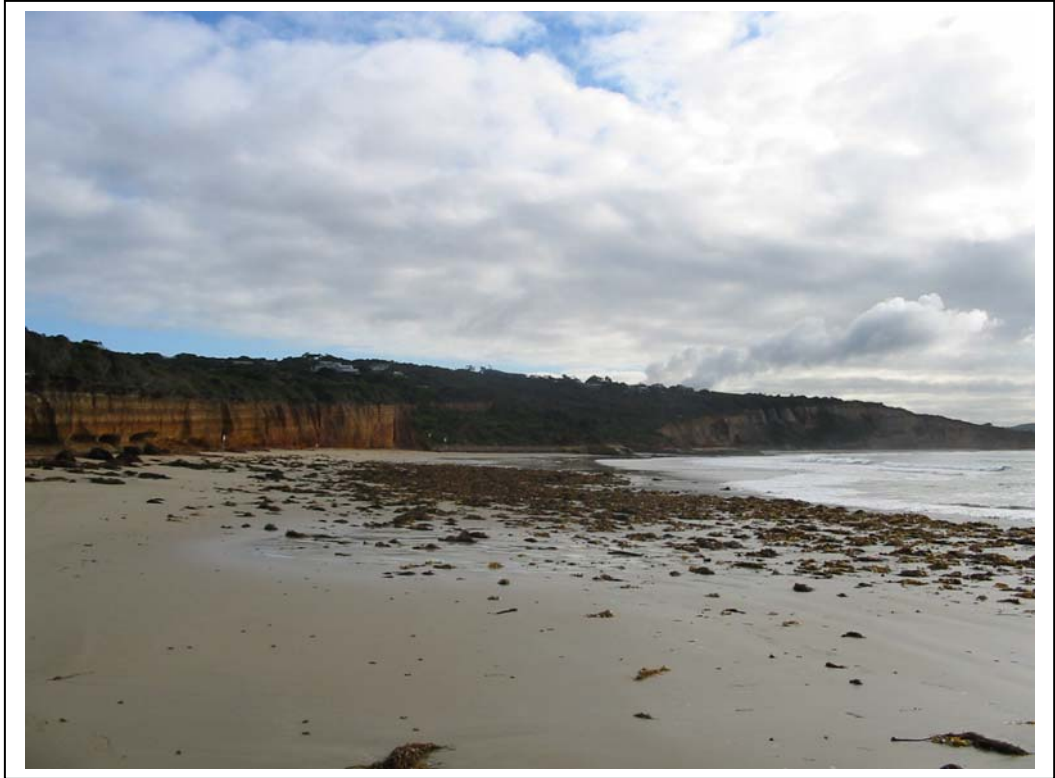
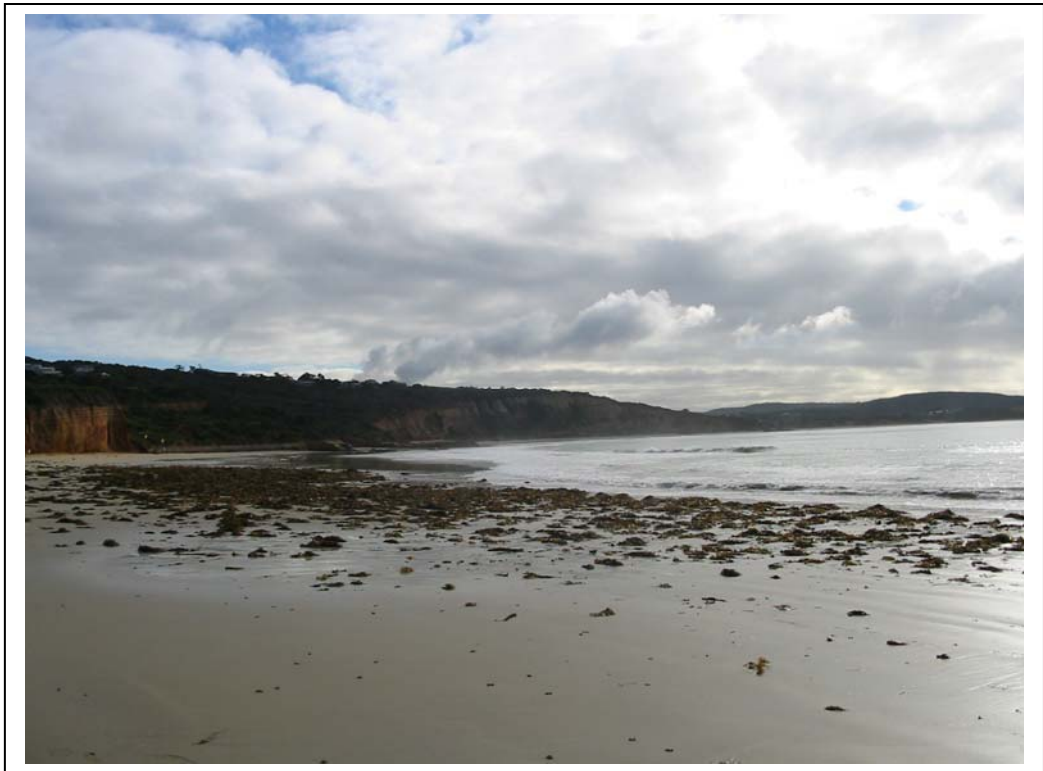
The landslide is curvilinear in plan with a subvertical profile and varying in height from 10 to 15 m. The landscape north of the headscarp of the slide rises at 1 in 12. To the east a series of isolated stacks show the path of cliff retreat. Beneath the face the area is quiet hummocky with a zone of "flowage" reaching towards the sea where material is being actively eroded away.

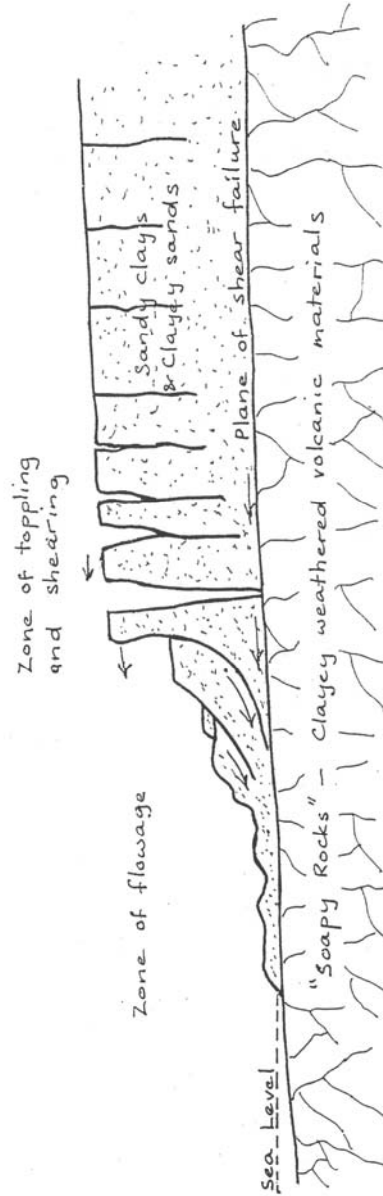
FIG. 14

Landslide at Point Roadknight, Anglesea
