Corangamite Catchment Management Authority and the City of Greater Geelong

Case Study for Erosion and Landslides.

Horsehill West Rd, Elaine

Report No: 356.3/33/06

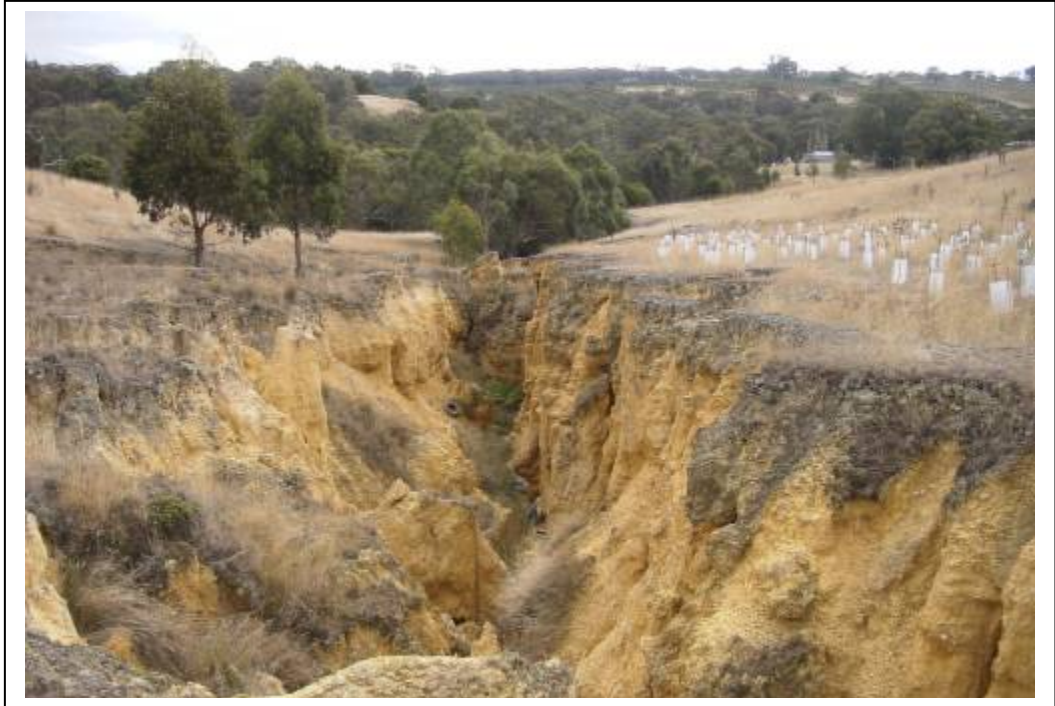
Extensive gullying and tunnel erosion exist at the site and have the potential to impact access roads and some drop structures in the head of the gully.

Extensive gullying has degraded the drainage line to such an extent that the gully is now very difficult to remediate. The concrete drop structure has been undermined and requires significant repairs. The access road is in danger of being undermined and will also need to be stabilised.

As discussed the gully is extensively impacted although due to the deep incision the amount of land around the gully effected is still minimal. The road is yet to be impacted whilst the concrete drop structure is un servcieable

The extent of gully and tunnel erosion is beyond any limited solution and requires carefully planned and staged total catchment remedial works probably over a period of a decade and may be beyond the resources of this project. The consensus of discussion at the site was to tackle the erosion from the top of the catchment with the primary focus on halting of the migration of the headward erosion of the main gully.

Initial works would involve excavation below the current gully-head structure to assess the extent of the tunnelling. Depending on the conditions of the footings it may be necessary to construct a concrete key into solid foundation materials and backfill the excavation with either well compacted on site materials or a bentonite cement sand mixture which would provide a hydraulic barrier to water at the location. An exploratory excavation and reconnaissance site investigation would assess the requirement for future works. A more detailed specification could then be prepared with better estimates of materials and equipment requirements.

The short term stability of the road is also of concern, although may not be a priority for funding under this project. When the road collapses, the simple and practical solution will be to repair the road as it fails by backfilling the trench with rock. Although it is not a long-term solution it would be the most economical way of dealing with the problem.
