a.s.miner
Geotechnical
Consulting Engineers

Case Study for Erosion and Landslides.

Penny Royal Erosion – Clissolds

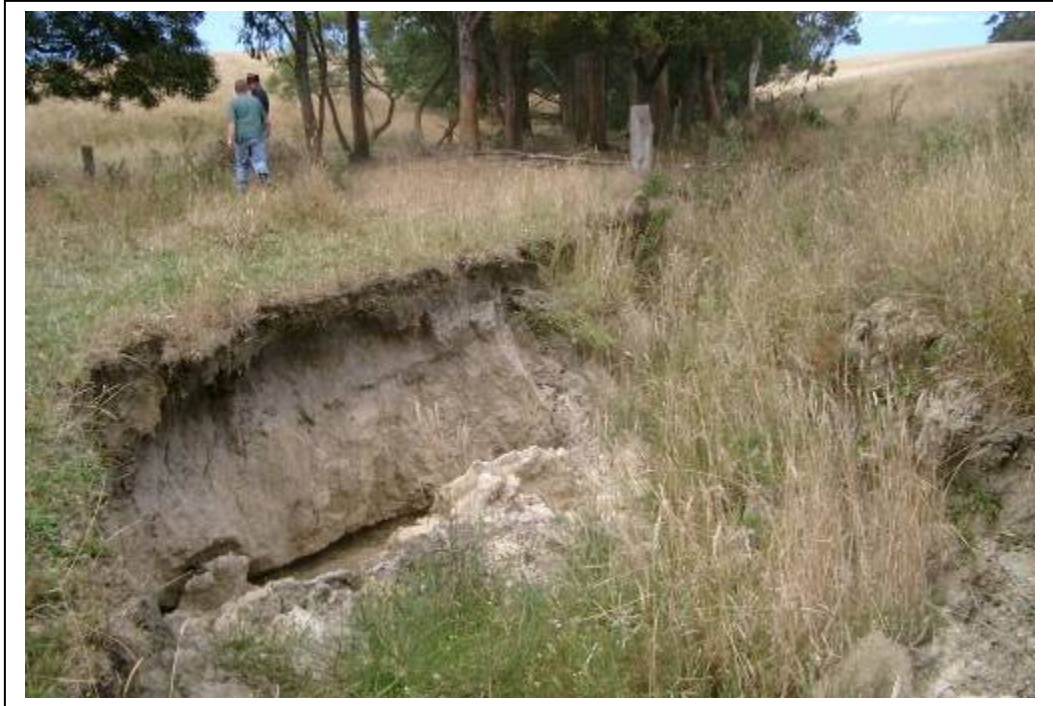
Photo 1 Initial site assessment prior to works February 2005. Photo taken looking east

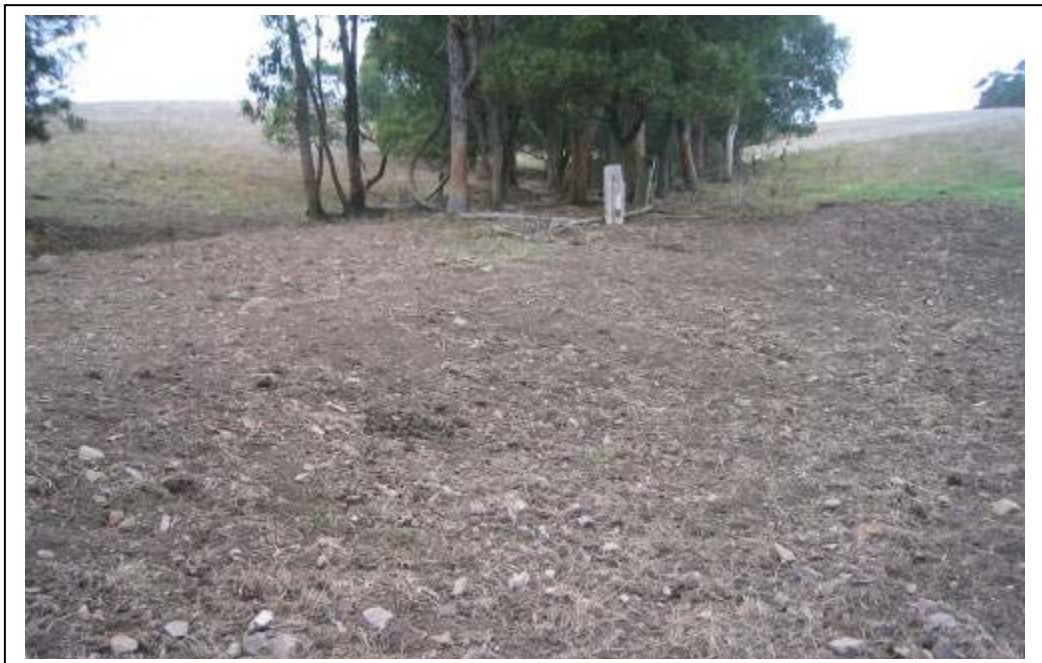
Photo 2 After works, same site as above photo, taken May 2005

Earthworks – gully battering, bringing in fill, compaction

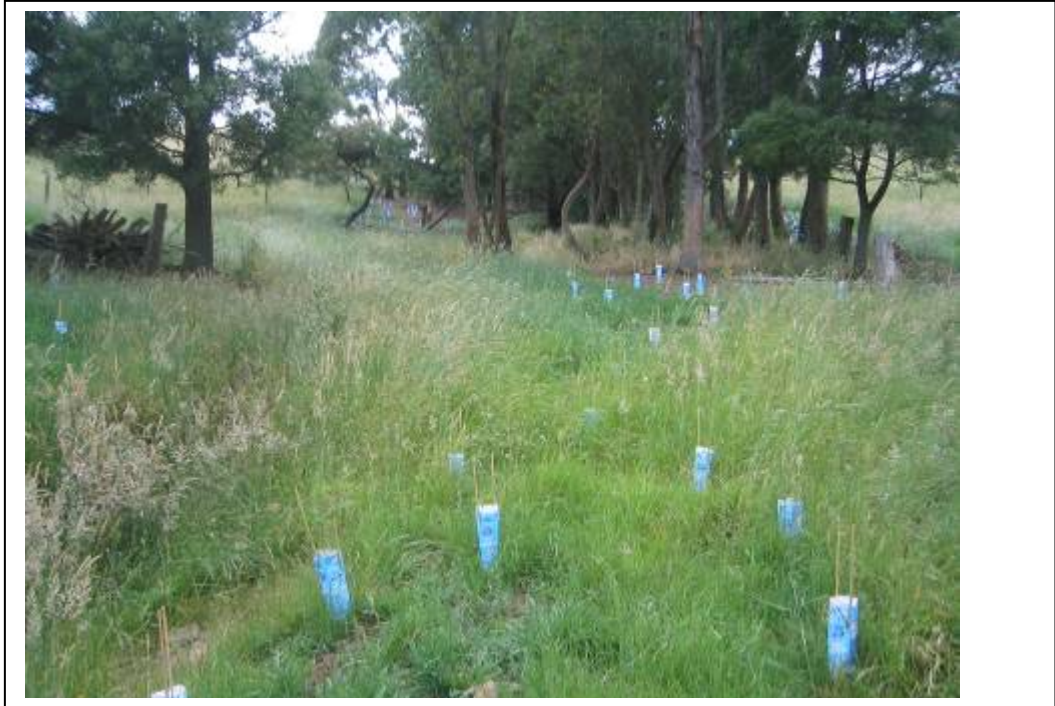
Photo 3 2006. After fencing and revegetation of site.

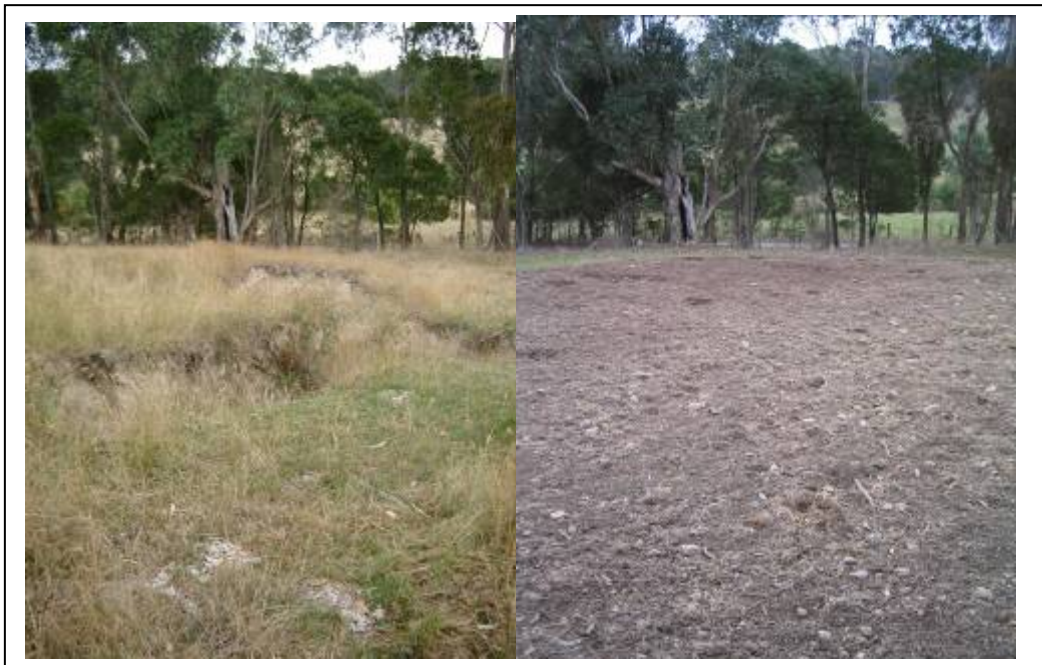
Dimensions of the collapsed gully are 15m (L), 2 – 3m (depth), 3 – 5m (W).

Photo 4 Before (Feb 2005) and after (May 2005) photos of collapsed gully section.
Photo taken looking west

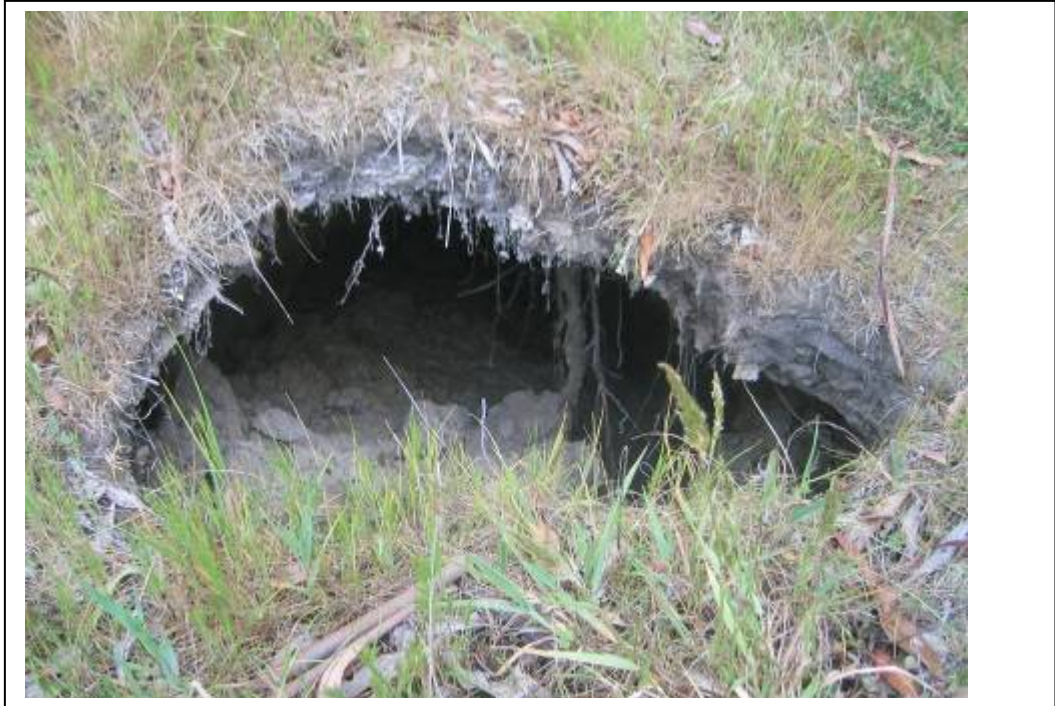
Ineffective – tunnelling must have continued or compaction of area was insufficient because a new area collapsed in, further reducing the landholders access via that track.

Photo 5 November 2006, a section of the track has re-collapsed, opening up a 2m sq. 'cave' under the area previously worked on.

Further groundwork's may be required to fill and compact the new hole

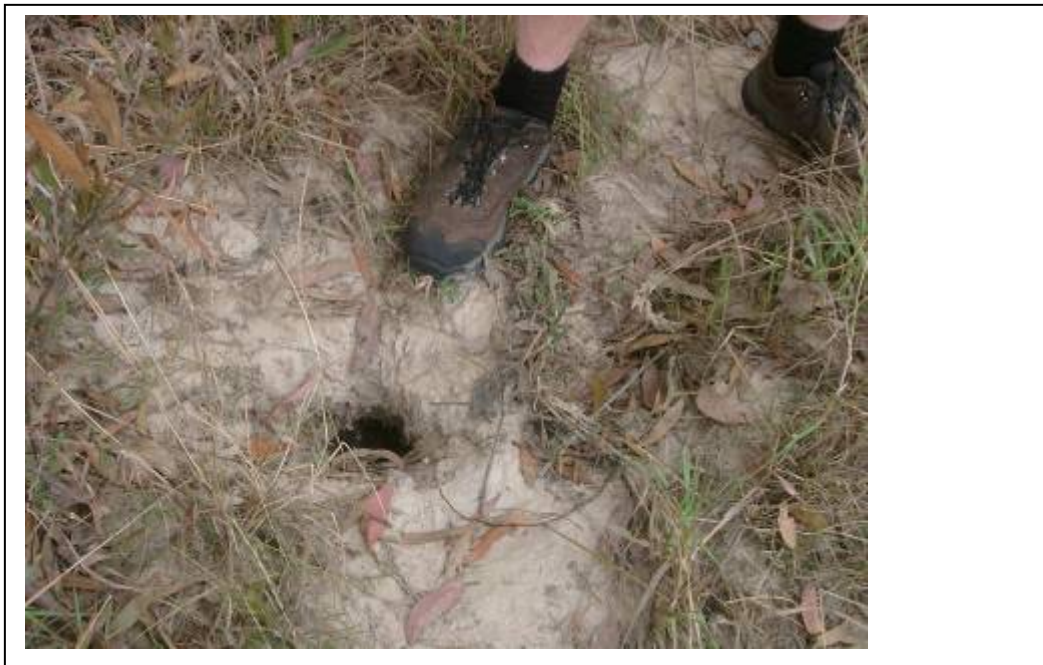
The hazard at the site is tunnel erosion, a length of less than 100m along a drainage line. A small section of this has collapsed and created tunnel erosion. This site is above the Pennyroyal valley road and sediment being removed for the site via the tunnelling is being deposited on the road. There is a small 'exit' hole from the tunnelling where sediment fans out on the road side. The danger is that more extensive undercutting of the road may be occurring but is not yet visible. With the site being so close to the Pennyroyal Creek there is also a high risk that, in heavy rainfall events, sediment may be transported into the water system.

Photo 6 The tunnel erosion 'exit' site is on the edge of the Pennyroyal Valley Road and deposits sediment on the road. Sediment was still being deposited after works were completed at the Nov. 2006 inspection.
