a.s.miner
Geotechnical
Consulting Engineers

Case Study for Erosion and Landslides.

Guys Rd Corriemungle (Pau's)

Report No: 356.3/12/06

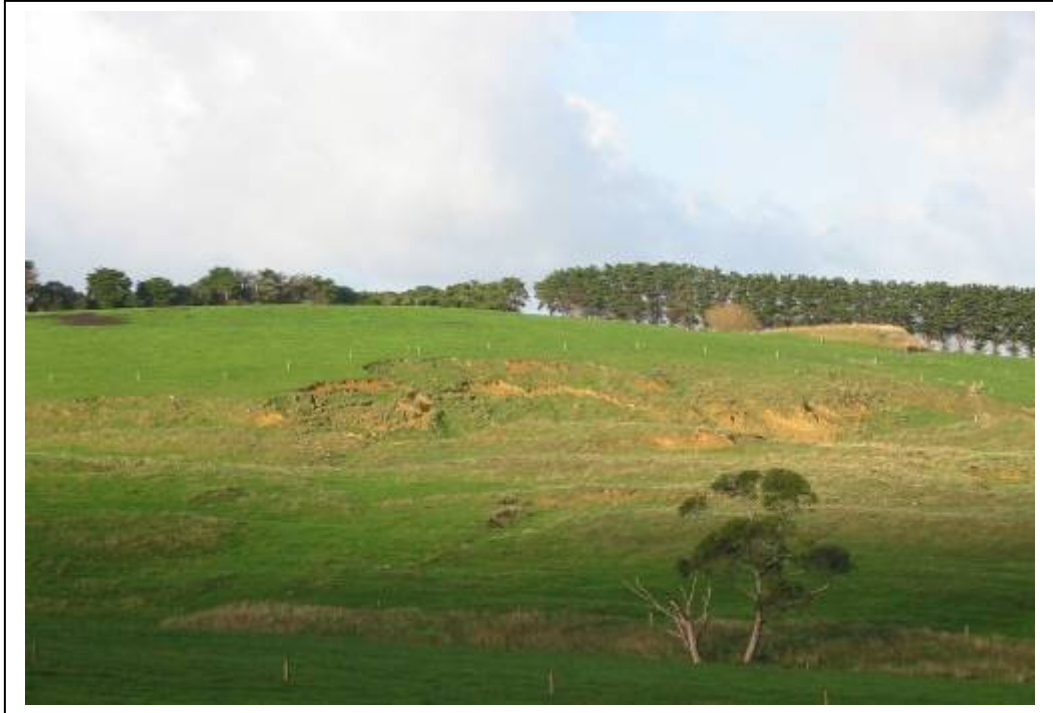
Photo 1 John Pau's Property sometimes referred to as "Sliding Slopes" taken in Aug 2006 during a reconnaissance inspection of The Heytesbury
