Appendix D: Processes and results for validating investment priorities

D.1 Validation of risks

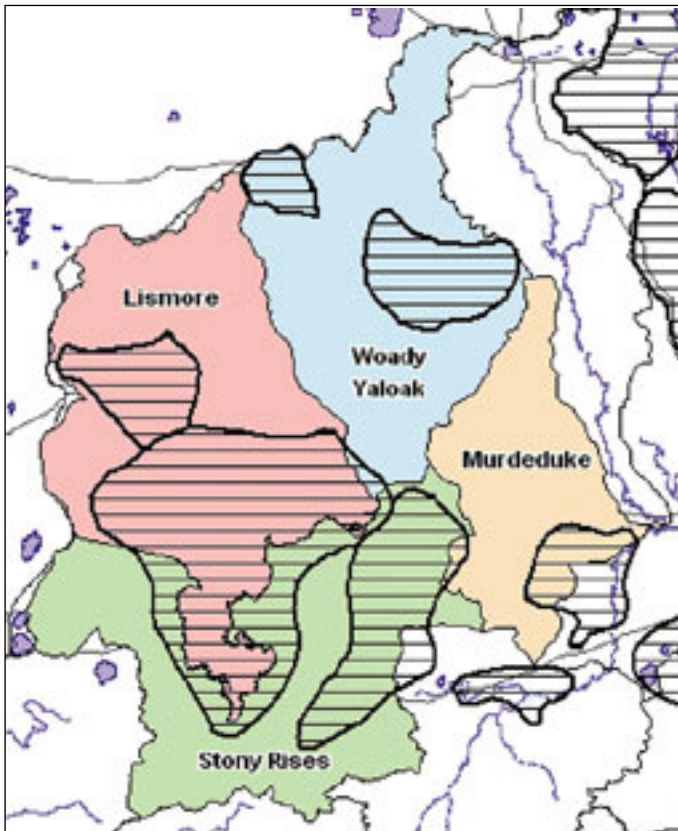
Figure D1: The overlap between the Corangamite Salinity Action Plan target areas (hatched) and the four landscape zones where secondary salinity is a priority in the Corangamite Soil Health Strategy

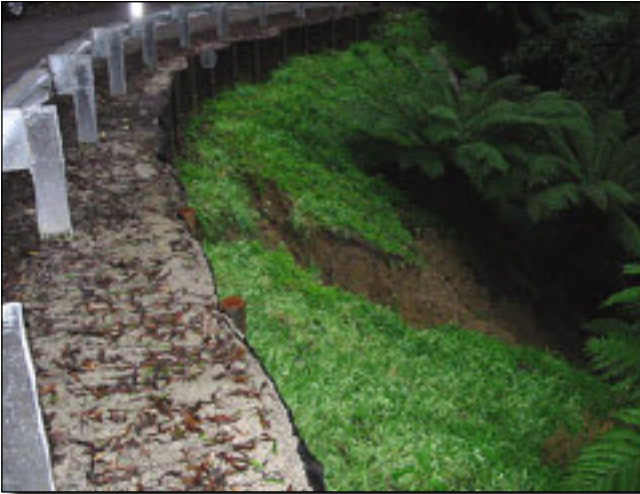
The highest-ranking landscape zone was the Gellibrand, which was found to contain a diverse range of landslides (*Table D1*). Significant impacts were noted on major tourist roads at various locations on the Great Ocean Road, including a recent failure at Princetown requiring engineering works and major stabilisation. In excess of \$700,000 for remediation works were required on Turtons Track due to landslide damage after a severe rainfall event in February 2004 and ongoing occurrences of landslides below these remedial works were noted during the recent inspection (*Fig. D2*).

Figure D2: New failure below recent remedial works on Turtons Track (Gellibrand Landscape Zone) Photograph: A. Miner 2006

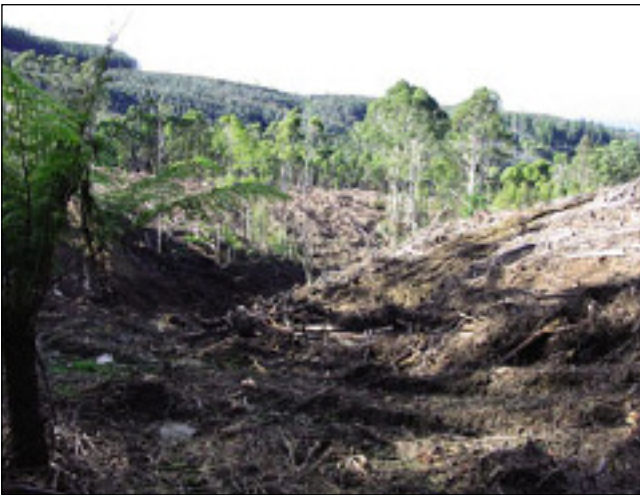
Risks to water quality and the environment were recently emphasised by the closure of the Ford River due to a landslide, which occurred after forestry activities. Other areas of logging and forestry were also noted at the northern end of Bins Road and in the Beech Forest area and whilst access to such areas was restricted, risk to water quality and the environment are considered possible if good forestry practice is not employed (Fig. D3).

Figure D3: Forestry and logging with minor landslides and erosion on waterway just off the Great Ocean Road (Aire Landscape Zone) Photograph: A. Miner 2006

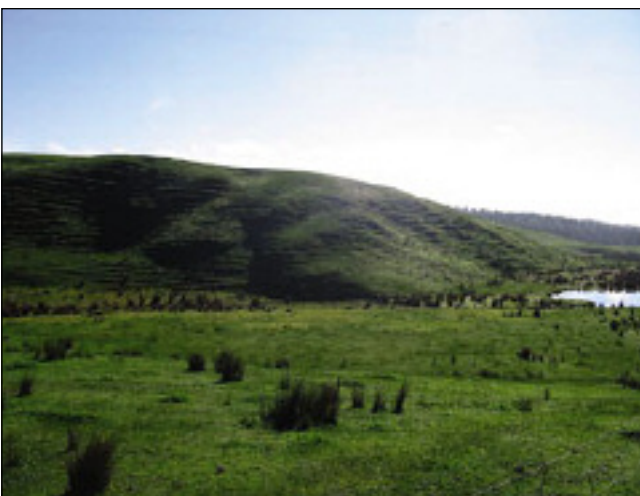
Minor slides on the Barwon River on the Lorne-Winchelsea Road were noted as having a minor risk to water quality, with a similar assessment of risks along some of the smaller creeks such as Scrubby Creek. More significant risks have been assessed for some sections of the water supply infrastructure in the region, with landslides known to have impacted on the main supply channel and associated syphons taking water from the West Barwon Dam to the Wurdee Boluc Reservoir. Other isolated slides are also known to have occurred adjacent to the channel near Wurdale Road. Any long-term disruption to this channel represents a significant risk to Geelong's water supply network.

Figure D4: Landslides adjacent to Scrubby Creek (Upper Barwon Landscape Zone) Photograph: A. Miner 2006

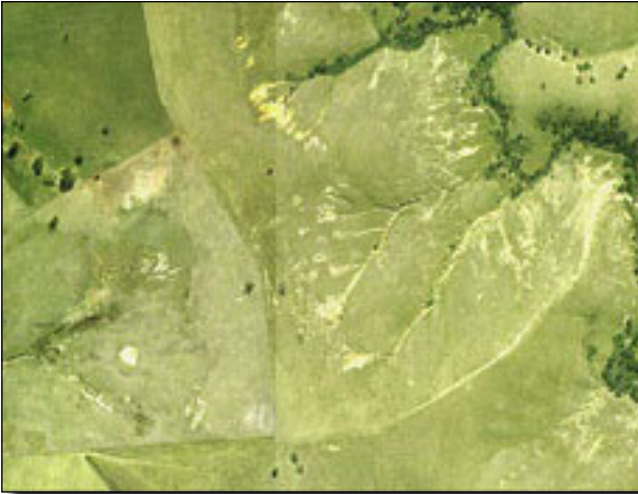
Along with the Moorabool, erosion by water in the Woody Yaloak Landscape Zone was verified to have the highest risk of all landscape zones (Table D2). The most severe erosion in the Woody Yaloak, and perhaps the Corangamite region, was on the hills surrounding the Misery and Moonlight creeks (Fig. D5). This area had extensive sheet, rill and gully erosion. Significant sedimentation to the Misery and Moonlight creeks from the erosion is highly likely. Much of this sediment will flow into the Woody Yaloak River, which will eventually flow into Lake Corangamite.

The erosion has significantly impacted on agricultural production in the Misery and Moonlight area. Many of the hills have no livestock as there is no ground cover available for feed. Some farmers have spent thousands of dollars over the years to address the erosion and to bring back the productive value of their land. Amelioration of erosion in the area has had varying success.

Figure D5: The pale areas indicate areas of sheet, rill and gully erosion in the Moonlight Creek area (Woody Yaloak Landscape Zone)

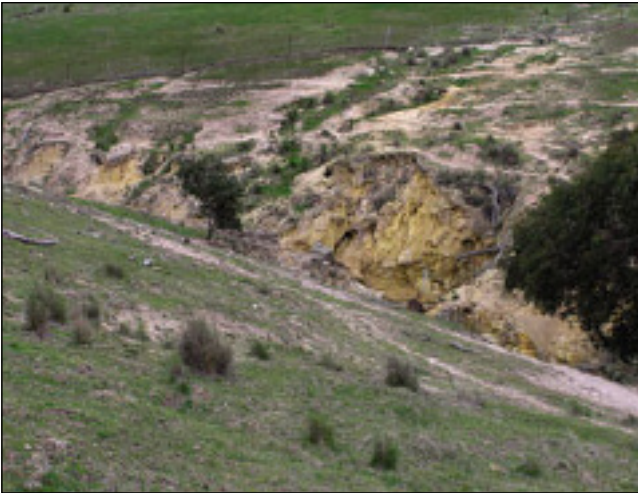
Field verification found a number of active erosion sites along most of Eclipse Creek, which is a tributary of the Moorabool River north-east of Meredith (*Fig. D6*). This area has numerous sheet, rill and gully erosion sites, most of which were active.

Sedimentation from Eclipse Creek is likely to contribute sediment loads into the Moorabool River and eventually into water supply reservoirs and into the Barwon River, which flows into Lake Connewarre. Investigations have linked sediments found at Lake Connewarre to sediments derived from the Moorabool River. Central Highlands Water and Barwon Water have expended large resources in the past for water quality treatment and dredging sediments from their water supply reservoirs.

Figure D6: A gully erosion site along Eclipse Creek (Moorabool Landscape Zone)

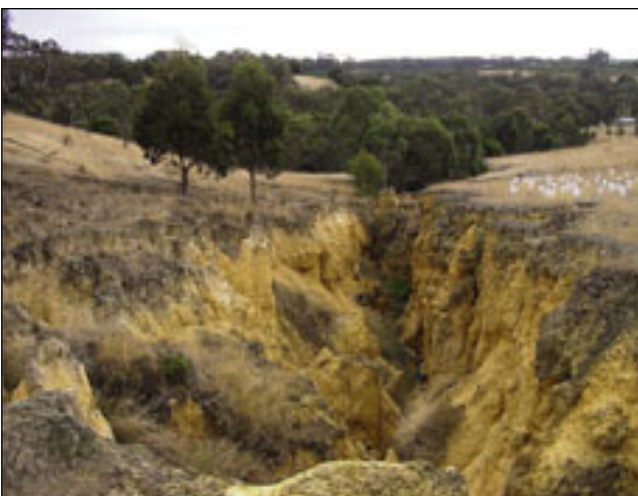
Figure D7: A gully erosion site connecting with a tributary close to the entry of the Leigh River (Leigh Landscape Zone)
