Corangamite Catchment Management Authority and the City of Greater Geelong

# Case Study for Erosion and Landslides.

Great Ocean Road (1949)

Report No: 356.3/32/06

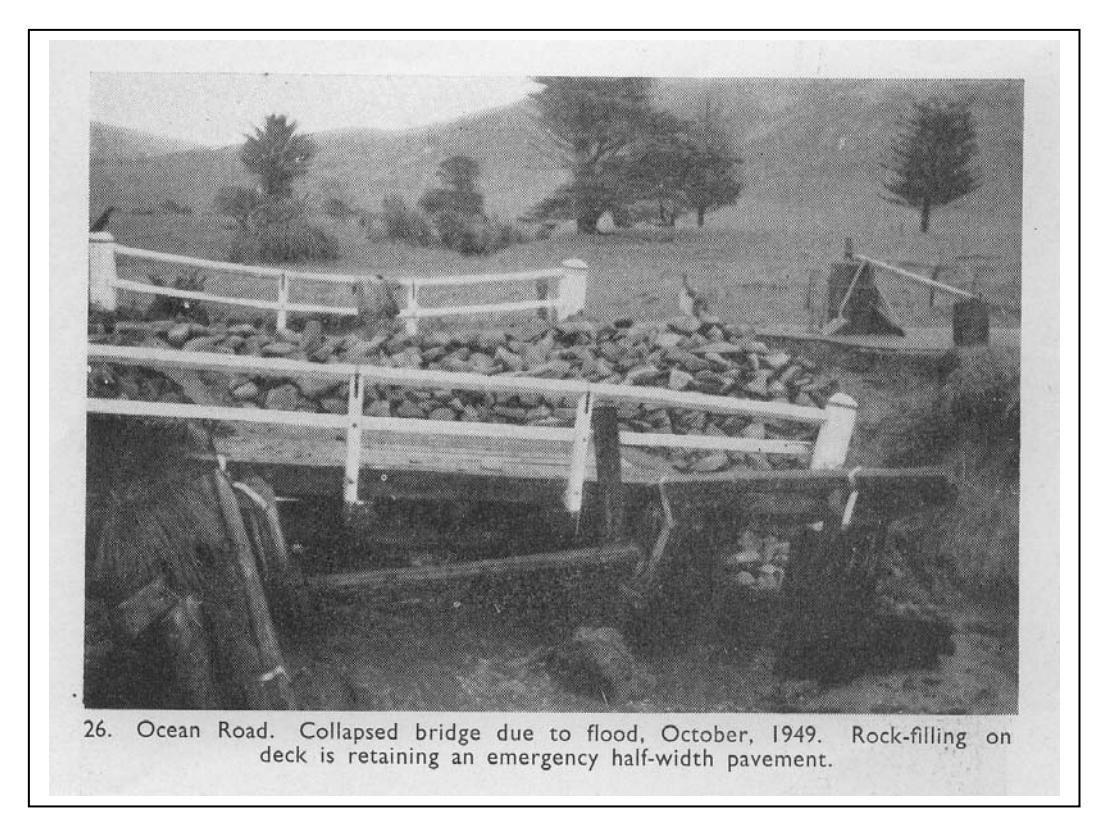
Photo 1

Rockfalls slides and collapses of bridges occurred during heavy flooding in October 1949 (see attached photos). The result was traffic was blocked between Lorne and Apollo Bay with a section between Lorne and Anglesea also closed but for a shorter period. Principal damage derived from slips from the high side of the road but more serious slips also occurred on the low side which involved the provision of retaining walls. The slide at Cape Patton (see Photos) is a good example of a low side slide.

Slips were probably removed by machine (excavator) and side cast over the coastal edge of the road. New retaining walls were built at some locations including Cape Patton.

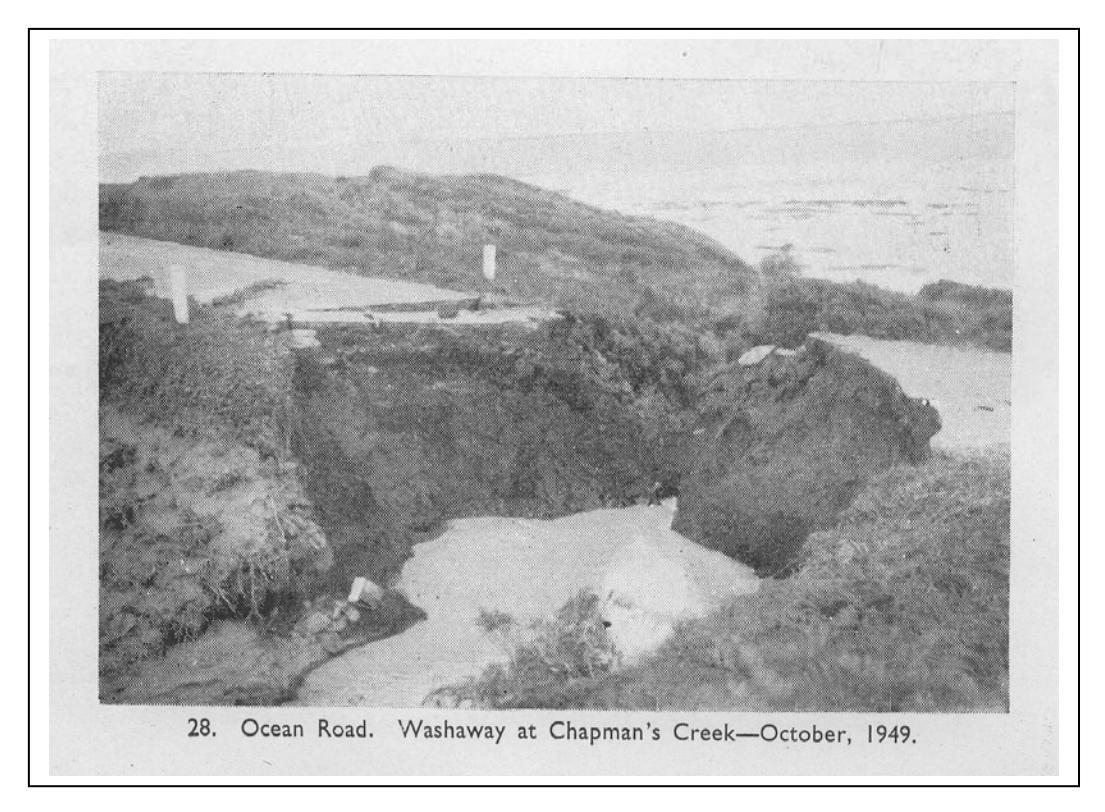
Photo 3

In all, damage occurred at 38 points between Lorne and Apollo Bay as well as damage to a culvert and filling at Chapman's Creek (see Photo) and the loss of a bridge near Apollo Bay (see Photo).
