a.s.miner
Geotechnical
Consulting Engineers

**Field Verification of Relative Risk
to Asset Rankings for Erosion
and Landslides in Landscape
Zones in the CCMA**

Supporting Document to the
Corangamite Soil Health Strategy

Report No: 352/01/06

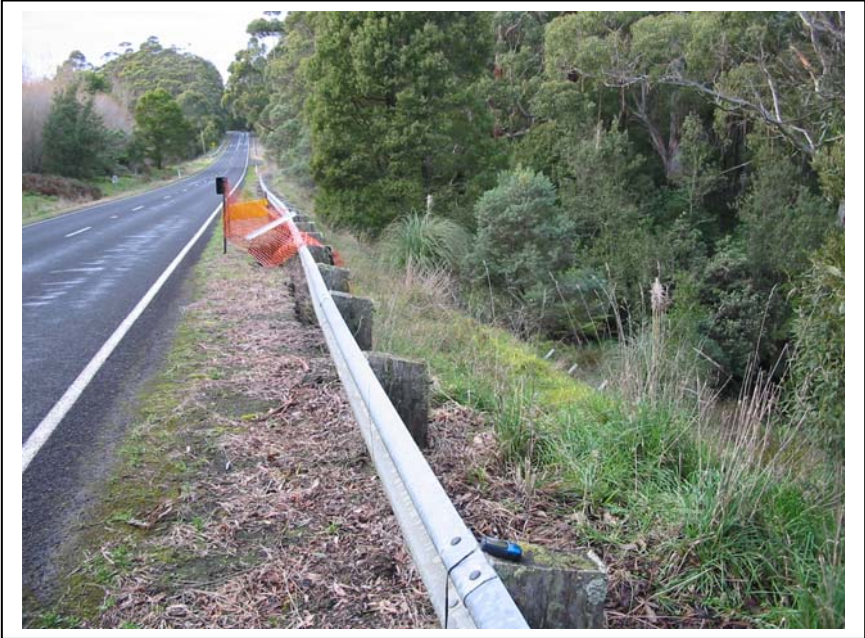
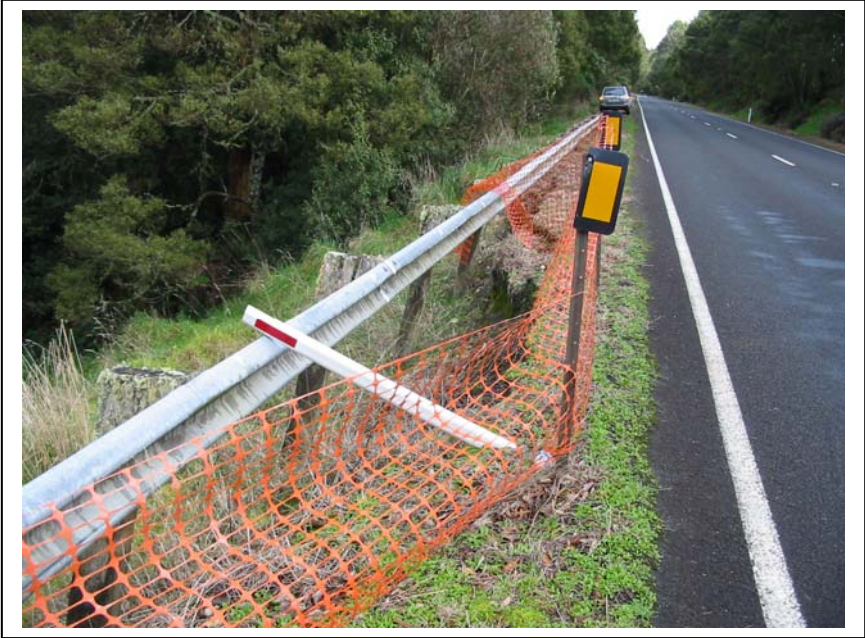
Photo 1

What might happen? Small sized landslides has caused damage to road and retaining structure.

What damage, impact or injury may result? Damage to road causing partial closure and need for new stabilisation structure

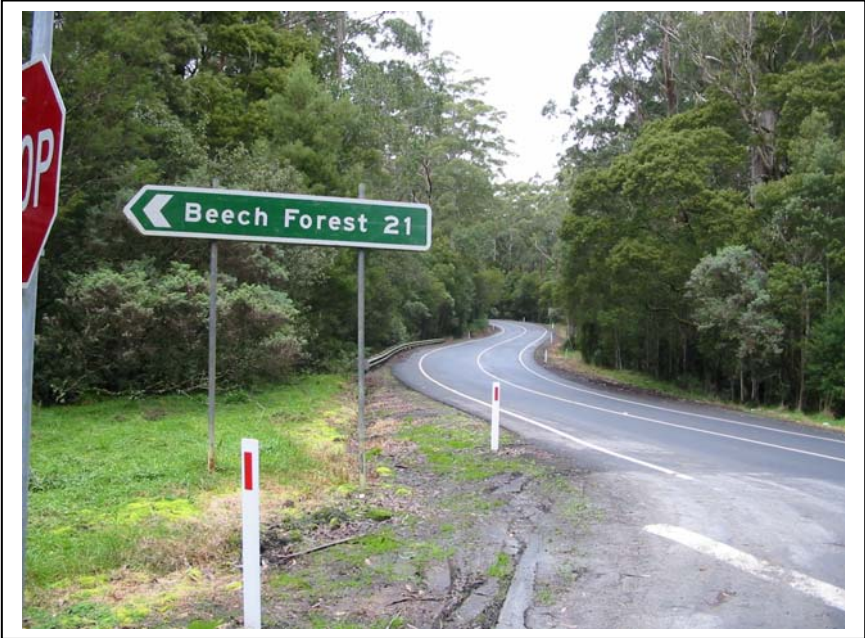
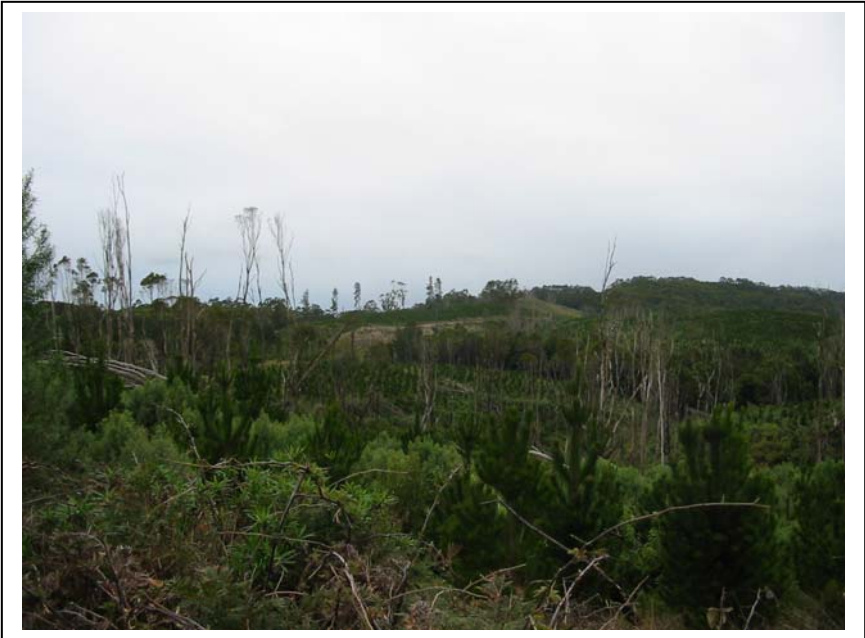
Photo 1

What damage, impact or injury may result? Sediment inputs into waterways

How important is it (sensitivity)? Could be moderate if significant sediment or rivers were blocked which has been observed elsewhere in the Otways

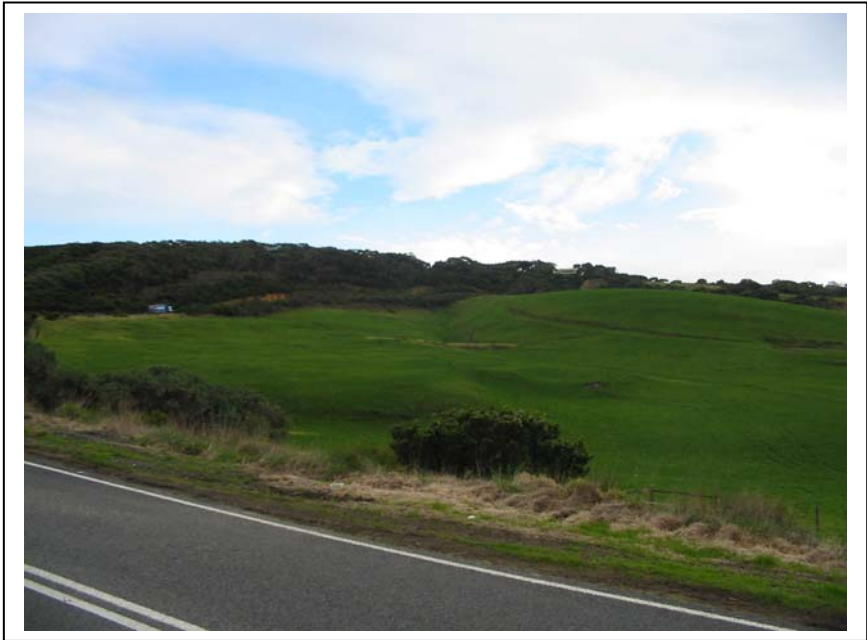
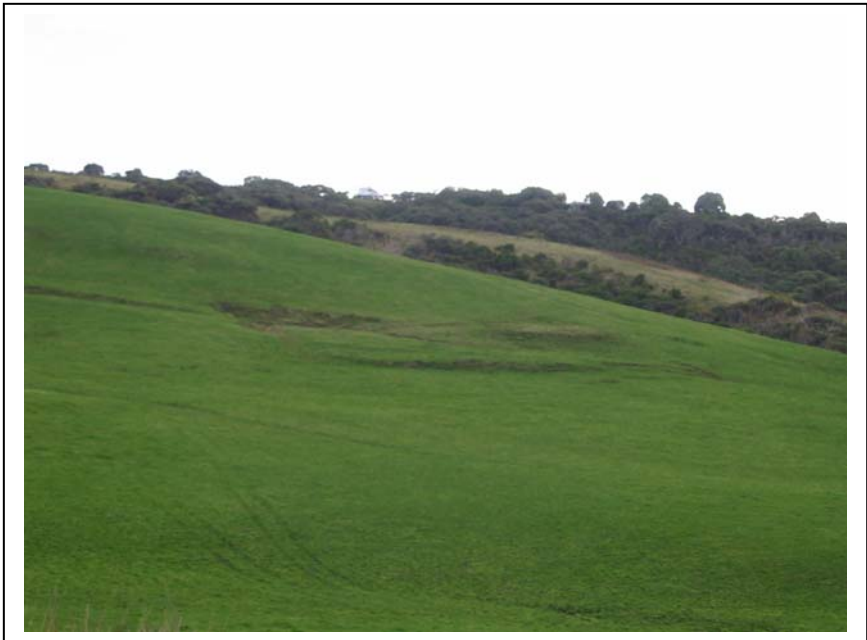
What damage, impact or injury may result? Disruption to farm track and ag land but generally minimal.

What can be done about it? Attention to site drainage and possible re-plough in area to avoid water infiltration.

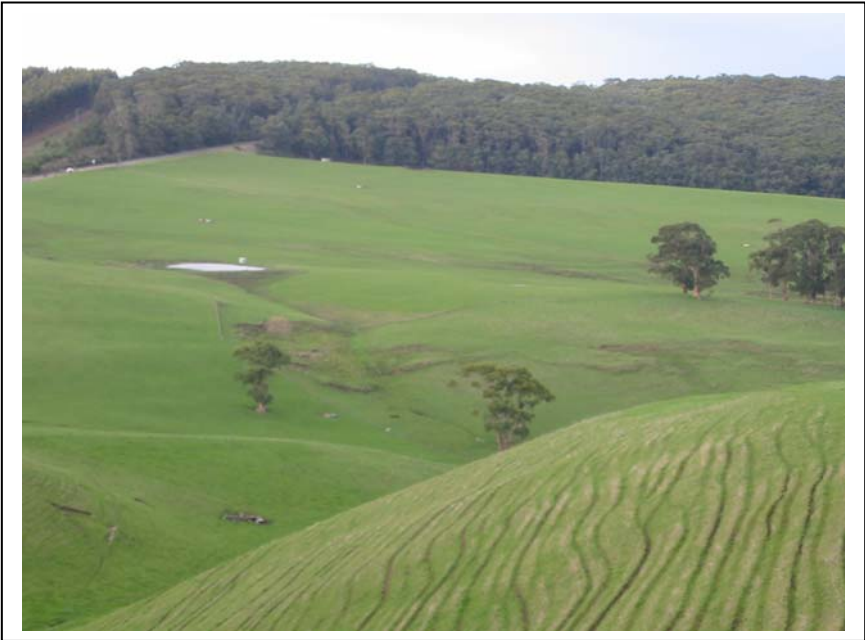
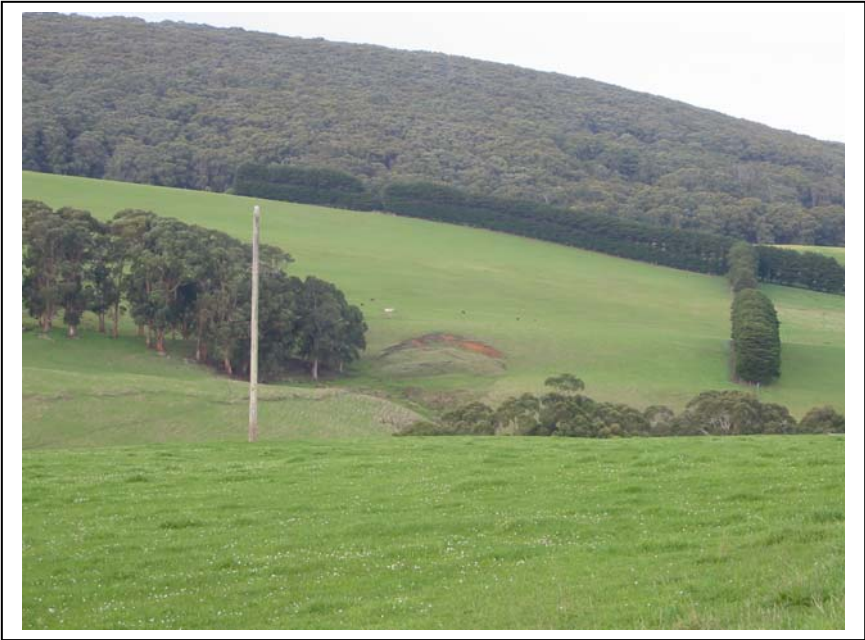
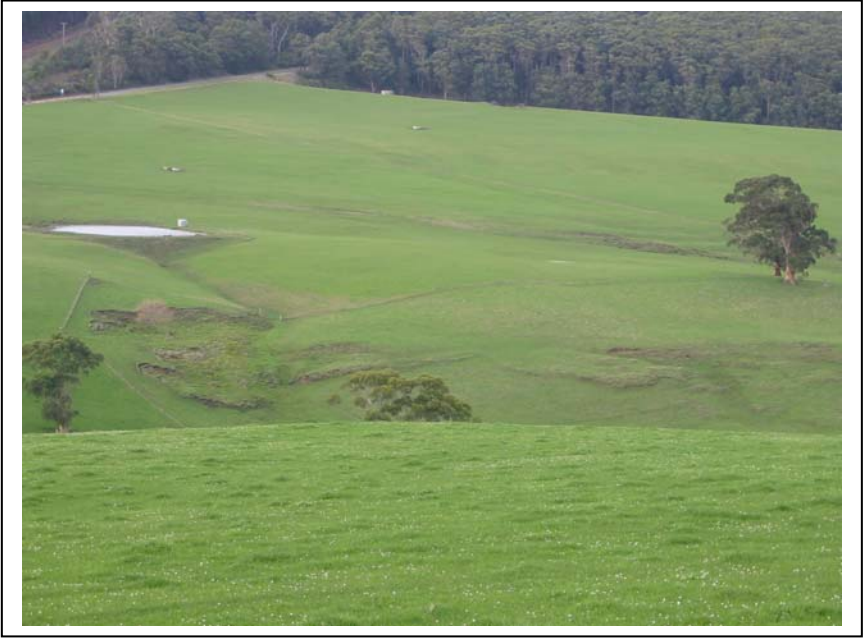
Photo 1

What damage, impact or injury may result? Damage might result to agricultural land but not much else.

What can be done about it? Attention to surface drainage and re-ploughing may avoid further infiltration.

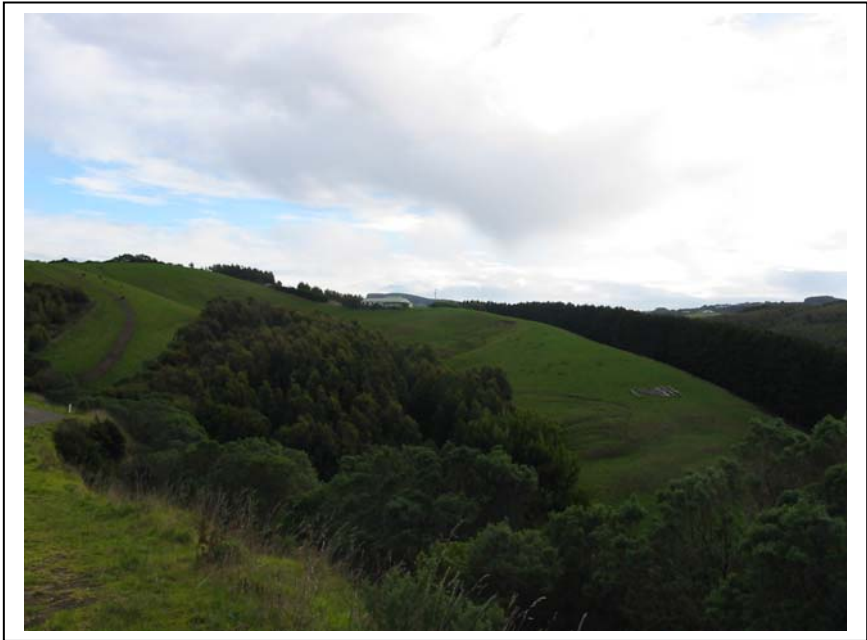
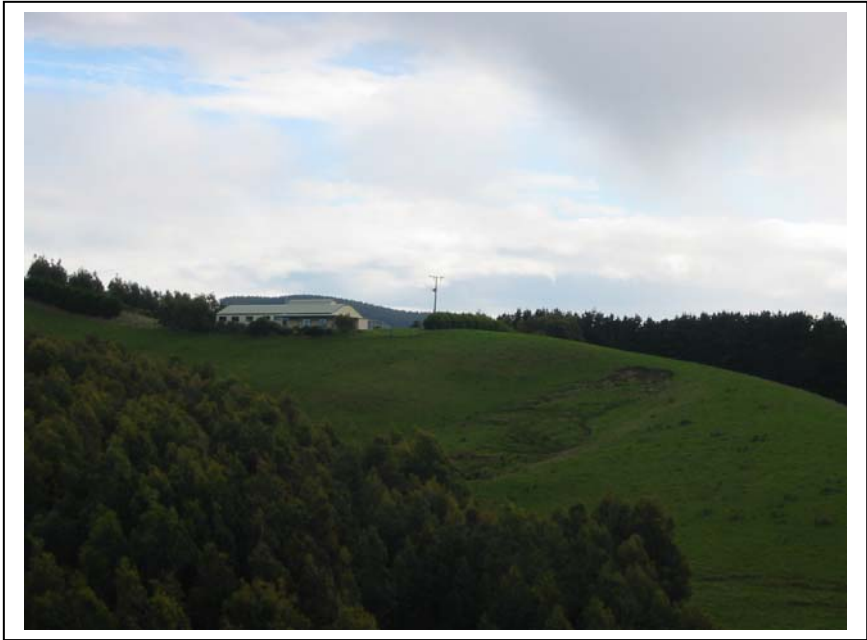
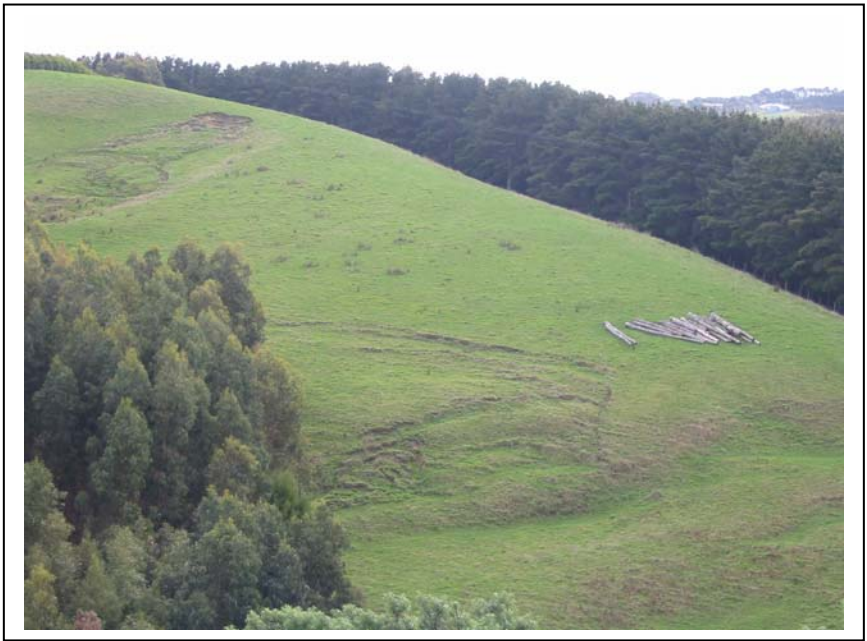
Photo 1

What might happen? Shallow translational failures are progressively occurring on slope below a dwelling on the ridge.

How likely is it? Likely to certain with potential for reactivation under adverse conditions.

What damage, impact or injury may result? Immediate disruption to agricultural land but may impact dwelling at some stage.

How important is it (sensitivity)? Relatively minor to house but consequence may increase if the slides progressively fail upslope

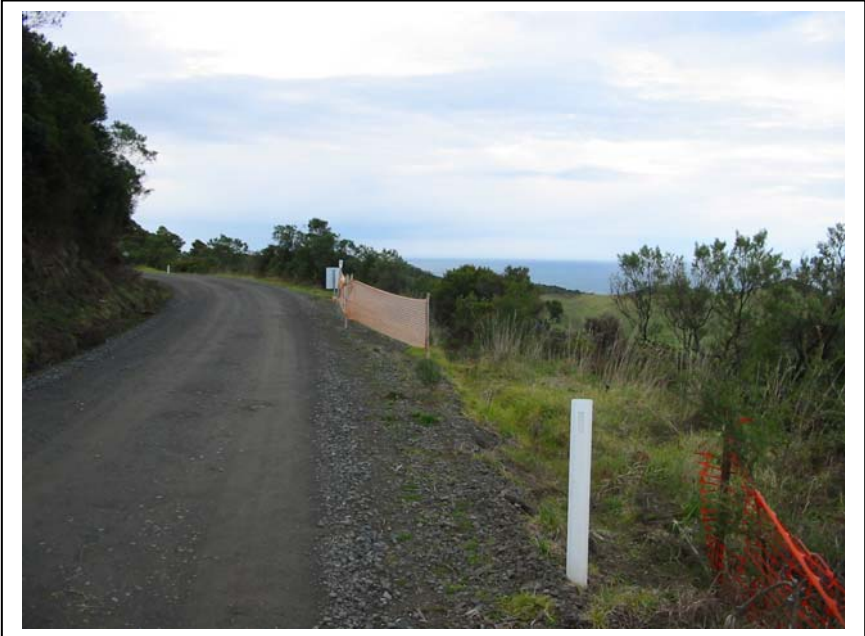
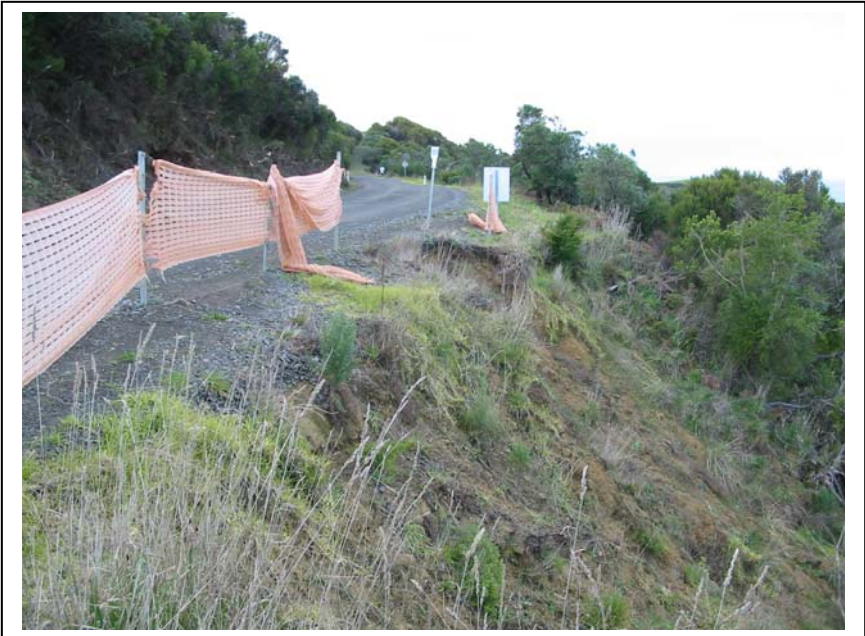
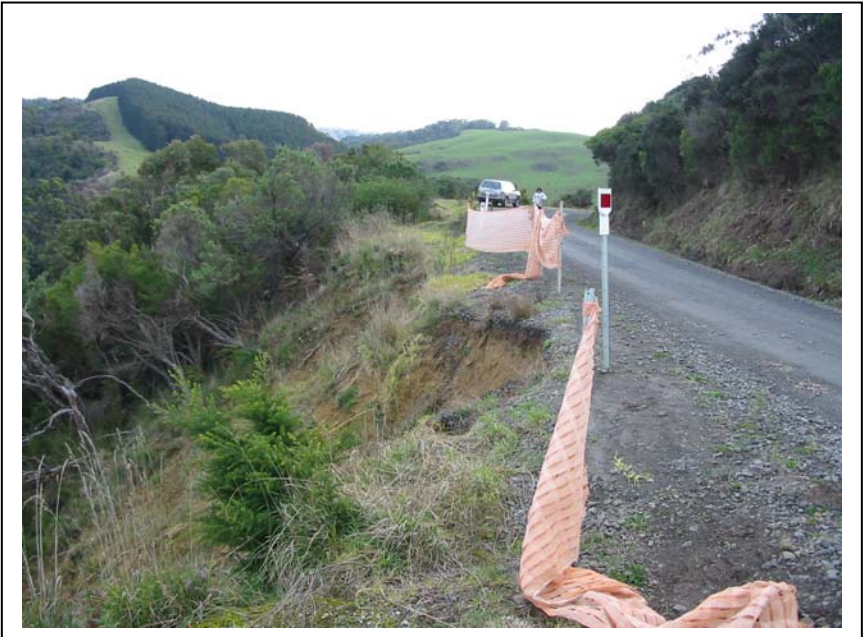
Photo 1

How likely is it? Certain as it has already happened and caused damage

What damage, impact or injury may result? Part of road has been undermined and possible failure of previous stabilisation works.

How important is it (sensitivity)? Moderately important as any further damage will block the road

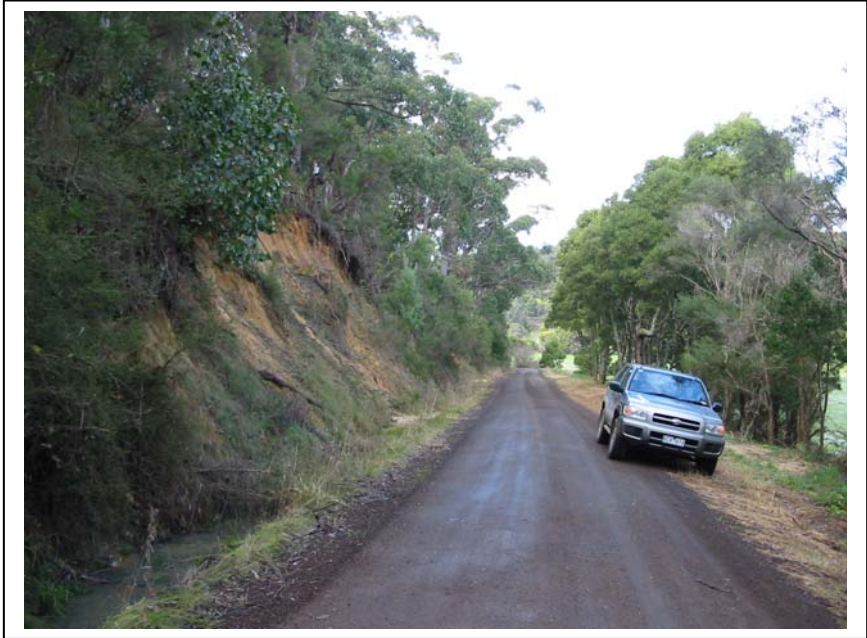
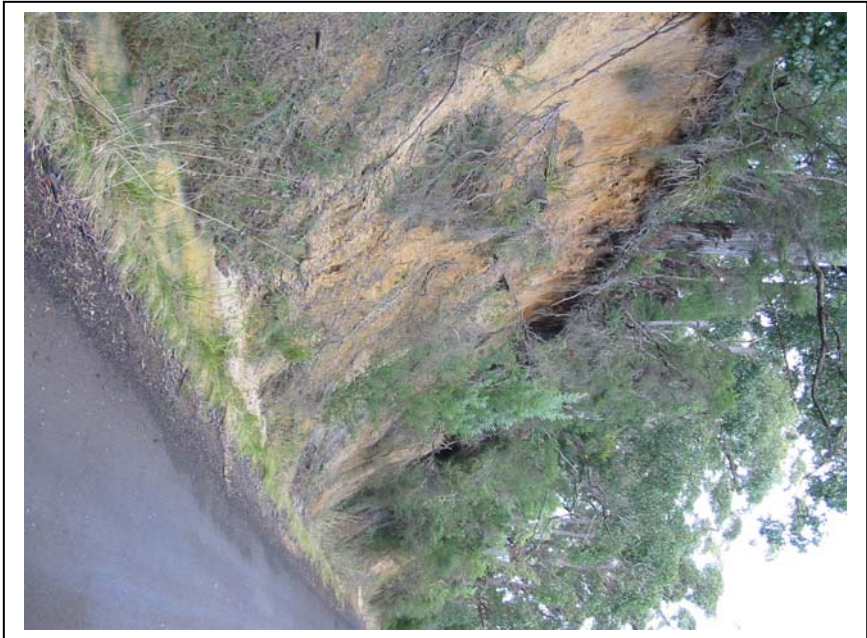
Photo 1

What might happen? Steep cutting may fail onto road plus potential for sheet erosion.

What damage, impact or injury may result? Minor deposition of materials on road with possible future wash into river.

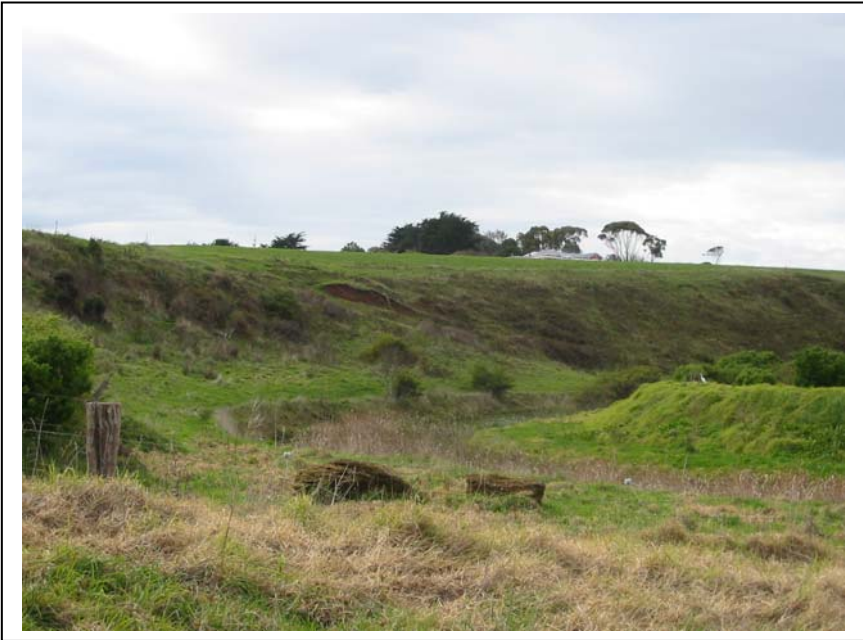
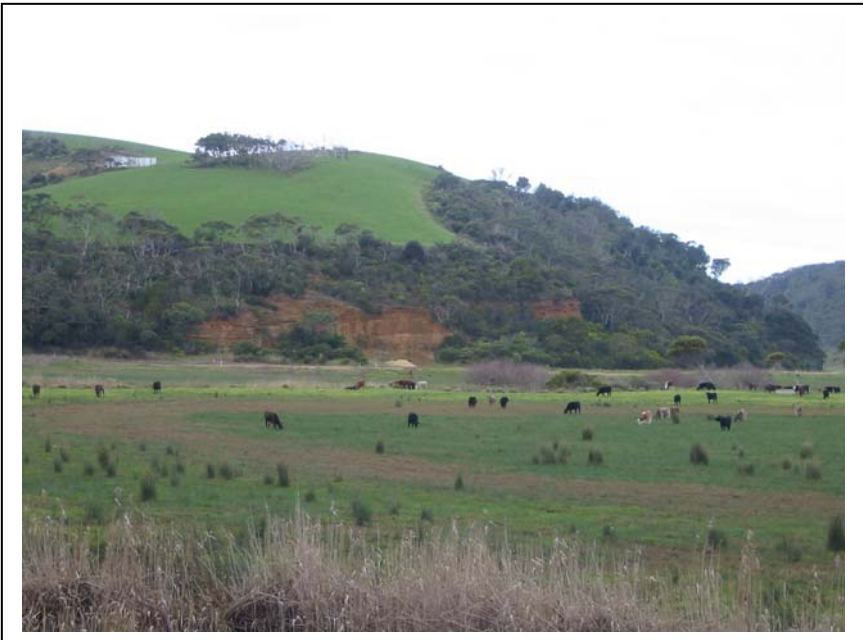
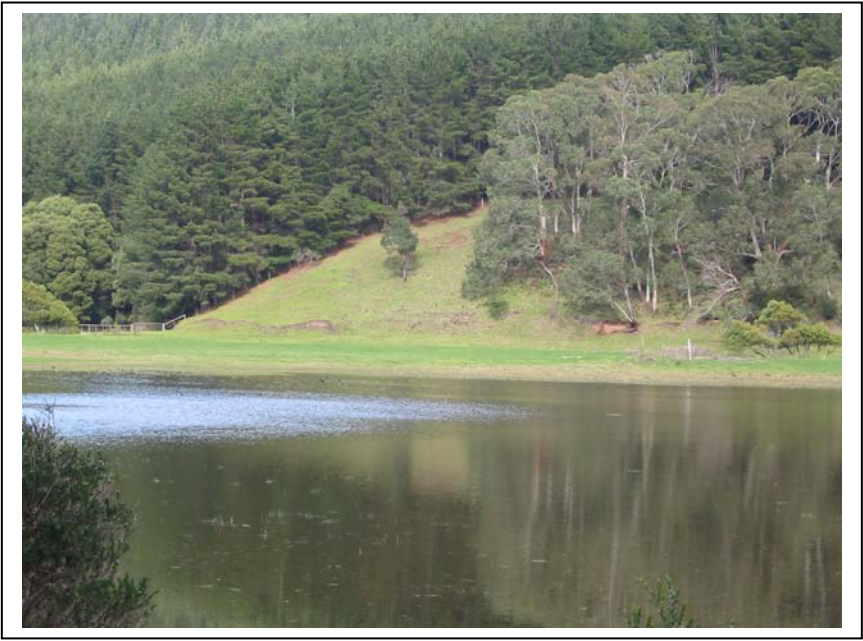
Photo 1

What damage, impact or injury may result? Possibility for some sediment input into the creeks and streams.

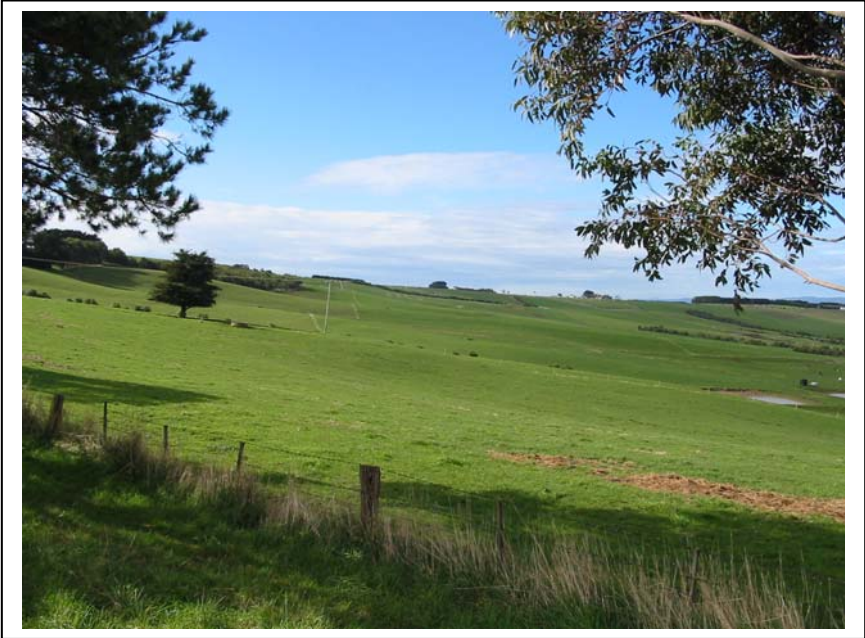
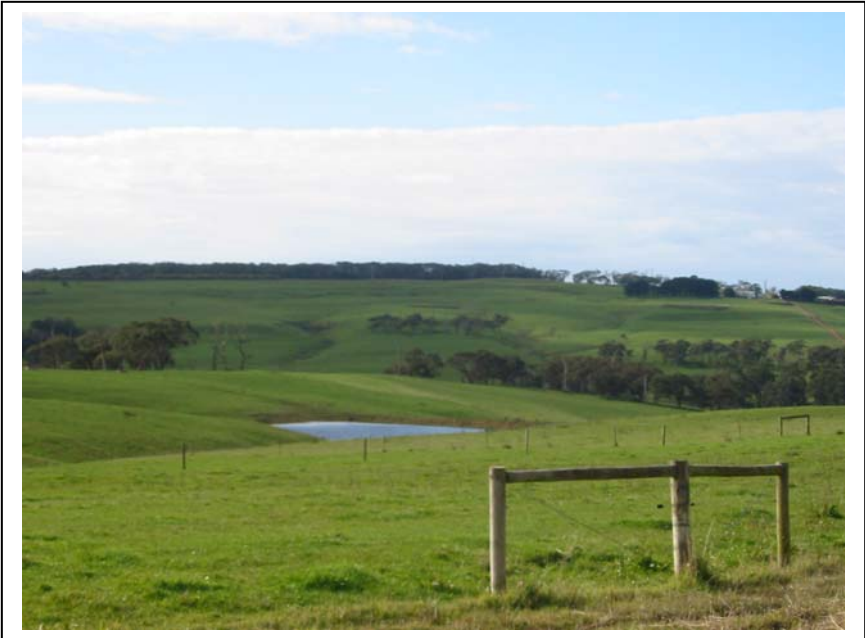
Photo 1

What damage, impact or injury may result? Disruption to agricultural land but little else.

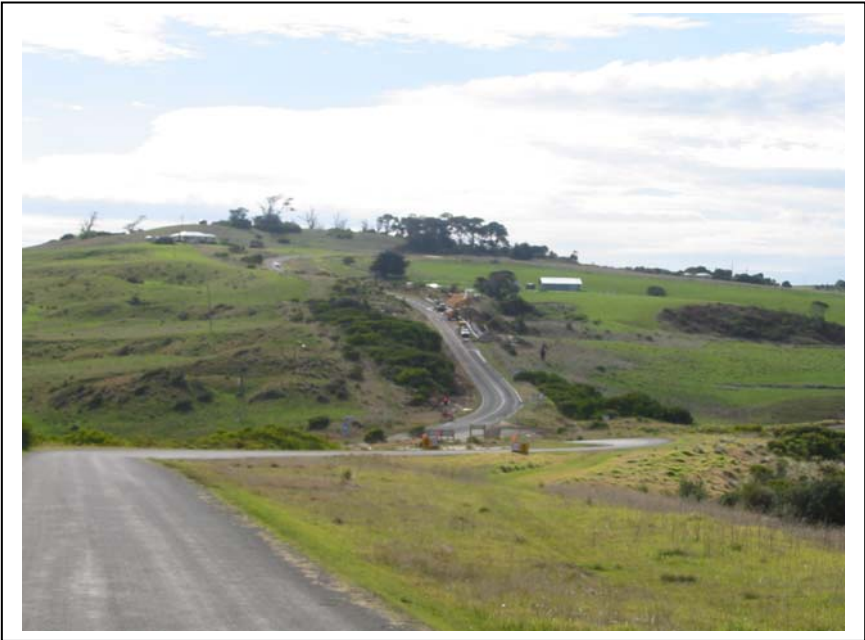
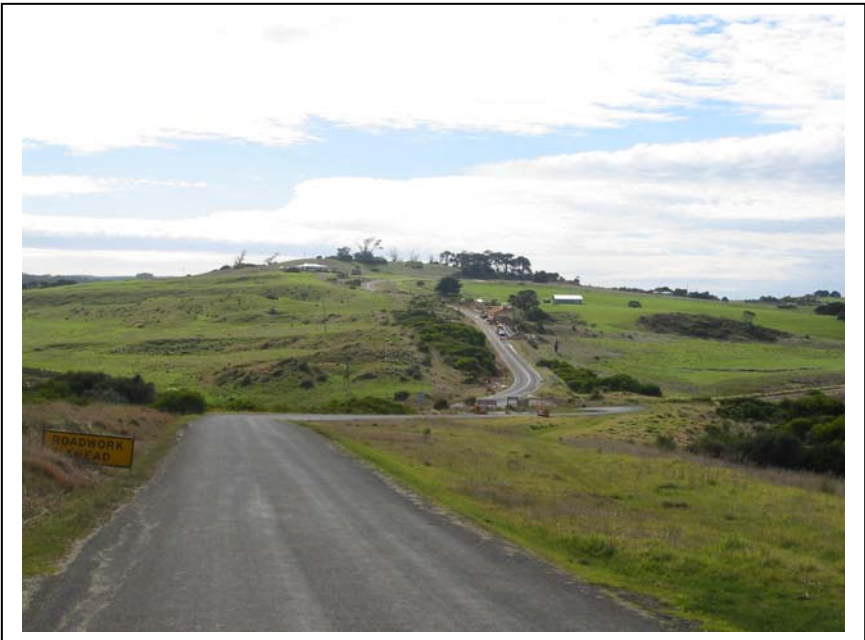
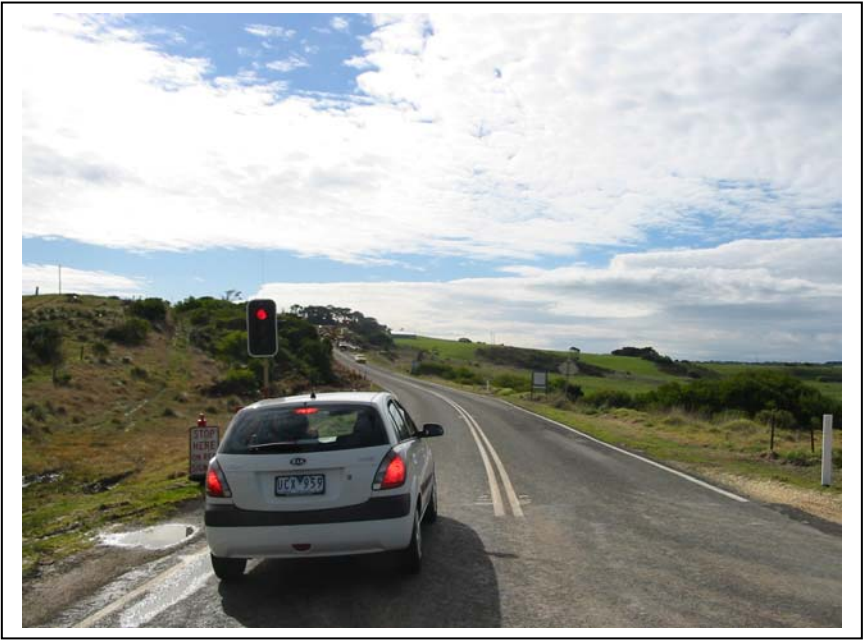
Photo 1

What damage, impact or injury may result? Significant damage to the Gt Ocean Rd.

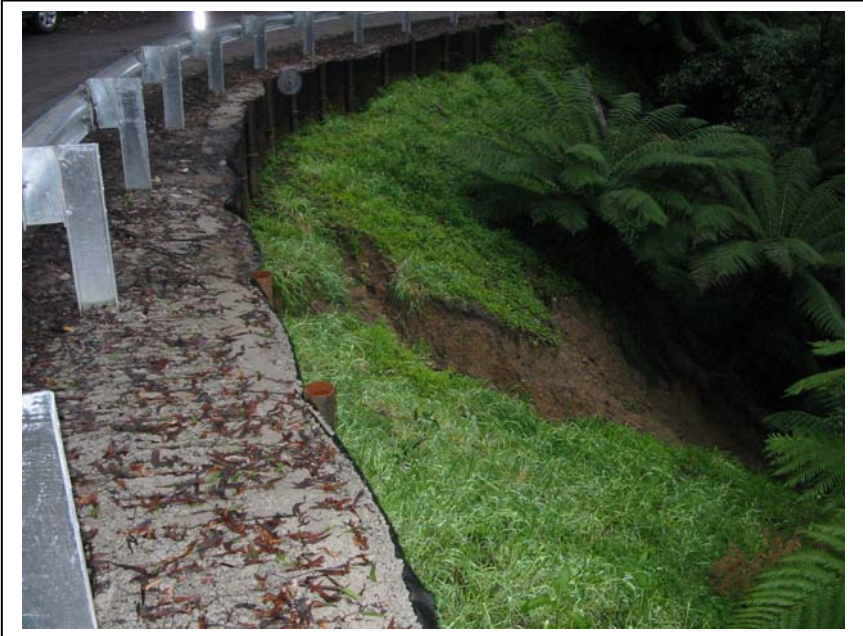
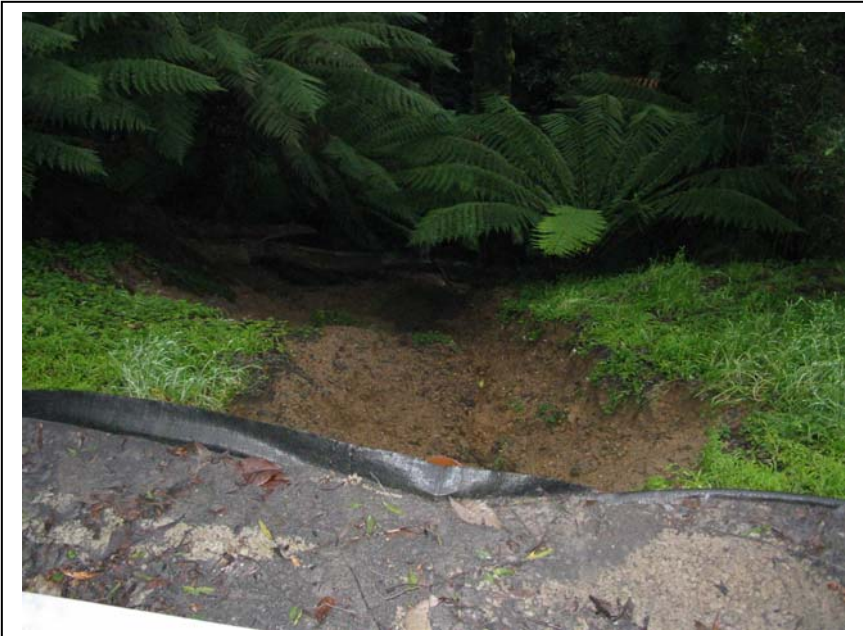
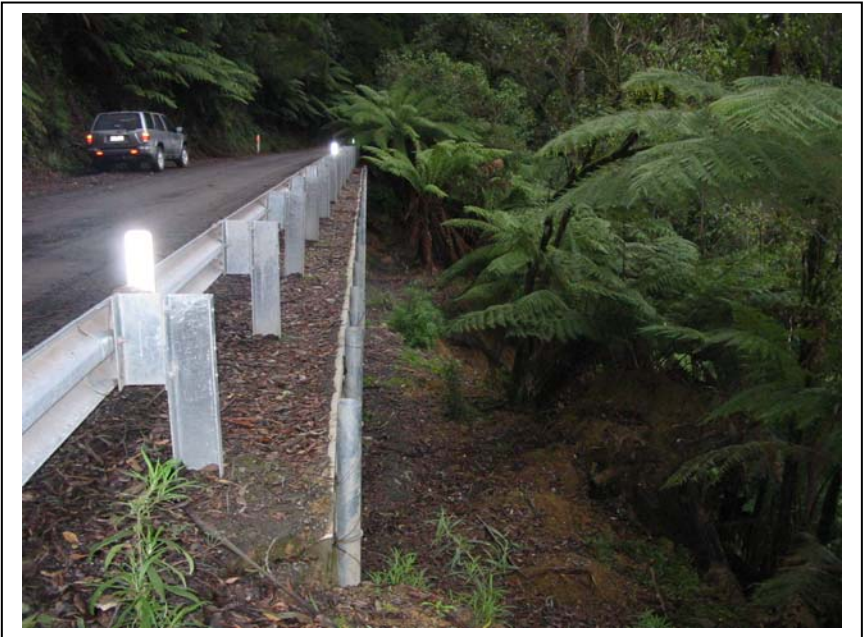
Photo 1

What might happen? Small landslides have caused damage to both the road and retaining structures

What damage, impact or injury may result? Continued damage to retaining walls will continue to undermine the road and can add small amounts of sediment to the catchment

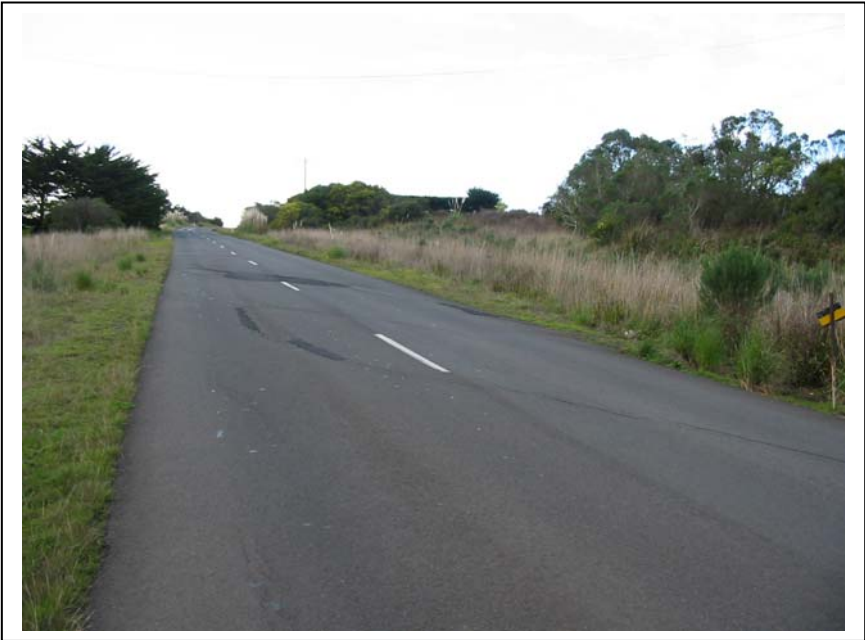
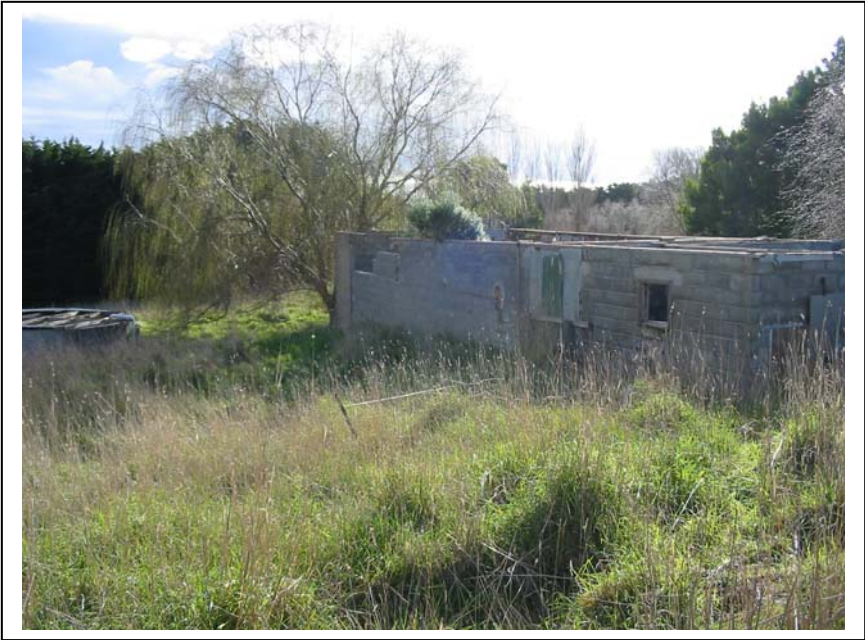
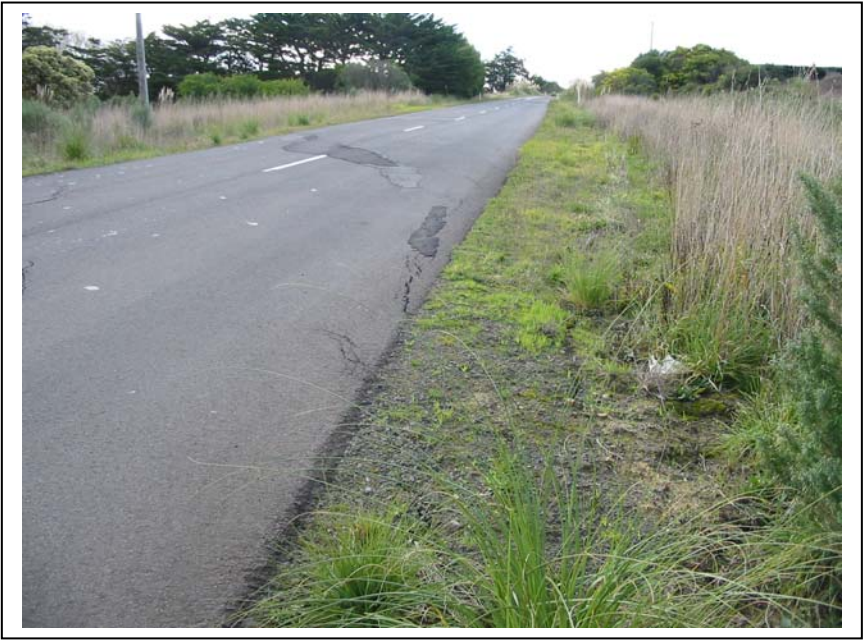
Photo 1

What might happen? Medium sized translational landslides have caused extensive damage to buildings and road. Slides has moved metres initially and now is moving cms

What damage, impact or injury may result? Significant damage to buildings and the road. Possibility for injury due to poor road state.

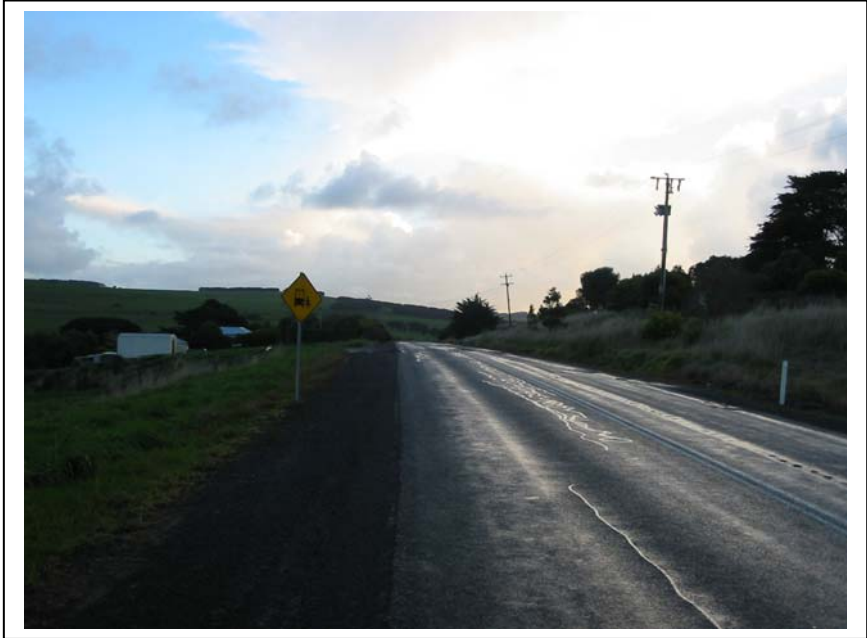
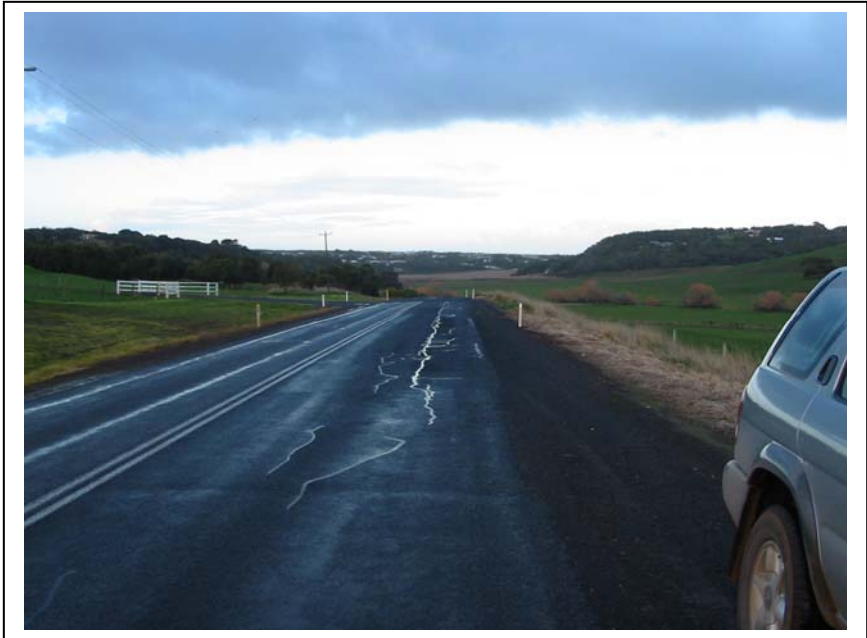
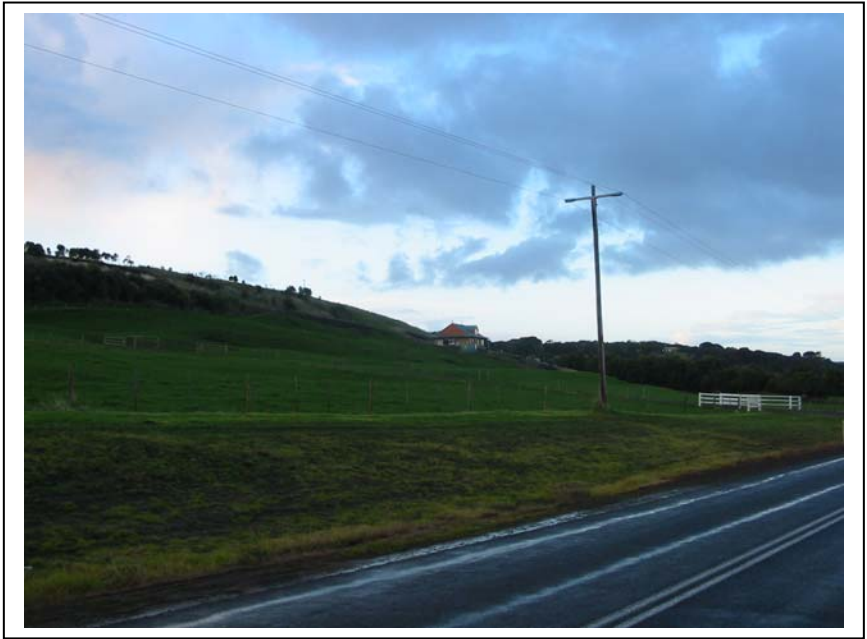
Photo 1

What might happen? Shallow translational slides causing damage to the Rd.

How likely is it? Likely to almost certain as damage has occurred and probably will continue to occur

What damage, impact or injury may result? Damage resulted in significant disruption to the road surface and some displacement below road in fields.

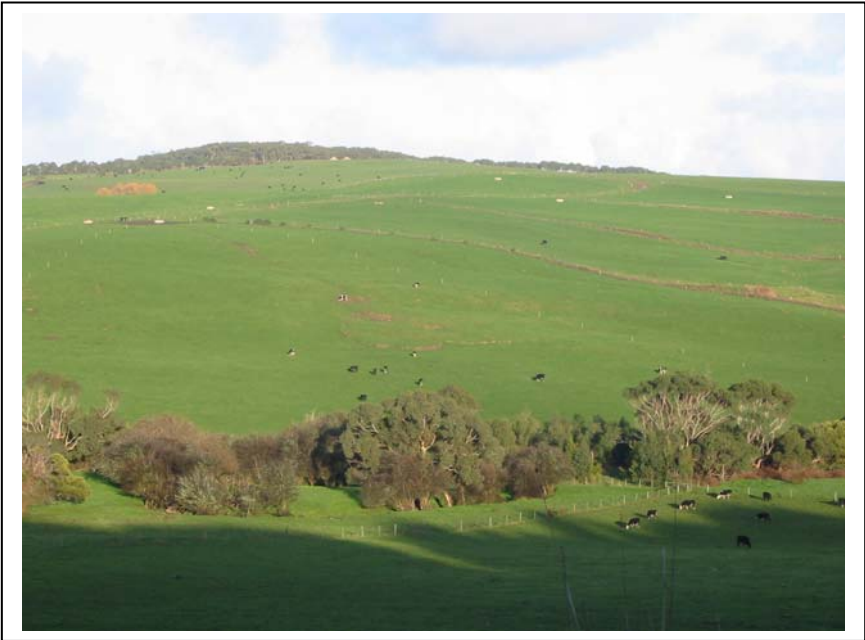
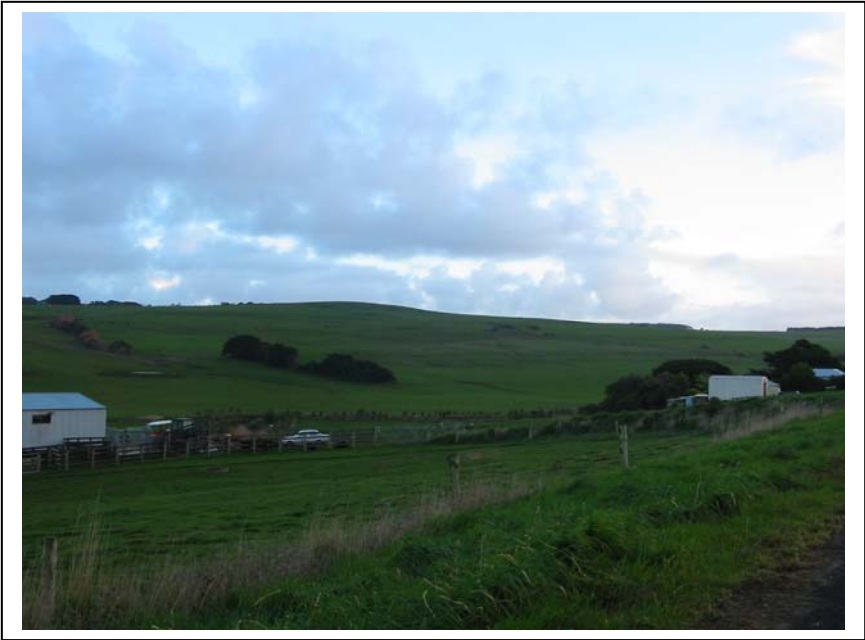
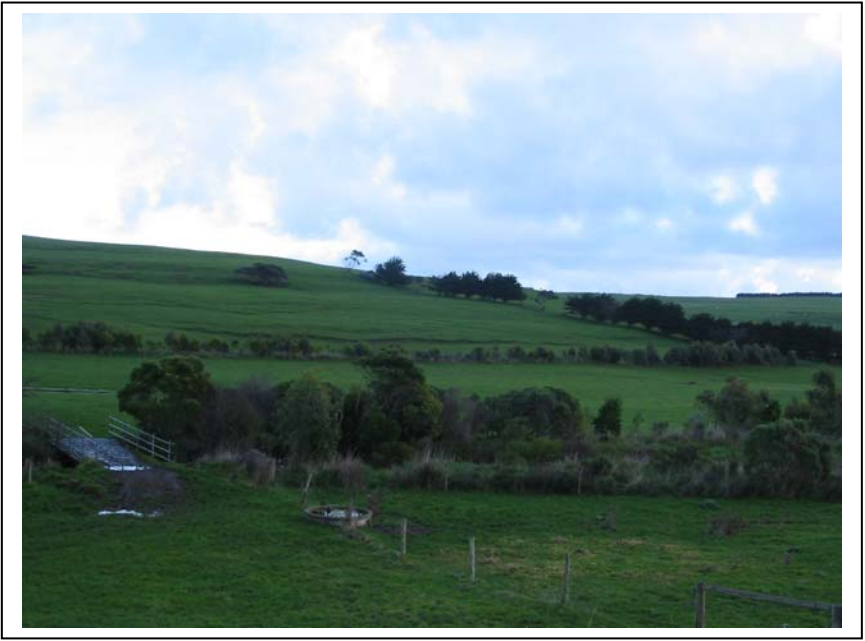
Photo 1

What damage, impact or injury may result? Minor disruption to agricultural land.

What can be done about it? Drainage and re work of slopes to avoid infiltration.

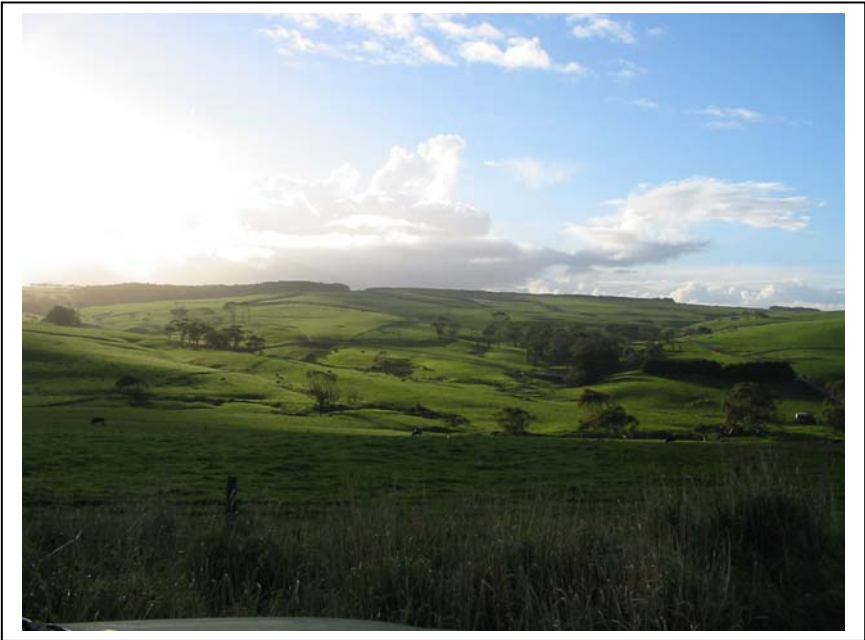
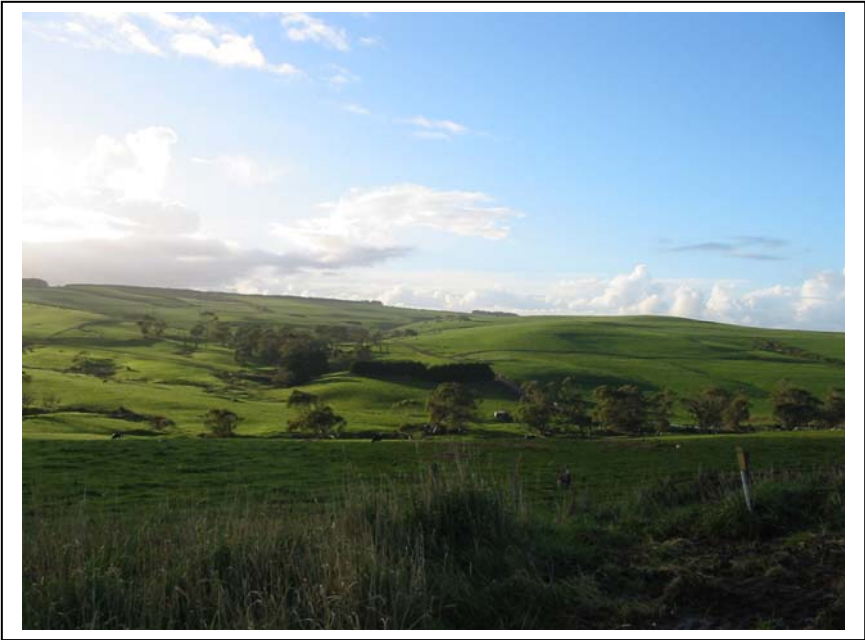
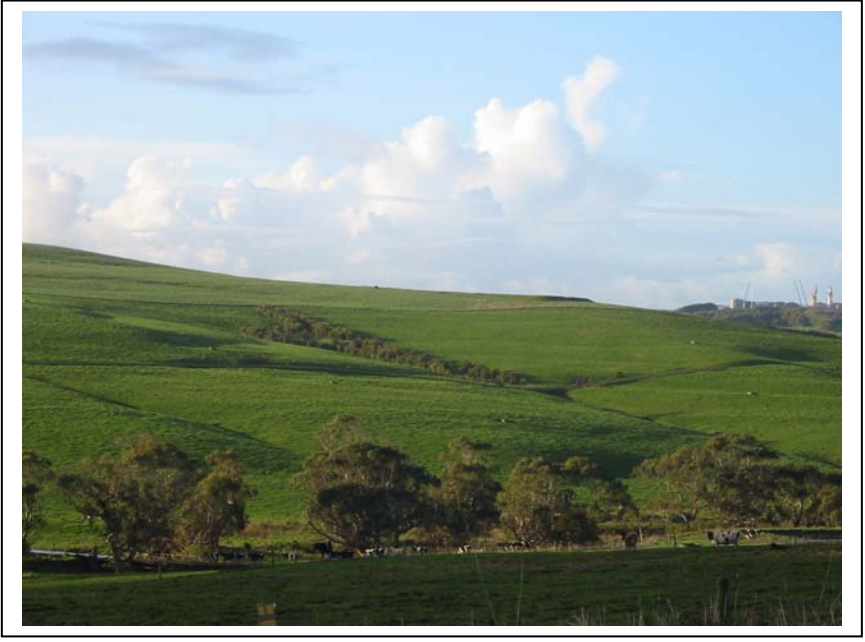
Photo 1

How likely is it? Likely to possible depending on conditions.

What damage, impact or injury may result? Disruption to drainage lines but not much damage to anything else some possibility of sediment loading to streams.
