a.s.miner
Geotechnical
Consulting Engineers

**Field Verification of Relative Risk
to Asset Rankings for Erosion
and Landslides in Landscape
Zones in the CCMA**

Supporting Document to the
Corangamite Soil Health Strategy

Report No: 352/01/06

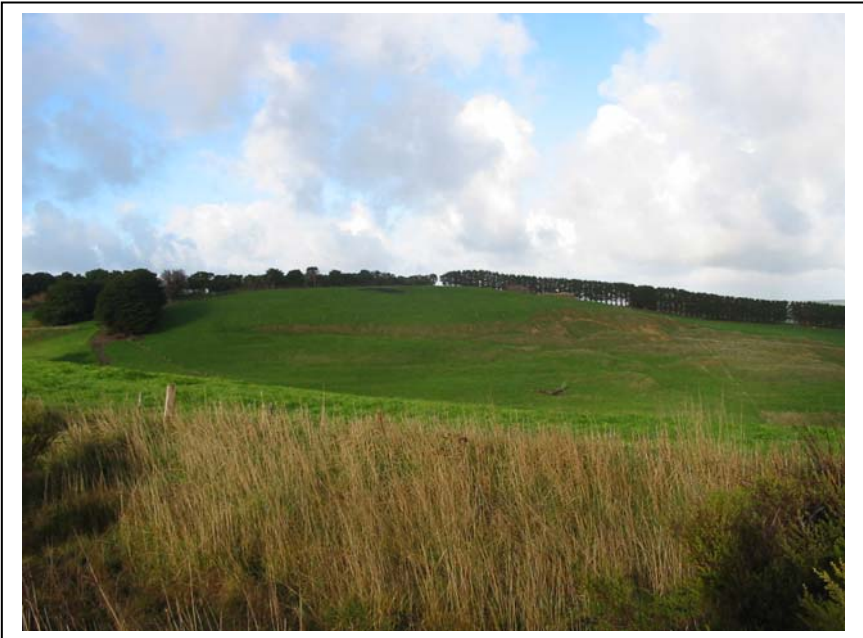
Photo 1

What might happen? Medium sized landslide has travelled metres and broken up.

What damage, impact or injury may result? Significant damage to pastures has meant land is useless and now out of production.

What can be done about it? Possible extensive earthworks and drainage but difficult to fully assess. It appears to be groundwater driven given the fluid nature of the failure. Site currently fenced off

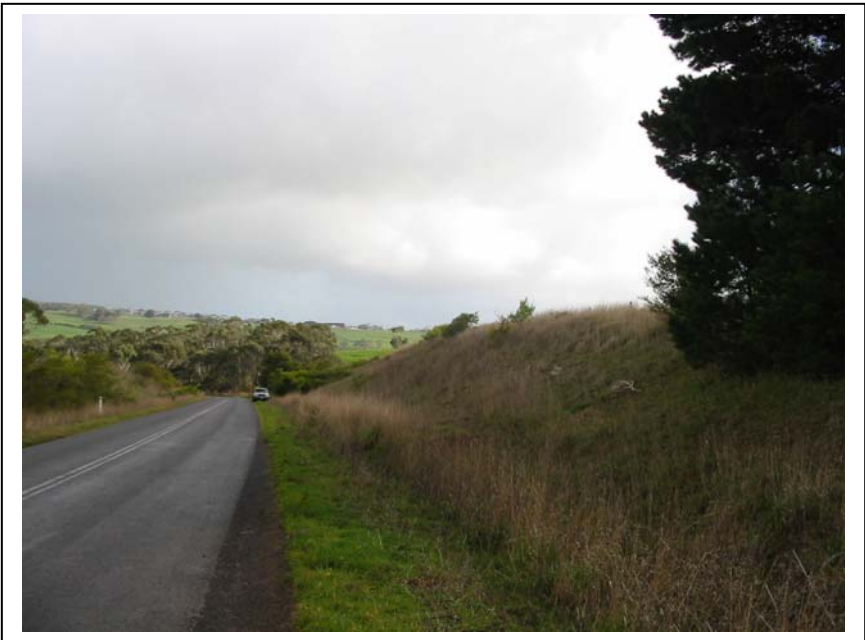
Photo 2

What might happen? Tension crack at top of embankment may have been a prelude to major collapse.

What damage, impact or injury may result? Could disrupt road and injury passer by

Describe the Danger: Translational or slab type failure travelling meters onto roads

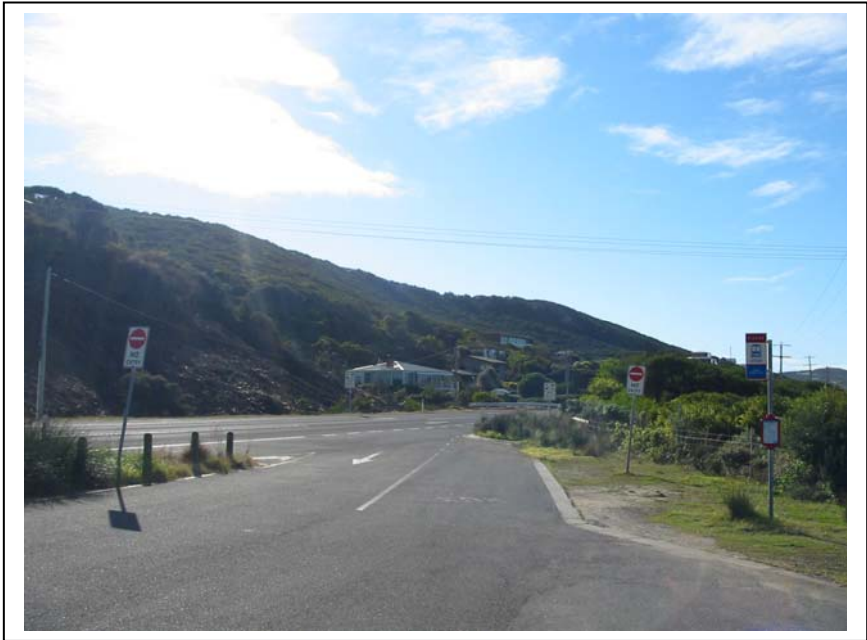
Photo 1

What might happen? Large landslide exists at the site and could reactivate under adverse conditions.

How likely is it? Movement has been noted at the headscarp within the last 20 years and is possible to likely.

What damage, impact or injury may result? Whilst houses in the centre of the slide may undergo limited damage those around the rim could be severely damaged. Large movements could impact Gt Ocean Rd

How important is it (sensitivity)? Any loss of property would be significant. Large movements on the road would be significant and could disrupt tourism and cause possible injury and even death

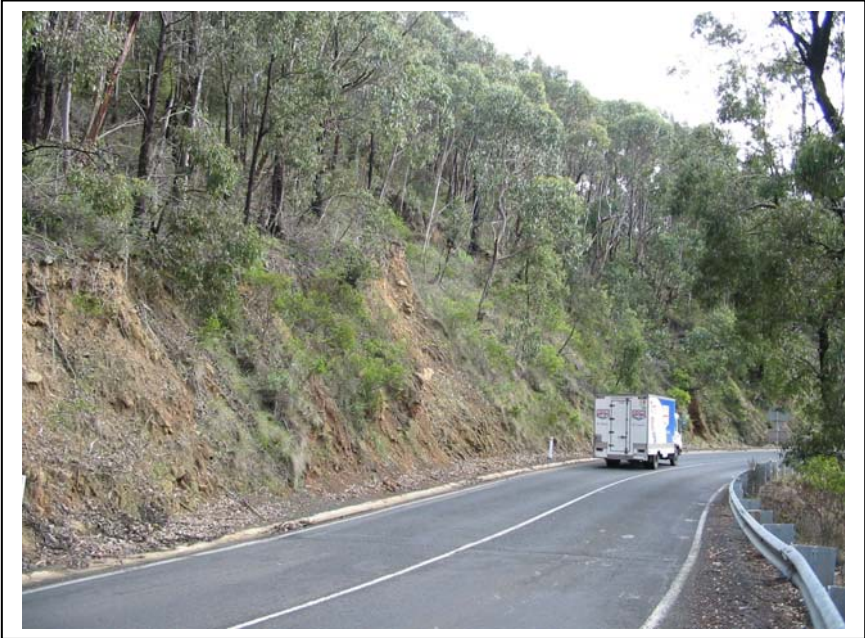
Photo 1

What might happen? Continued failure of fill embankment and further rockfalls and slides on high side of road.

How likely is it? This event has already occurred and further falls are likely. Likelihood of fill embankment failure reduced due to stabilisation...

What damage, impact or injury may result? Very significant road stabilisation required. Possibility of injury or death given steep slopes below road.

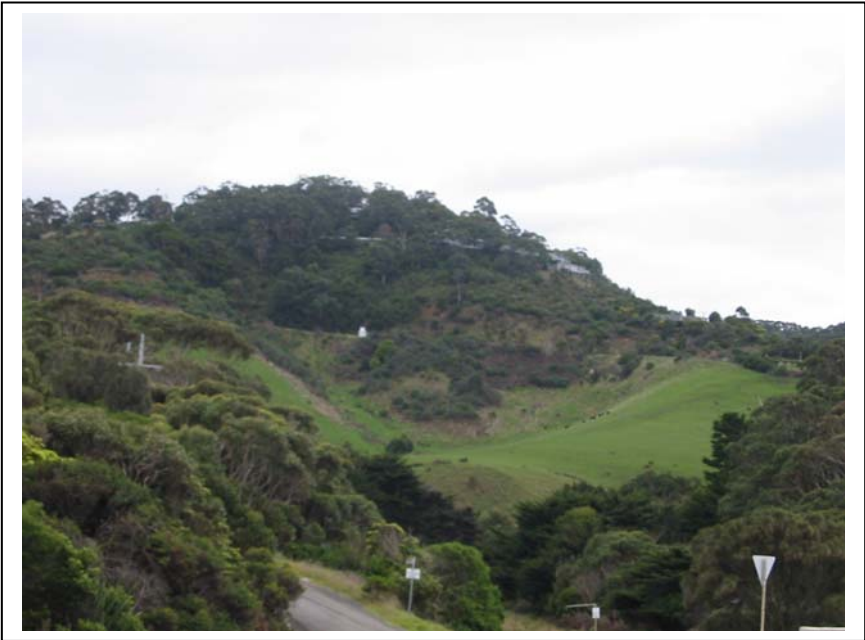
Photo 1

What might happen? Multiple slides and wedge failures on road. Failure in embankment at Beacon Pt.

How likely is it? New failures occur every few years and are likely to continue.

What damage, impact or injury may result? Deposition of materials on roads and in one case closure. Some potential for injury to drivers.

Describe the Danger: Small cutting failures travelling up to a metre onto the road

Describe the Danger: Embankment Failure below Beacon PT

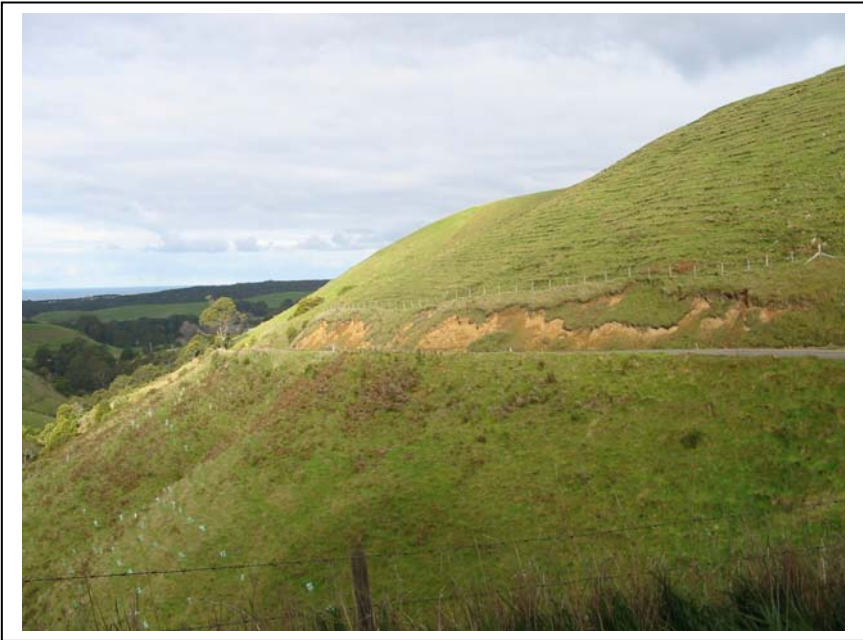
Photo 1

What might happen? Large old slides may reactivate under extreme conditions. Smaller slides are more common.

What damage, impact or injury may result? Large slides could cause catastrophic damage to houses and block river. Smaller slides could also cause significant damage to house and even deaths.

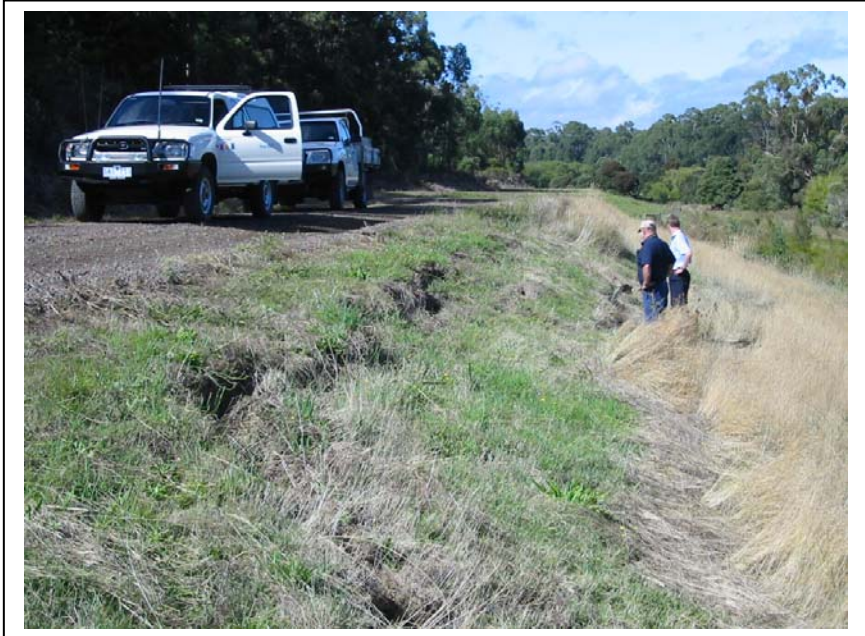
Photo 1

What might happen? Small to medium sized landslides have caused damage to both the support structures for the siphon and sections of the concrete lined water supply channel.

How likely is it? Damage has already occurred at the Siphon and in at least two sections of the channel and future slides are considered possible under adverse conditions.

What damage, impact or injury may result? Damage resulted in leakage from the siphon and breaches in the channel requiring disruption to water supply schedules.

What can be done about it? Remedial repairs to the siphon and channel, relining of the channel and ongoing observation and management of this section.

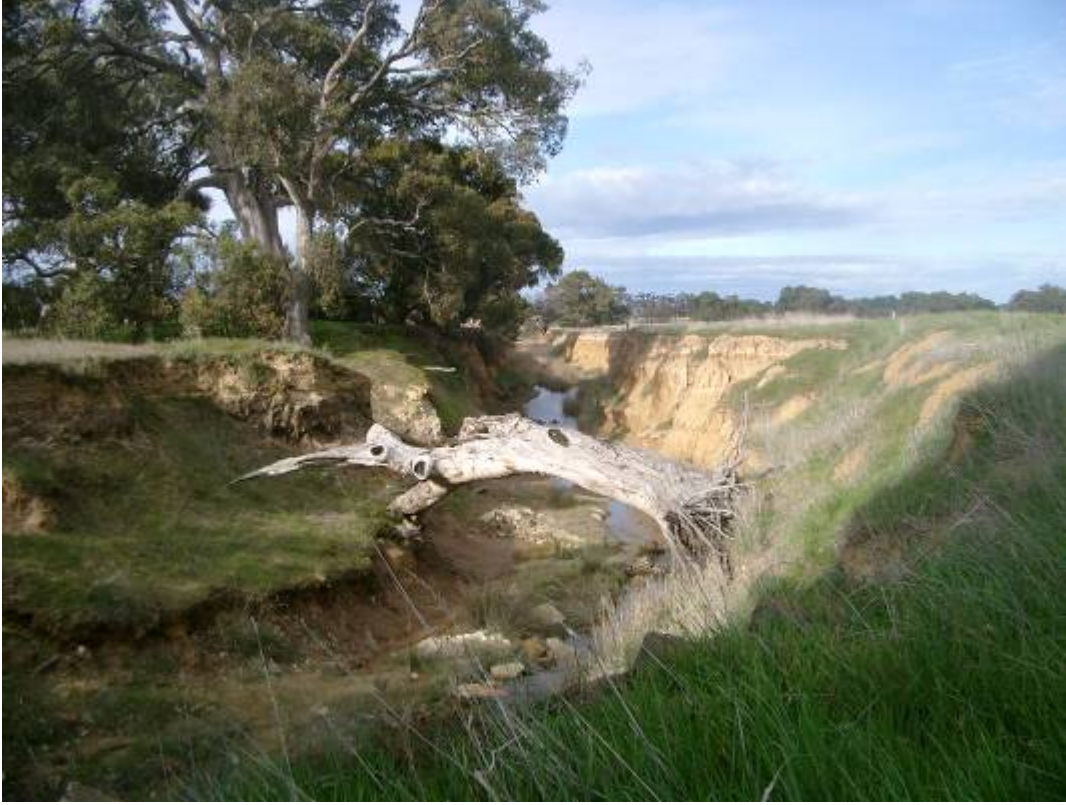
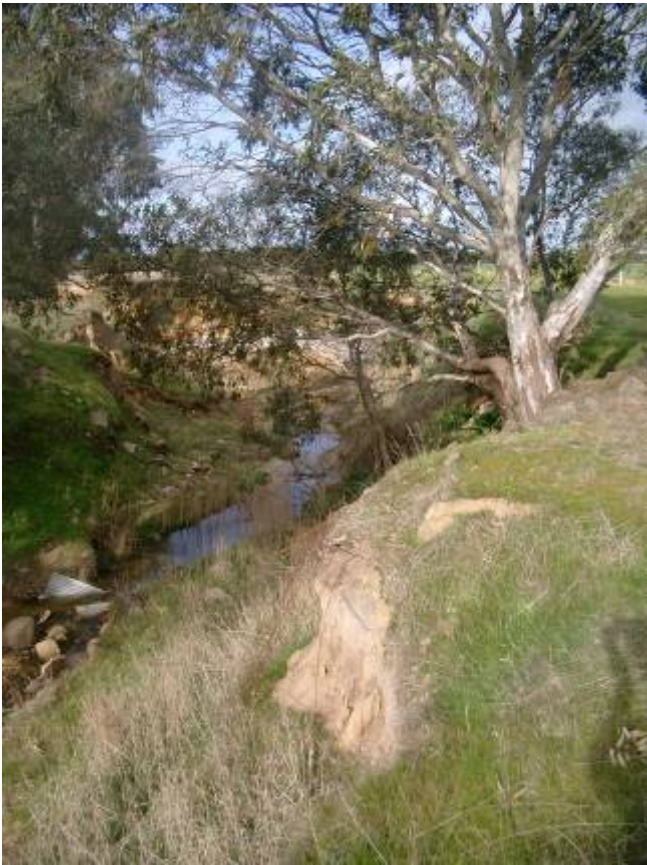
Moorabool

Mostly red gum trees

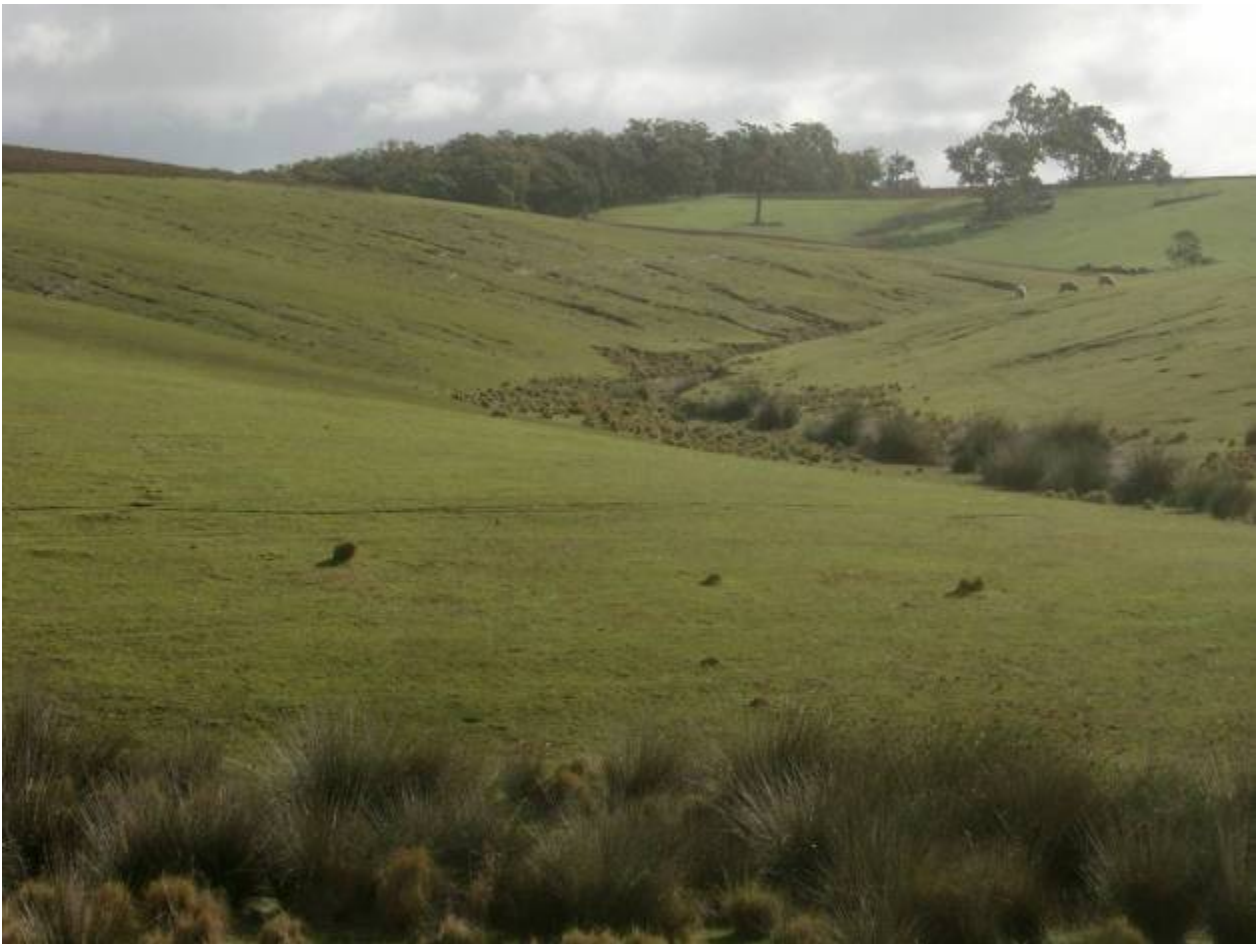
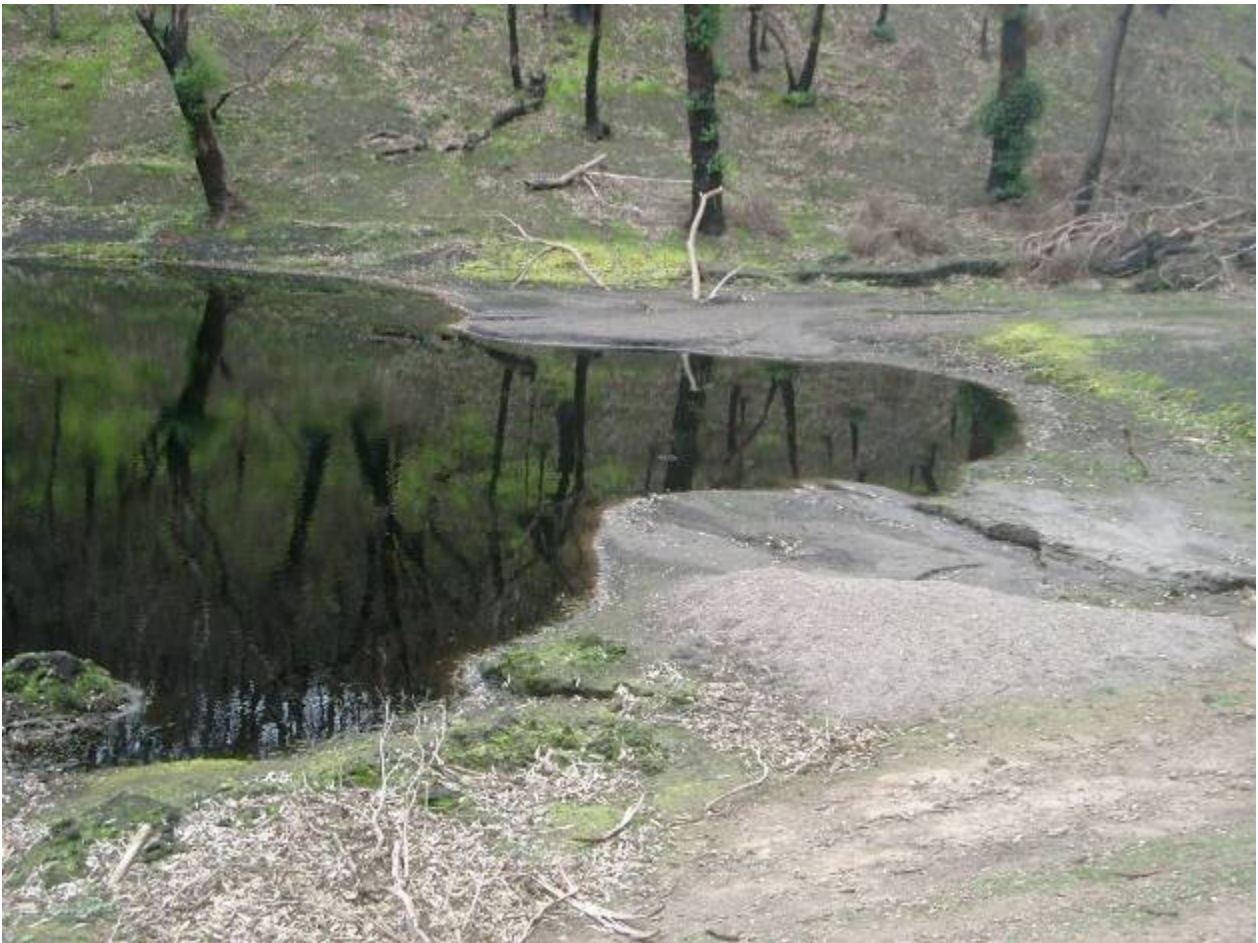
Site 1

Unlikely to cause sedimentation.

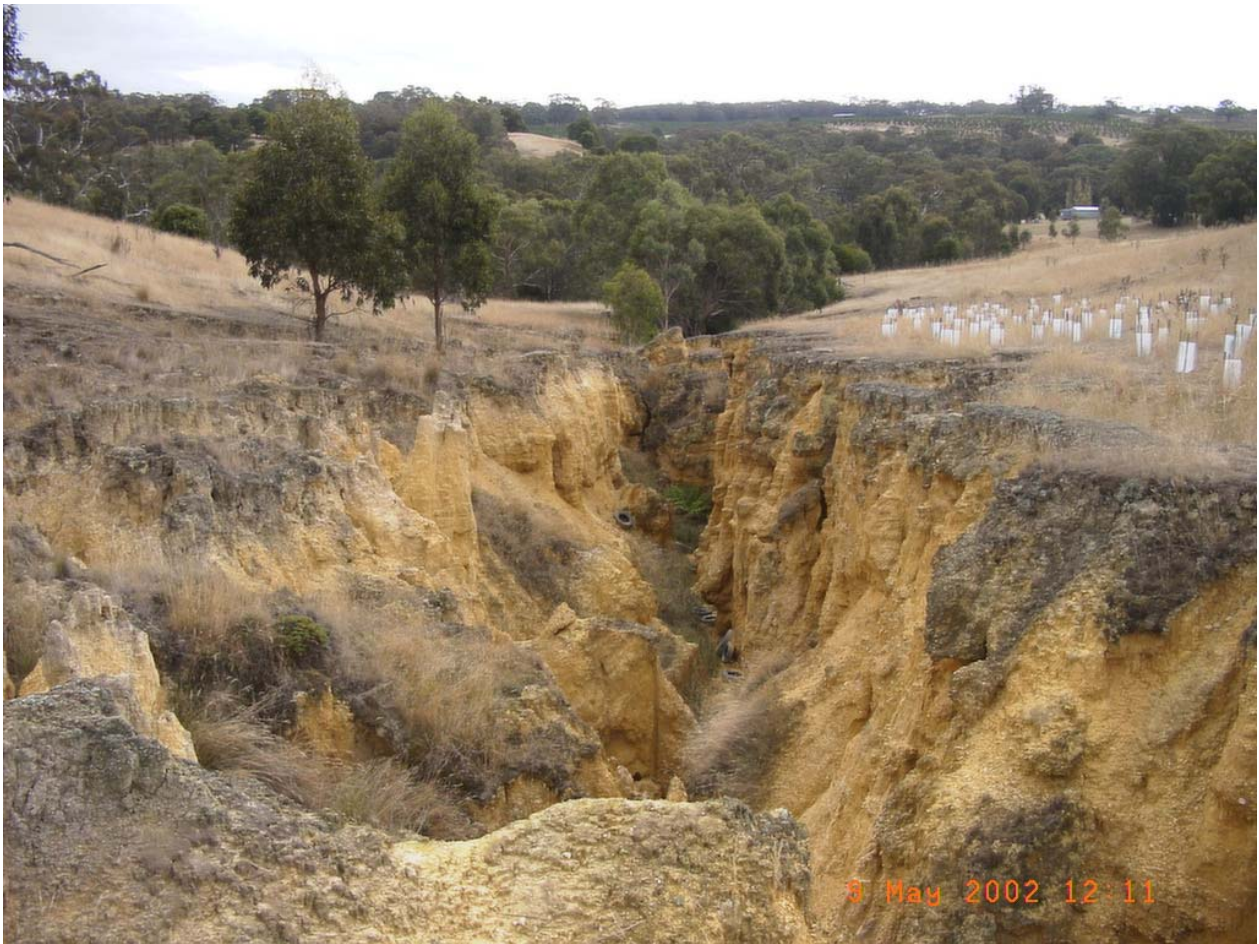
Magpie

Shrubs & tree along creek lines
