Department of
Primary Industries

CCMA Landslide and Erosion Database

Version 2

Warren Feltham
July 2005

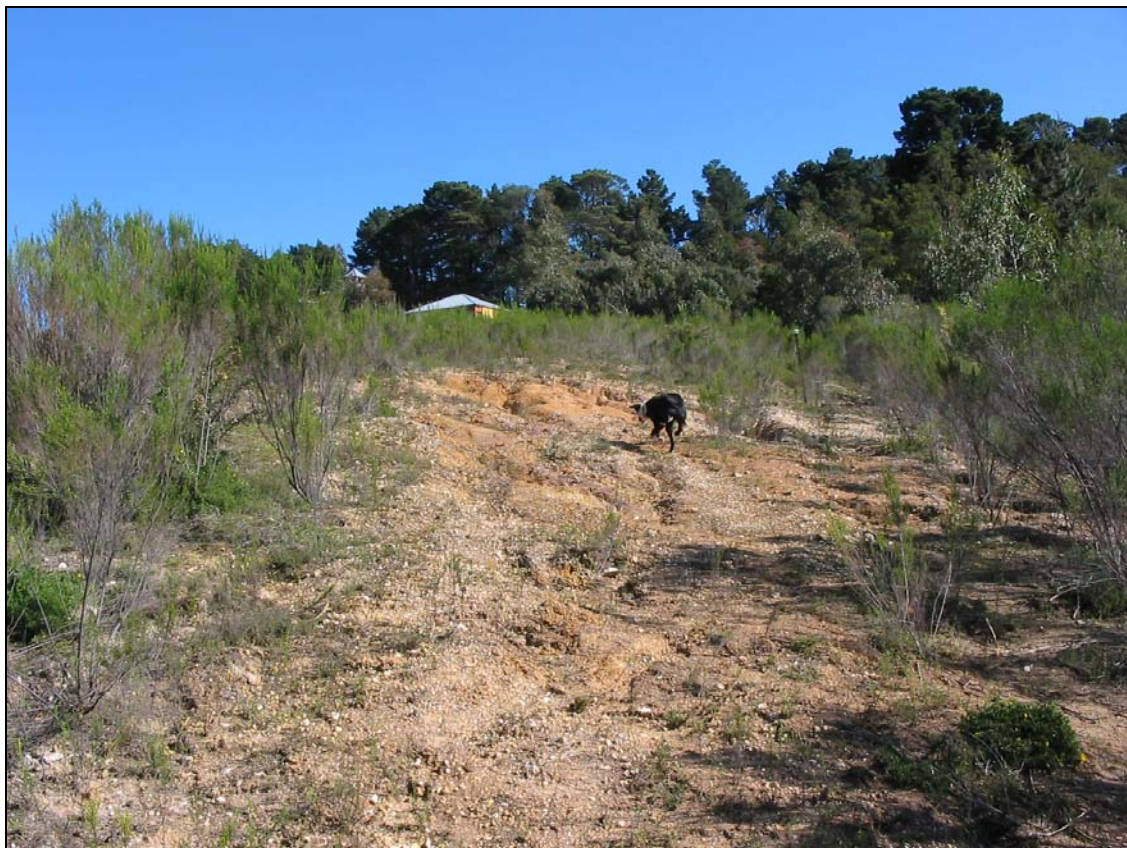
Figure 2.2 Feature WF05. Inter-rill / Rill erosion, Peady Street Reserve, Ballarat.

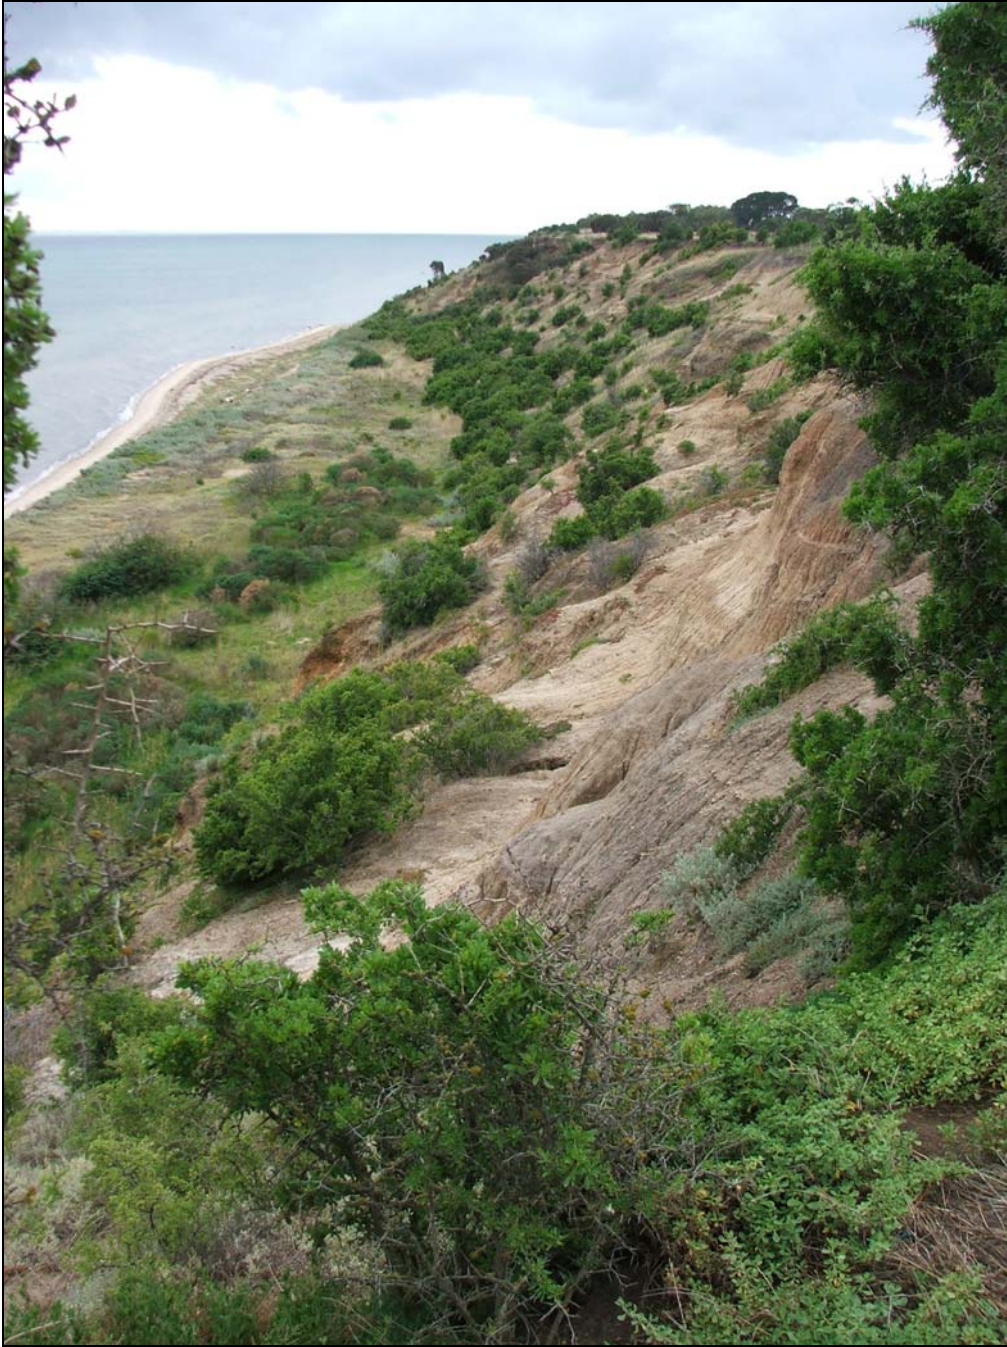
Figure 2.3 Feature WF2391. Inter-rill / Rill erosion east of Clifton Springs along the north shore of the Bellarine Peninsula.

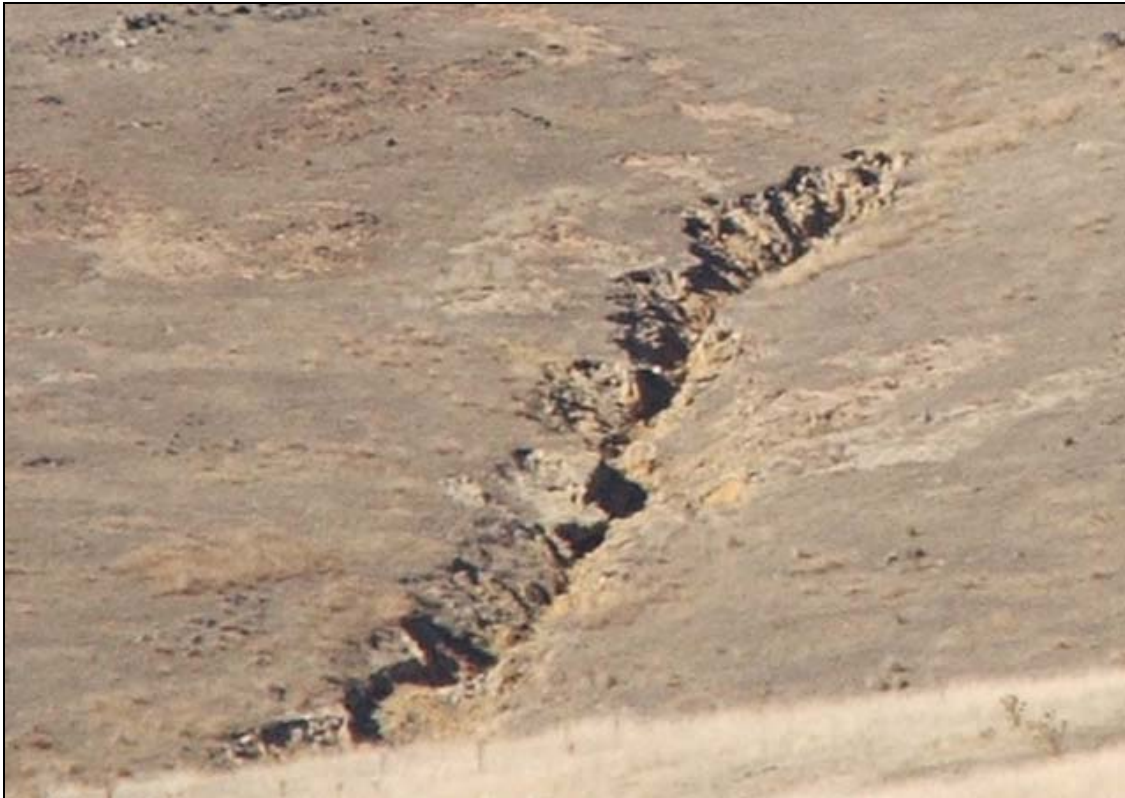
Figure 2.4 Feature WF2422. Gully erosion south of Berringa.

Gully erosion is the most visually apparent form of erosion. Gully erosion is the development of steep sided channels that erode headward due to concentrated runoff (McDonald 1990) (Figure 2.4 - 2.7). Gully erosion occurs in areas of the landscape that form natural depressions where overland flow generated from a rainfall event converges into a concentrated flow (Toy *et al.* 2002). Gullies may also form due to sub-surface tunnel collapse where sub surface flow forms tunnels in dispersive soils that are prone to collapse.

Erosion is concentrated at the head of the depression where steep scarps develop as a result of undercutting. The undercutting of the head scarp deepens the channel and undermines the headwall which eventually causes collapse, increasing the length of the gully upslope (Morgan 1986).

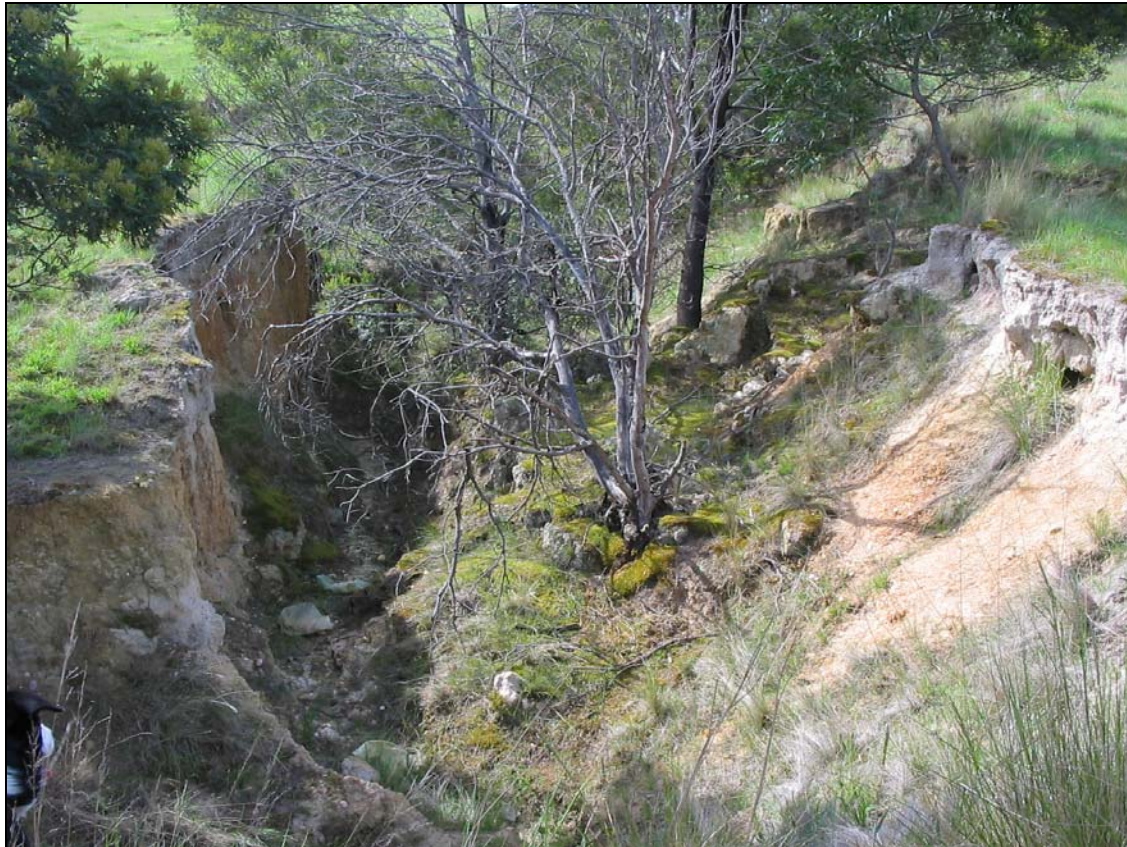
Figure 2.5 Feature WF27. Gully erosion north of Meredith.

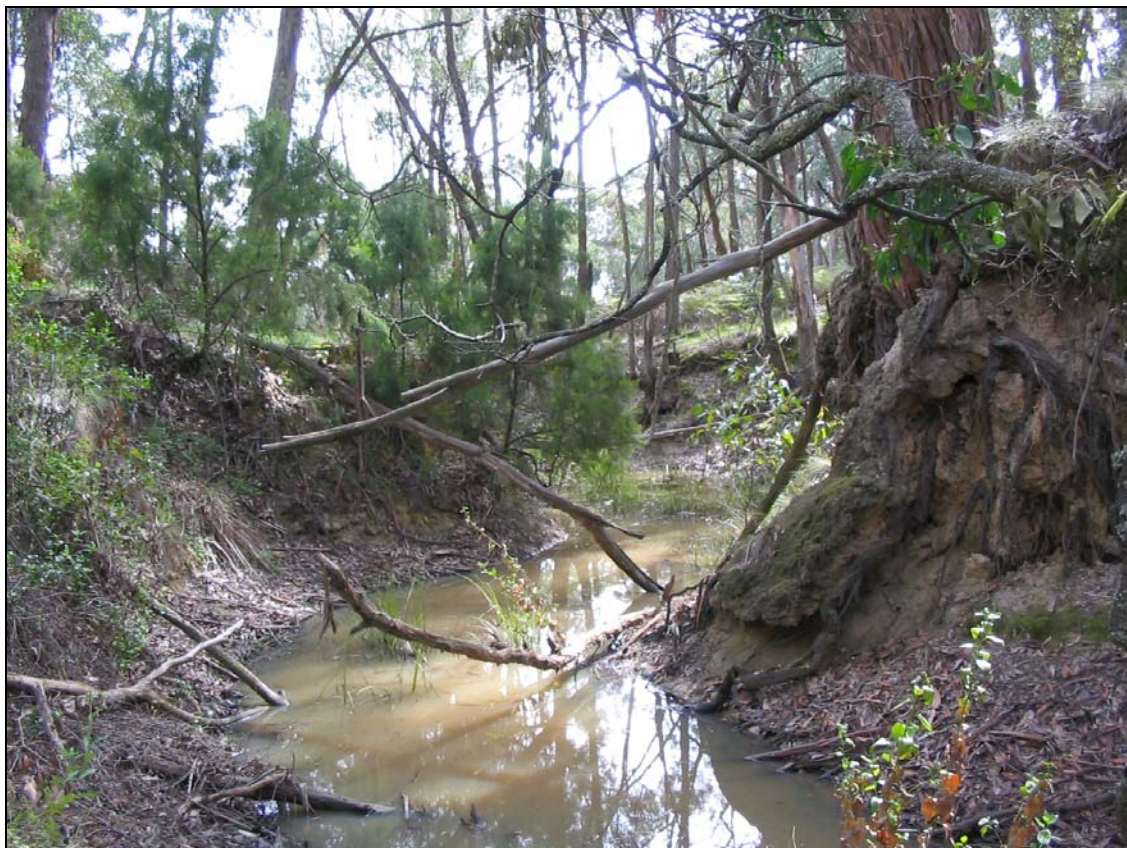
Figure 2.6. Feature WF38 revegetated but still active gully erosion, north of Invermay.

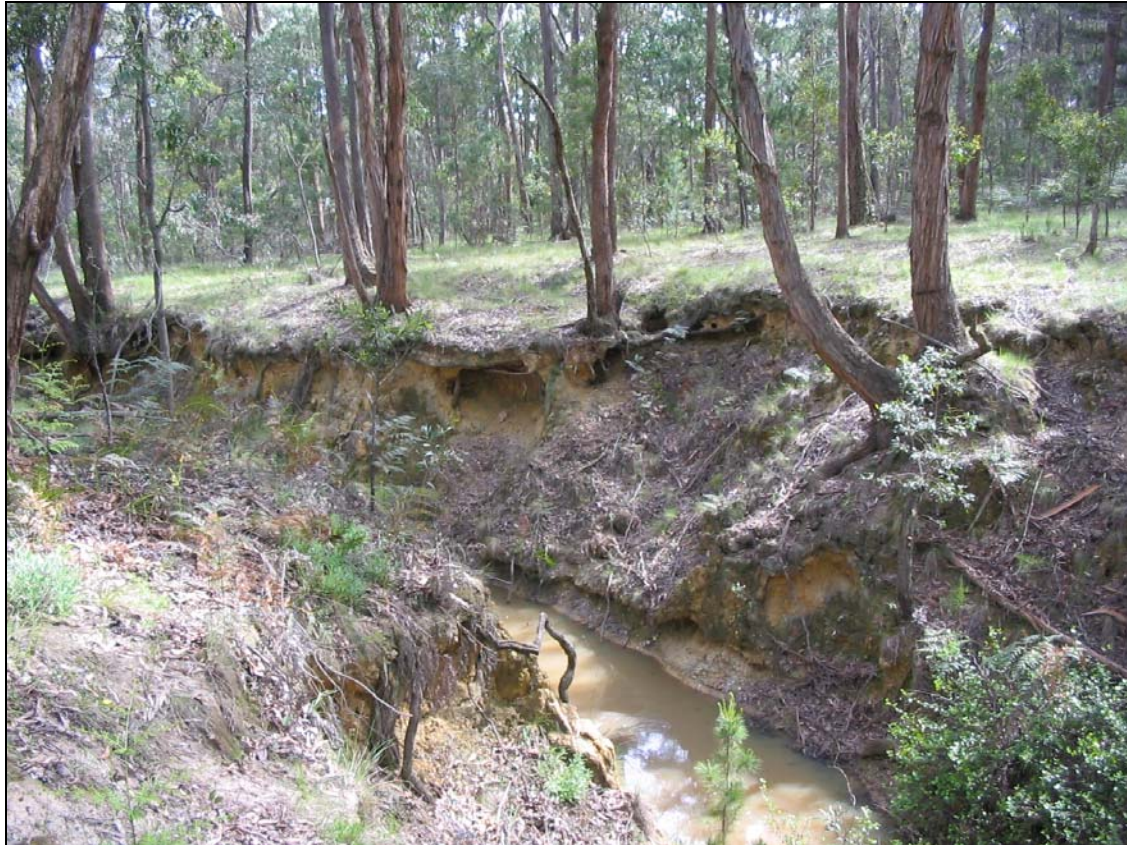
Figure 2.7 Feature WF39 revegetated but still active gully erosion, north of Invermay.

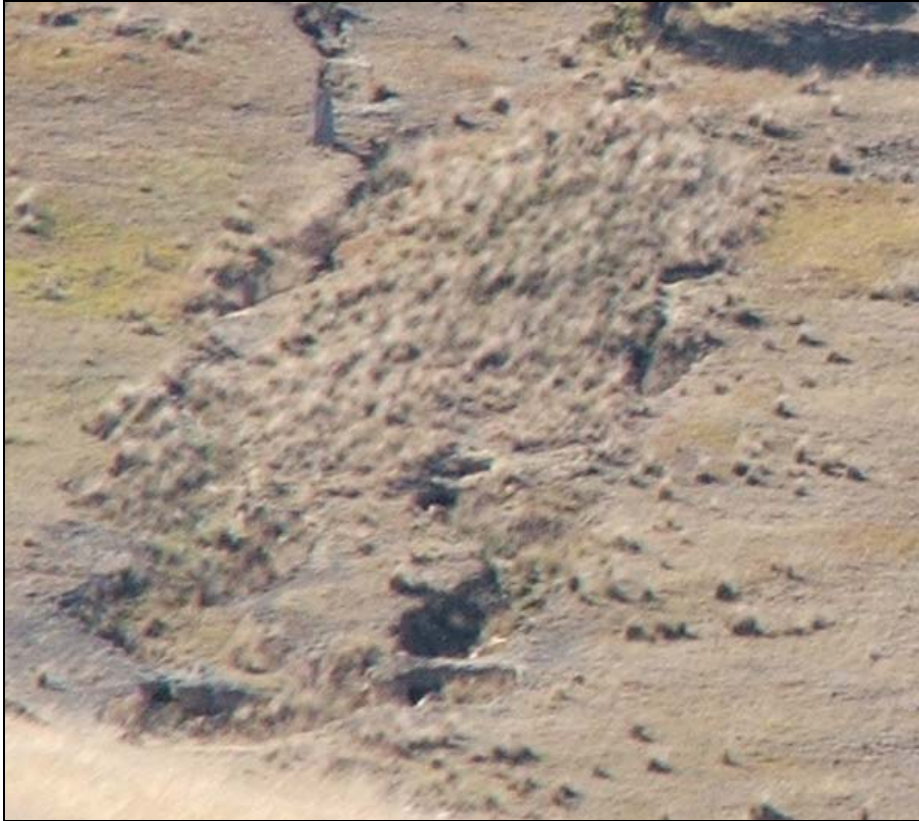
Figure 2.8 Feature WF2427. Tunnel erosion south of Berringa.

Tunnel erosion is the removal of subsurface material by water while surface material remains intact (Figure 2.8). Susceptibility to tunnel erosion is affected by soil properties, slope angle and high rainfall. This process can be accelerated by rabbit burrowing. Eventually tunnel erosion can collapse to form gullies. Tunnels occur in soils where the structural stability is poor, such as soils that are prone to slaking and dispersion or sodic soils.

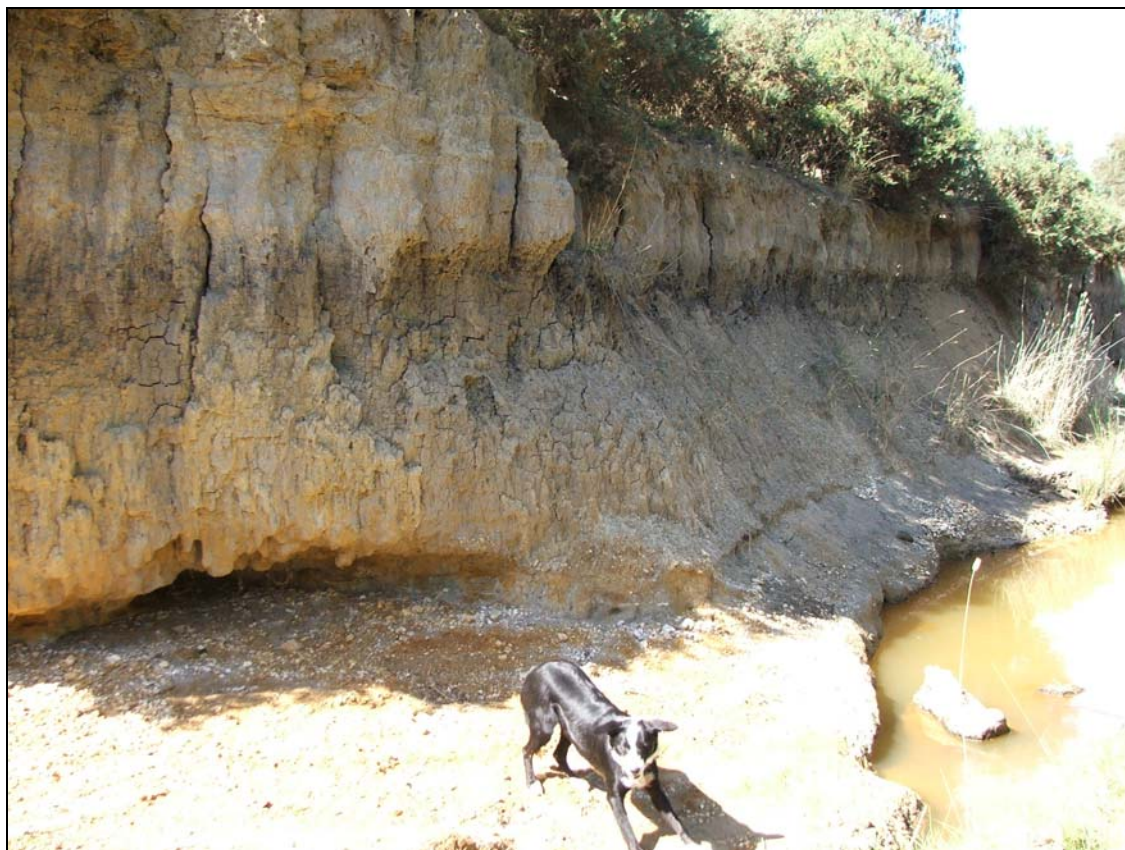
Figure 2.9 Feature WF648. An example of incised stream erosion north east of Rokewood, border collie for scale

Incised Stream erosion occurs along stream banks during periods of higher water volume such as flood waters (Figure 2.9 – 2.11). The stream banks are undercut by the flow of water and eventually the bank collapses into the stream. The clearing of vegetation along the banks of a stream can accelerate erosion (Morgan 1986).

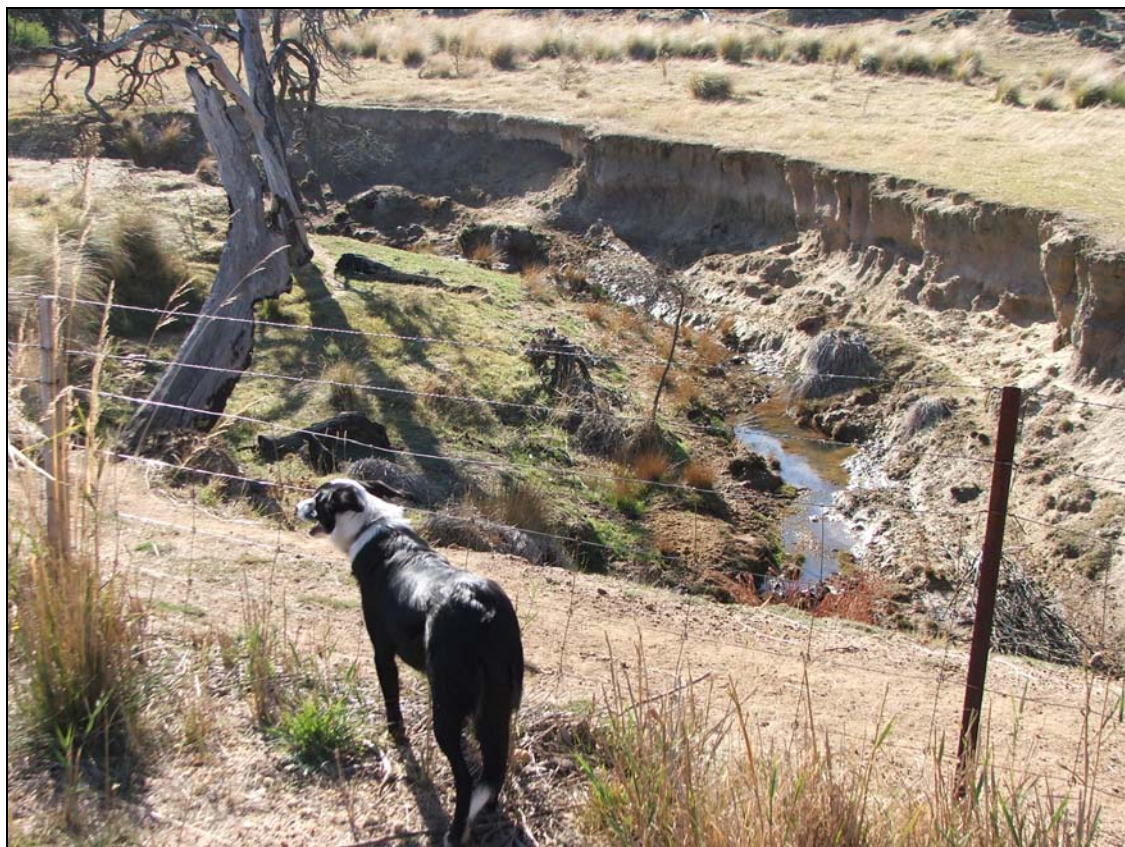
Figure 2.10 Feature WF695. Incised stream erosion near Rokewood Junction.

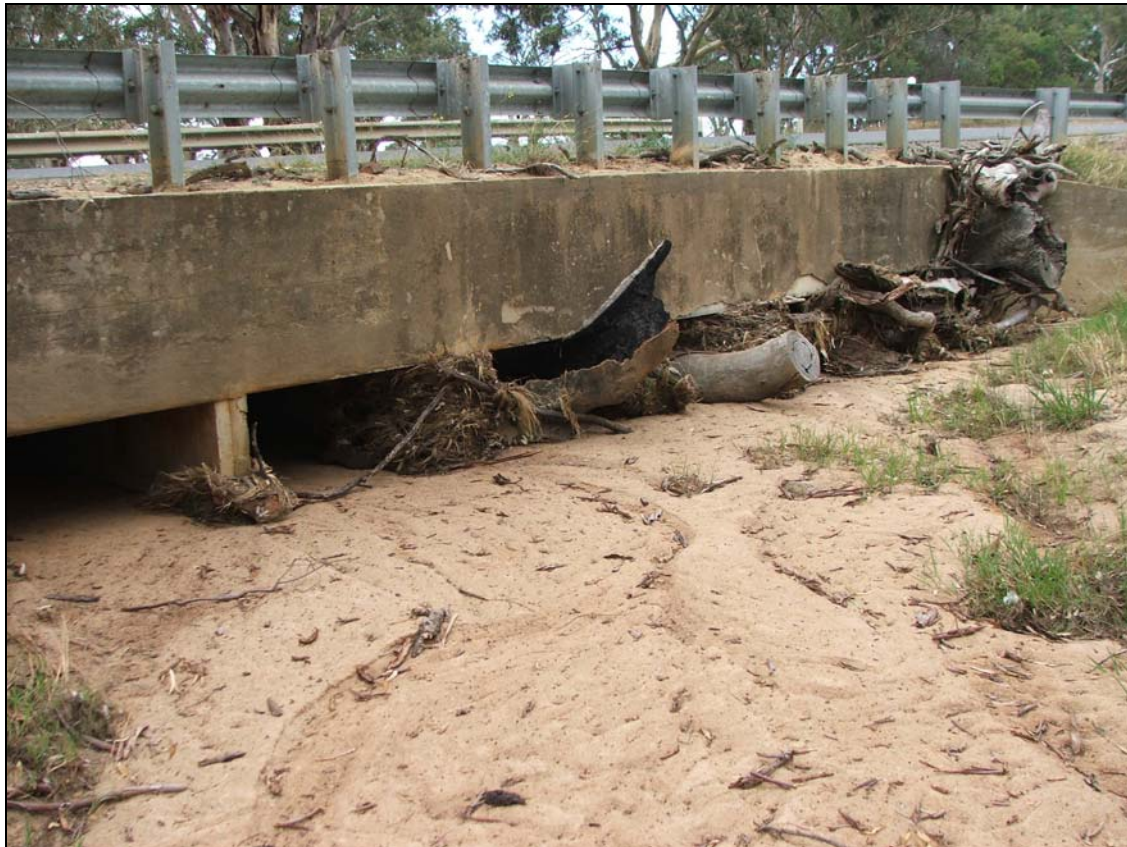
Figure 2.11 Feature WF2398. Stream sediment obstructing a road bridge along the Geelong - Bacchus Marsh Road.

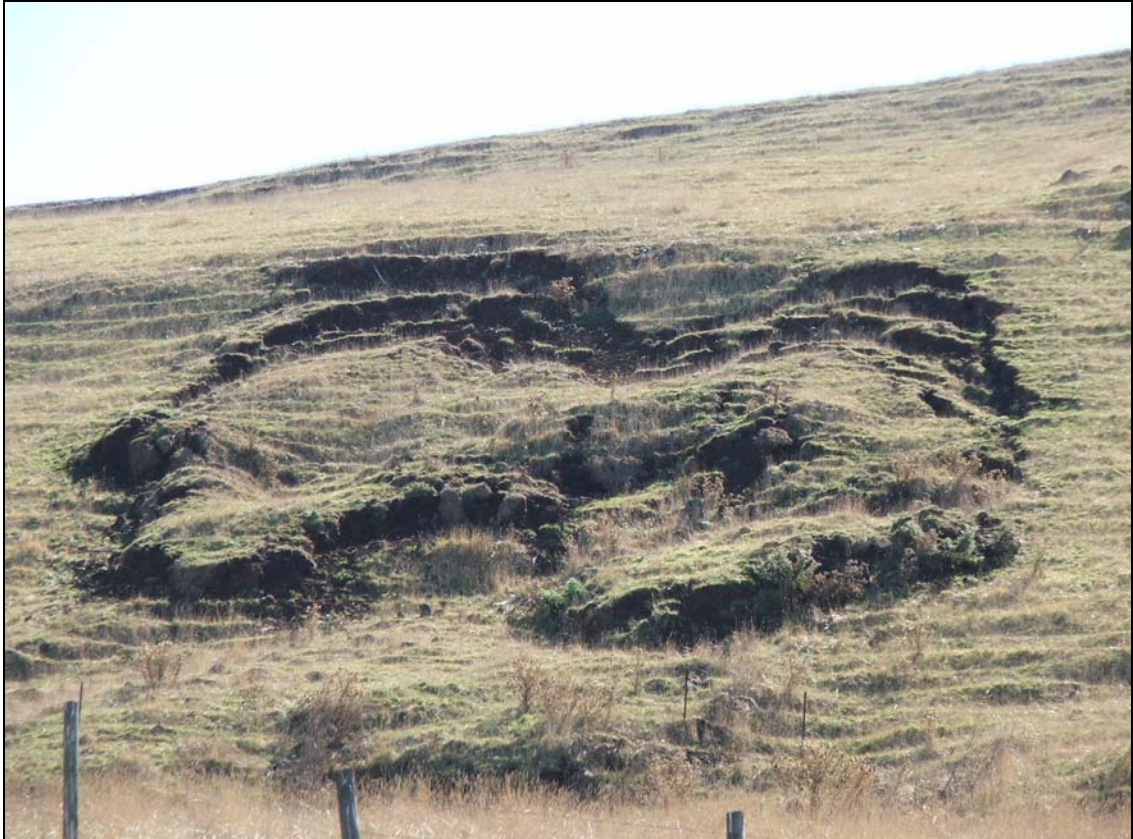
Figure 2.12. Feature WF2410. A recent landslide at Lake Bullen Merri near Camperdown.

Landslides consist of the movement of earth materials downslope under the influence of gravity. Landslide events are a natural geological agent in landscape evolution (Figure 2.12, 2.13). They are the major factor in the formation of valleys and coastlines.

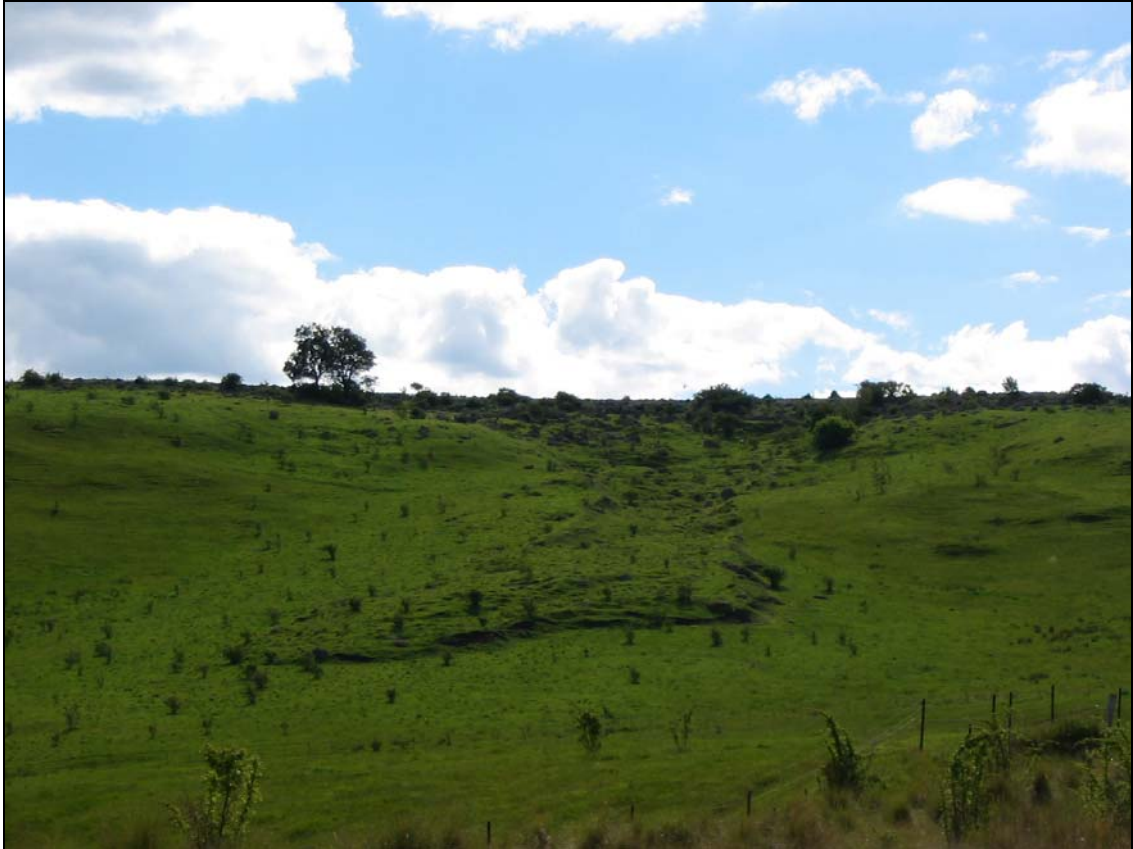
Figure 2.13 Feature WF28. A landslide north of Meredith

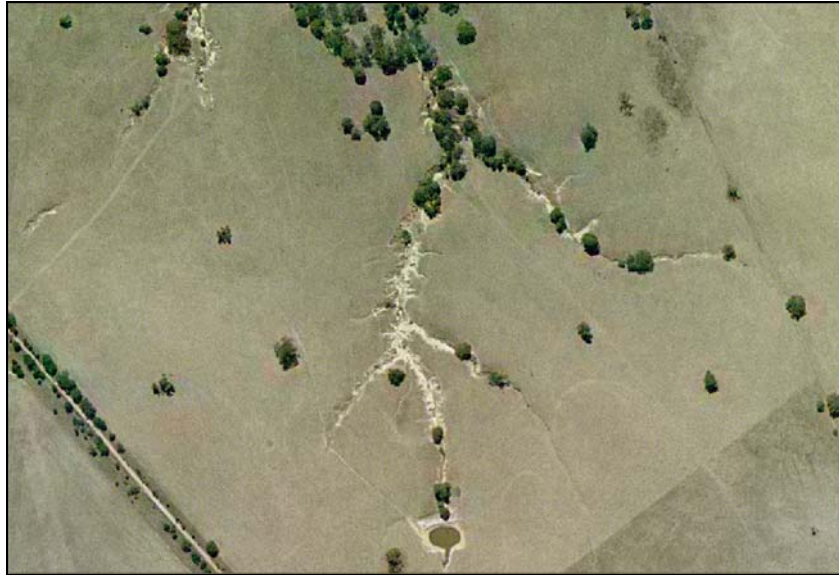
Figure 3.2 . Feature WF58. Aerial Photo Mapping of gully erosion

Features were entered as polygon objects for larger scale objects (Figure 3.1, 3.2), line objects were used for stream erosion and point objects were used for small scale features. Point objects were also used when the interpretation of possible degradation features was ambiguous but still worth recording.

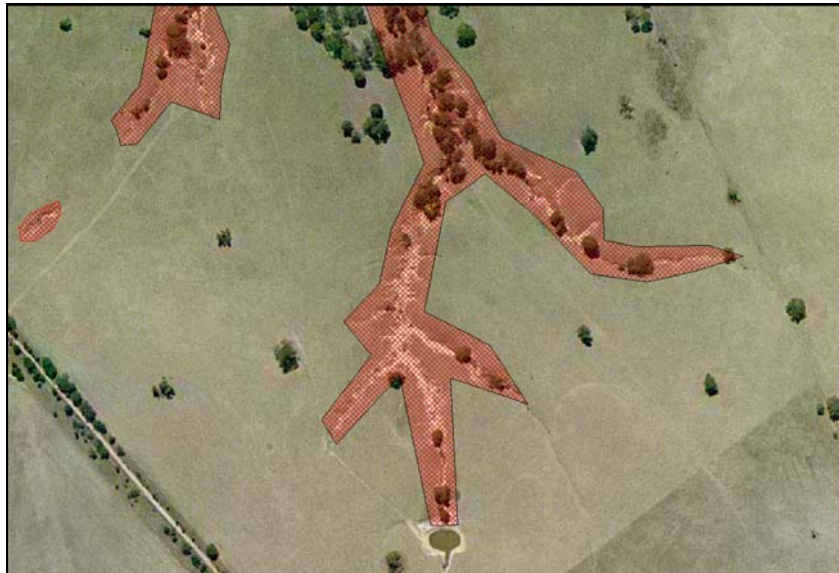
Figure 3.3 . Feature WF58. Aerial Photo Mapping of gully erosion with polygon object overlying the erosion feature.

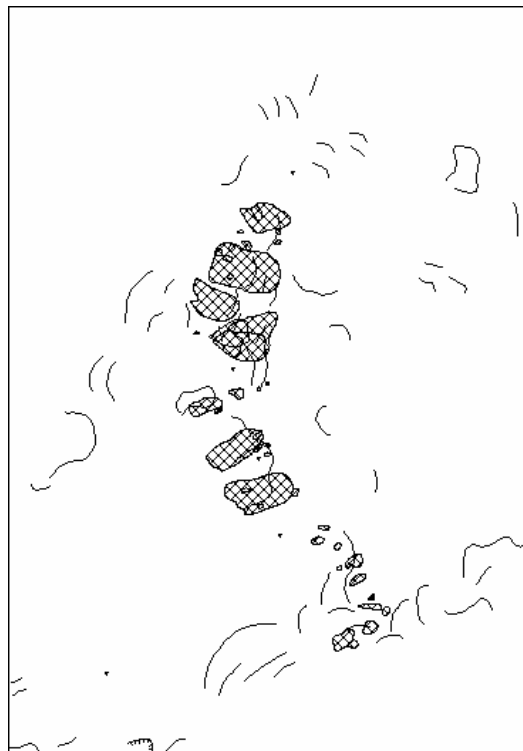
Figure 3.5 Example of features from the South West Landslides database

The data from the South West Landslide database can be distinguished by the graphical objects used to display the data. The object colour is black. Graphical objects consist of points, lines and polygons with a cross hatch fill pattern (Figure 3.5). The data was transferred by a simple MapBasic application that was written specifically for this task.

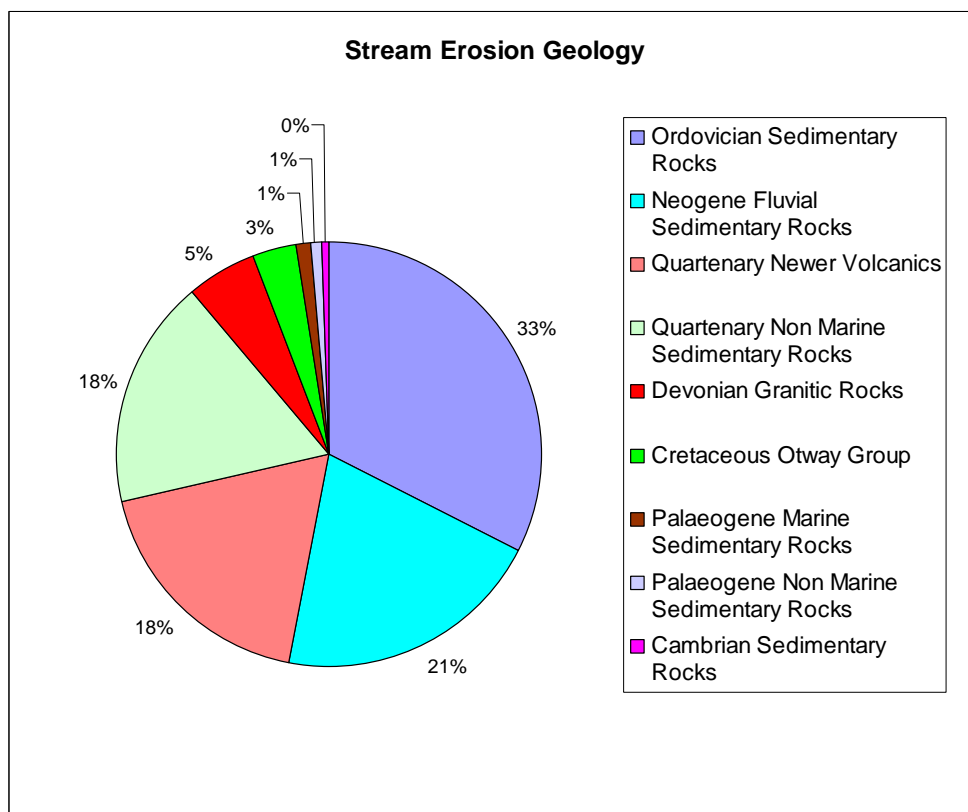
Figure 4.7 Stream Erosion represented by Surface Geology

The following pie charts (Figures 4.5 – 4.9) display the total number of each feature represented by surface geology. This comparison includes features from the database with a column value of “certain”, all features with a column value of “uncertain” were not included.

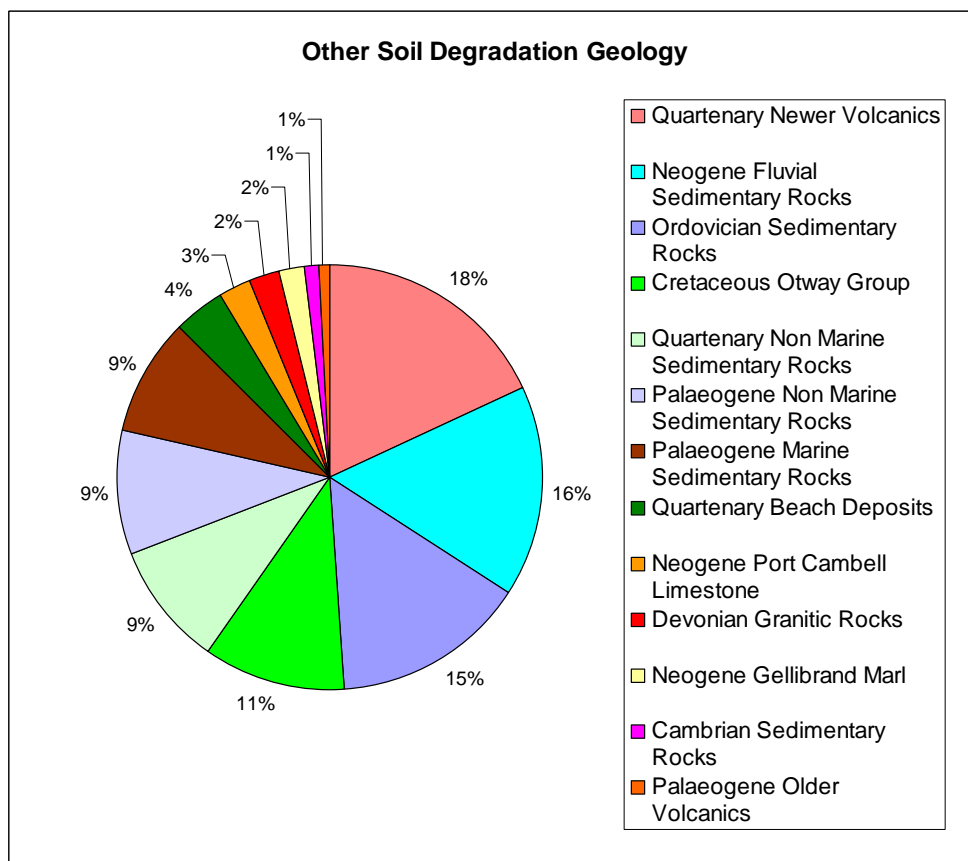
Figure 4.9 Other Soil Degradation represented by Surface Geology
