## Landslides & erosion

### Background information for the development of the Corangamite Soil Health Strategy

**Dahlhaus Environmental Geology Pty Ltd**

October 2003

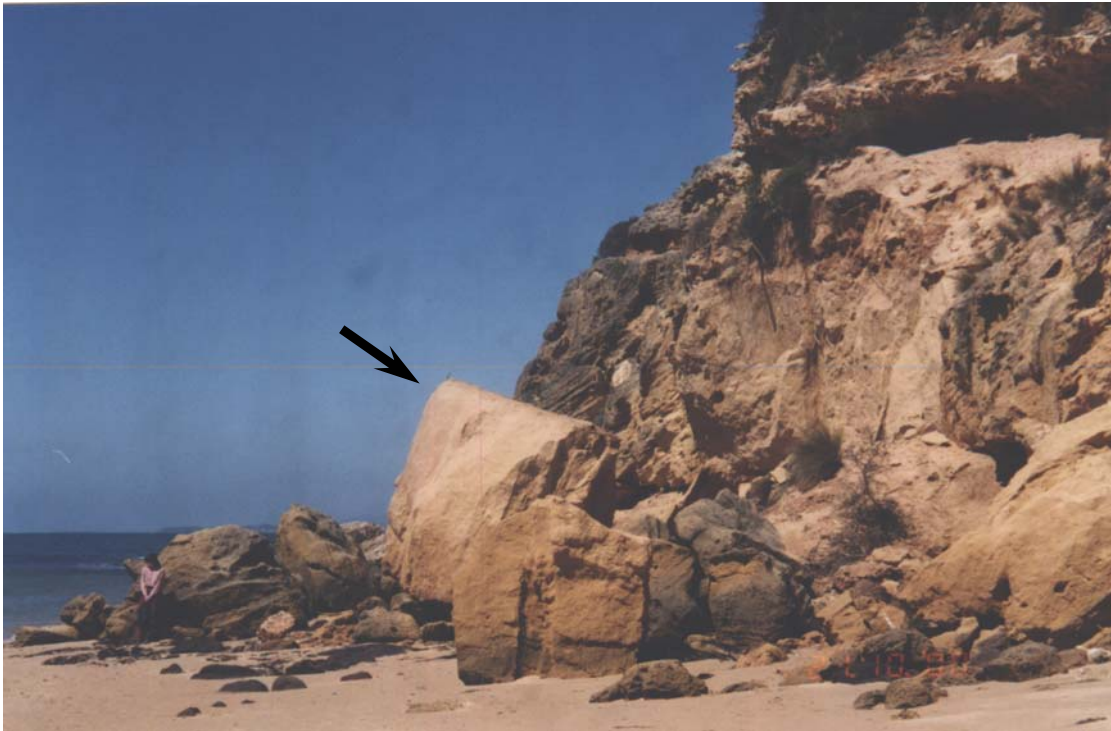
*Figure 2.2 An example of a rock fall at The Bluff, Barwon Heads.*

*The rock (arrowed) fell from the cliff following heavy rain in October 2000.  
Note the person on the left for scale.*

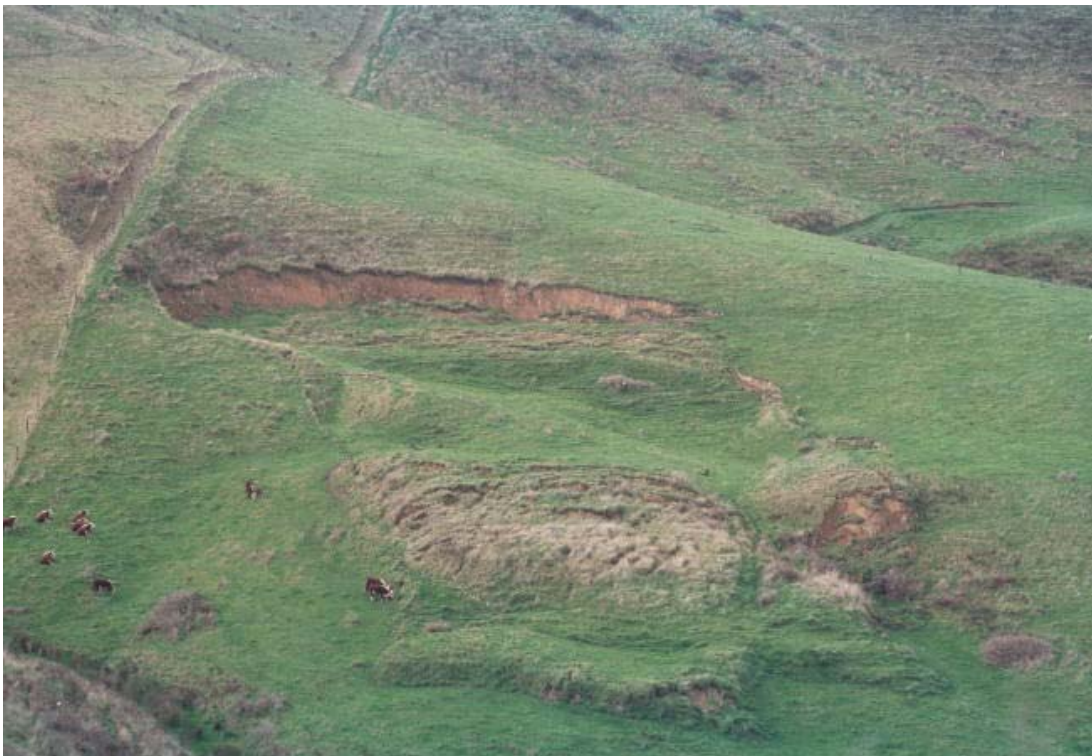
*Figure 2.3 An example of a debris slide and debris flow, Barham Valley*

*The slide occurred circa 1986.  
Note the cattle for scale*

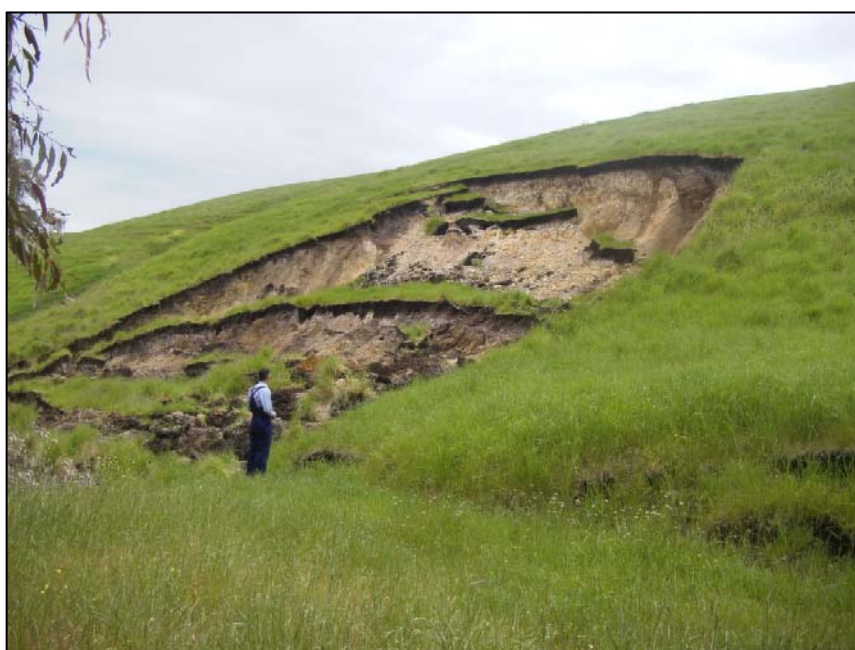
Figure 2.4 The Moorabool landslide, 2001

The landslide occurred in late November 2001. It threatened the stability of the adjacent She Oaks – Montpellier water supply aqueduct. The cost of the consequent works to secure the water main and stabilise the site is estimated at around \$200,000 to date.

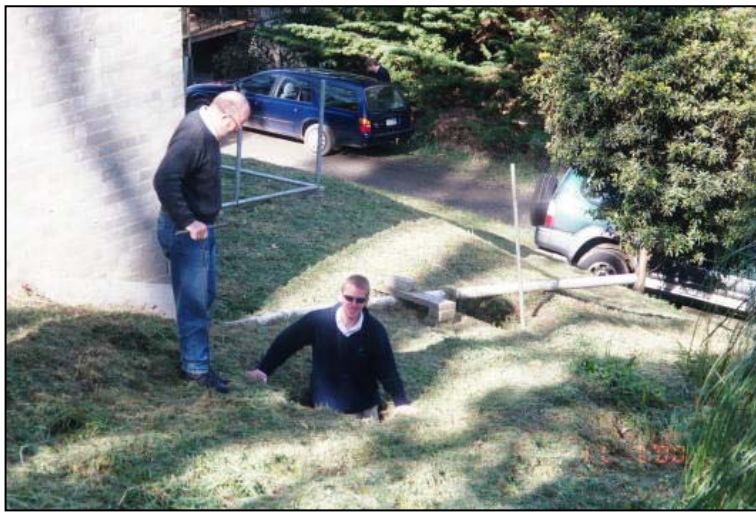
*Figure 3.2 Tunnel erosion adjacent to a house in Separation Creek.*

This tunnel appeared in July 2000 along a drainage line adjacent to a newly constructed dwelling.

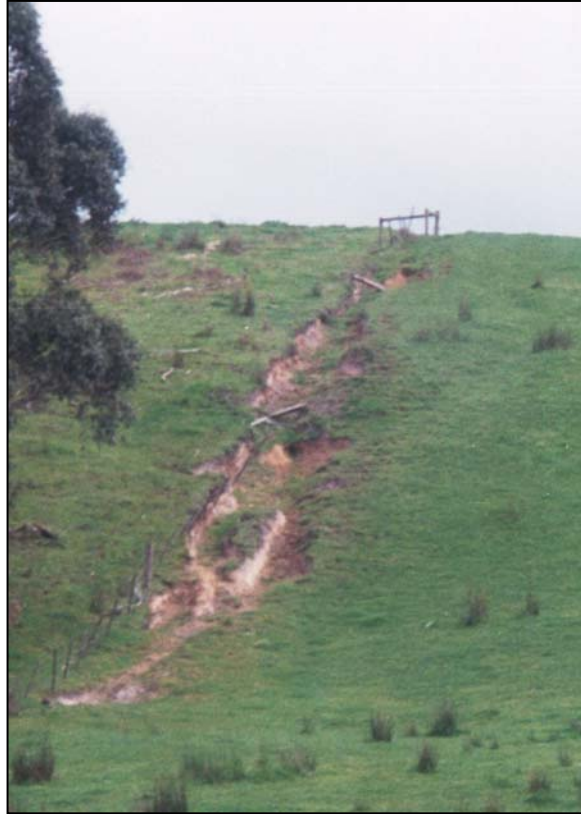
*Figure 3.4 Tunnel erosion progressing to gully erosion near Irrewillipie.*

The erosion at this site has been accelerated by rabbit activity.

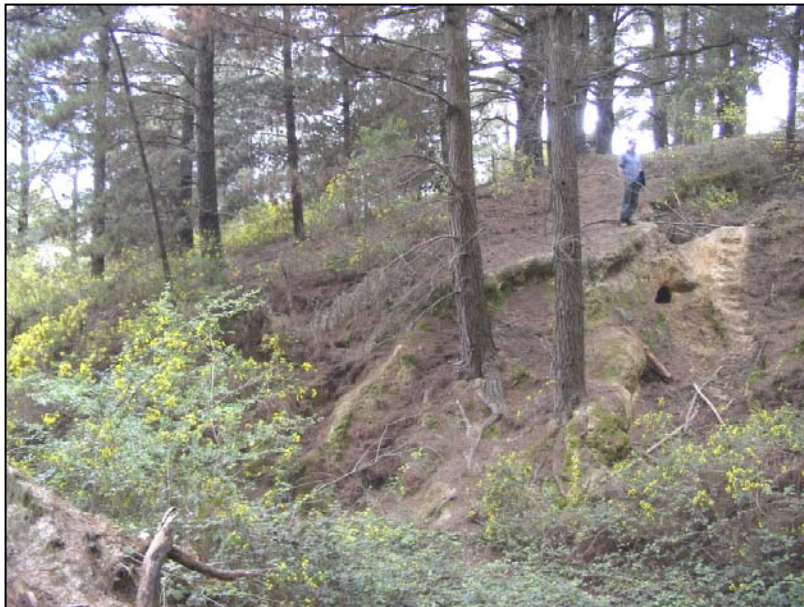
*Figure 3.5 Stabilisation of severe erosion at Black Hill, Ballarat using pine trees.*

Black Hill in Ballarat was extensively mined from the mid 1850s to early 1900s, resulting in four large open cut mines. By the 1930s the erosion was extreme and pine trees were planted in an attempt at erosion control. The photograph shows a deep gully on the eastern flank of the hill (note the person for scale) with tunnel development and small-scale slumping.

Gully erosion is the ultimate result of both tunnel erosion and rill erosion. Gullies are the most visually obvious representation of erosion in the landscape and have been the most common target for rehabilitation in the past. Spectacular examples of gully erosion are found near Elaine (Figure 3.3) and Clifton Springs. Other areas where gully erosion is known to be prevalent include Dereel, Linton, Lismore and Irrewillipie (Figure 3.4). In many areas gully erosion is a legacy of past land-use, particularly gold mining along creeks and drainage lines. Considerable efforts have been made over the past 60 years to rehabilitate many of these areas, although the technical knowledge may have been lacking at times (Figure 3.5).
