Appendix A: Threats to be addressed by the strategy

A.1 Landslides

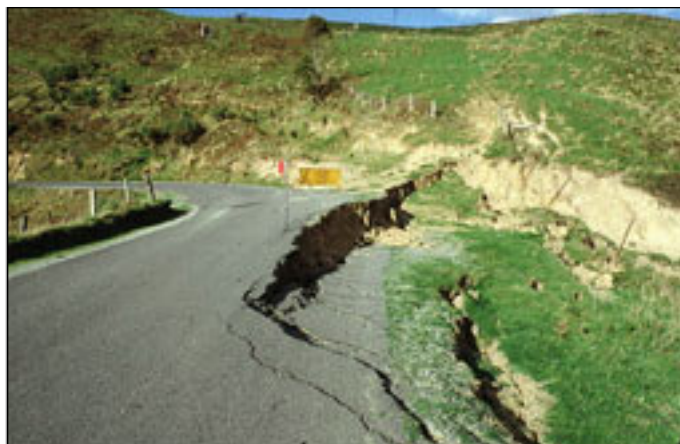
Figure A1: A landslide that has destroyed a road in the Corangamite region Photograph: A. Miner 2006

Anthropogenic factors must also be considered when assessing the likelihood of landslides. As more urban and infrastructure development proceeds in the region the chance of a catastrophic failure is substantially increased since more weight is added to a slope (buildings, roads, cars), more intensive infiltration occurs (septic tank effluent, gardens, roof and road run-off) and changes are made to slope morphology (roads, embankments, cuts). The combined effect may act to destabilise the slopes, putting property and lives at risk (Dahlhaus 2003). *Figure A1* shows an example of damage caused to a road by a landslide in the Corangamite region.

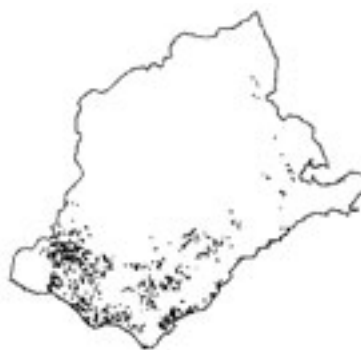
Figure A2: The location of landslides in the Corangamite region

The landscapes of the Corangamite region are among the most landslide-prone in Australia. Over 2252 (1924 certain) landslides have been mapped in various studies within the Corangamite region (*Fig. A2*).

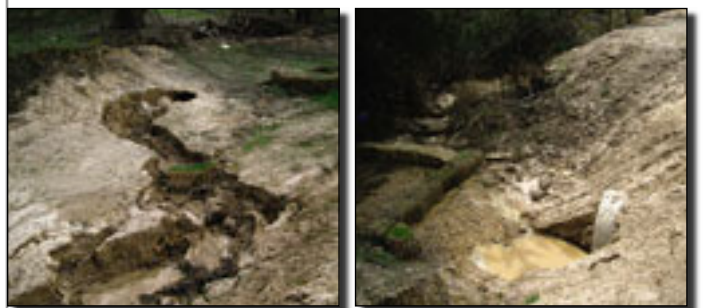
Figure A4: The start of an active gully erosion site, which washed sediments into a tributary of the Leigh River

Gullies erode headwards as the concentrated flow of water scours both the channel walls and bed. Eroded sediment is often deposited locally at the mouth of the gully as an alluvial fan. The deepening channel and retreating walls may intercept other sub-surface tunnels and/or the groundwater table, creating additional erosion by sloughing saturated soil into the channel. Figure A4 illustrates an example of active gully erosion and sedimentation from the erosion site entering a waterway.

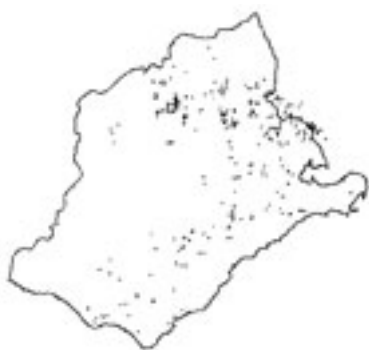
Figure A5: The location of sheet and rill erosion sites in the Corangamite region

Sheet/rill and gully/tunnel erosion has recently been mapped for the Corangamite region (Fig. A5 & A6). From this study, 1311 (933 certain) sheet/rill sites and 696 (626 certain) gully/tunnel sites have been identified (Faltham 2005). Many of these sites are located near priority waterways and other high-value assets which could be adversely impacted.

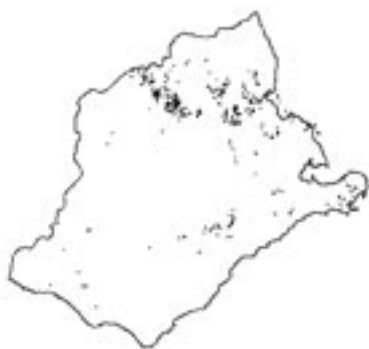
Figure A6: The location of gully and tunnel erosion sites in the Corangamite region

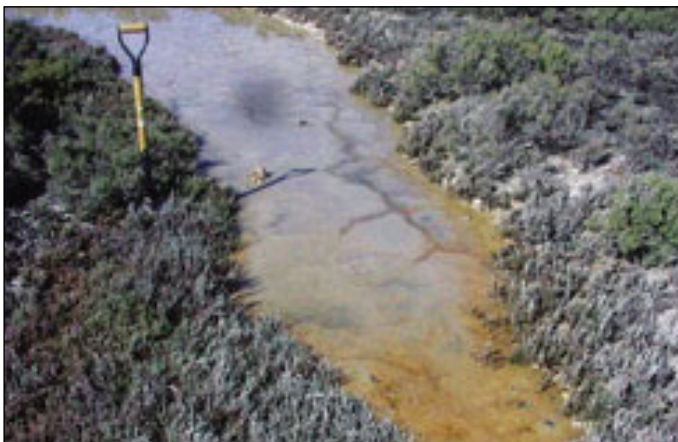
Figure A7: Drainage channels contaminated by high levels of acidity leached from disturbed acid sulphate soils

Left undisturbed, potential acid sulphate soils (PASS) cause few or no problems. Urban and regional development is often the main cause of disturbance of potential acid sulphate soils (Fig. A7).

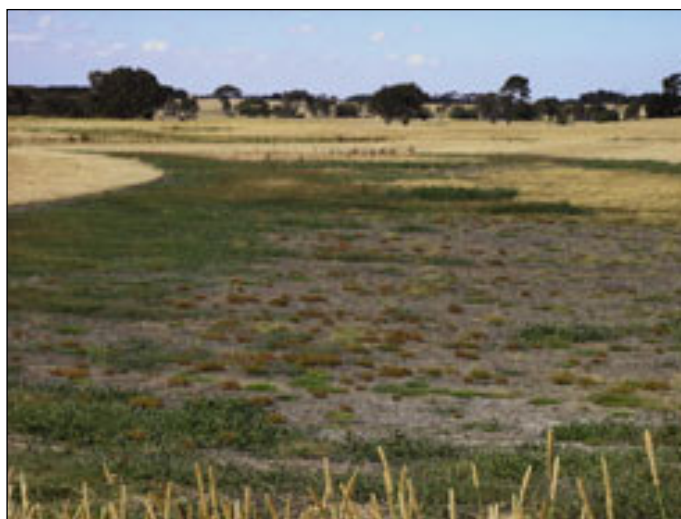
Figure A9: A secondary salinity discharge site found in the Corangamite region clearly shows bare areas and salt-tolerant species

Secondary salinity also occurs in areas unrelated to groundwater discharge where salts have accumulated in the soil profile over geological time. In the older landscapes of the region, cyclic salts (present in rainfall) have been accumulating in subsoils through evapotranspiration associated with deeper rooted vegetation (Fig. A9). Erosion, soil disturbance and hydrological processes have subsequently brought the salts closer to the surface. This is particularly prevalent where the deeply weathered regolith profiles of the Western Uplands have been exposed relatively recently by erosion or mining disturbance. Changes in the colour of vegetation, pioneering salt tolerant species and bare soil are all indicators of secondary salinity discharge sites.

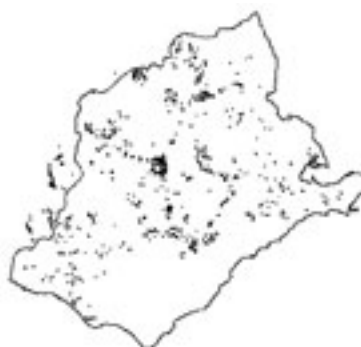
Figure A10: Location of secondary salinity discharge sites in the Corangamite region

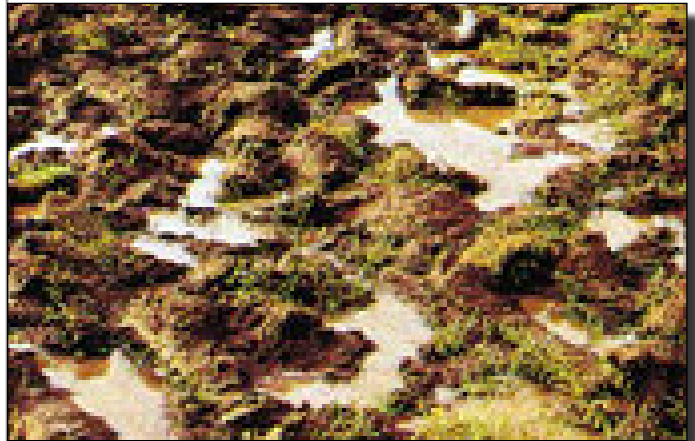
Figure A11: Pugging in waterlogged soils caused by dairy cattle, leading to soil structure decline

Pugging, a form of compaction, is a significant issue where animals are grazed on landscapes with wet or waterlogged (Fig. A11) soils. Severe pugging can occur on the clay soils in dairy country found in the south-west areas of the Corangamite region. A study by MacEwan (1998) confirmed the susceptibility of the region's soils to pugging, especially in landscapes where the soils are saturated or where the watertable is within 20cm of the surface soil.

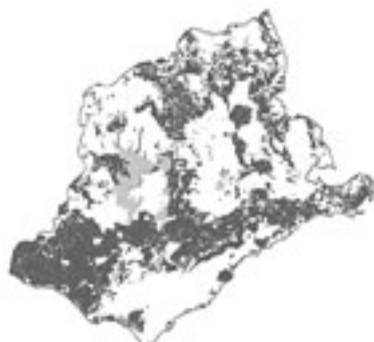
Figure A13: Areas of high to very high soil structure decline susceptibility in the Corangamite region

Waterlogging may be a natural condition of the soil, but can worsen with deterioration in soil structure. There is a strong relationship between high likelihood of soil structure deterioration and a high susceptibility to waterlogging. Susceptibility maps indicate that waterlogging is high to very high over more than 50% of the Corangamite region (Fig. A12). These susceptible areas are generally located on low-lying heavy duplex soils in higher rainfall areas. High to very high susceptibility to soil structure decline covers similar areas to that of waterlogging, predominant in the south-west section of the region (Fig. A13).

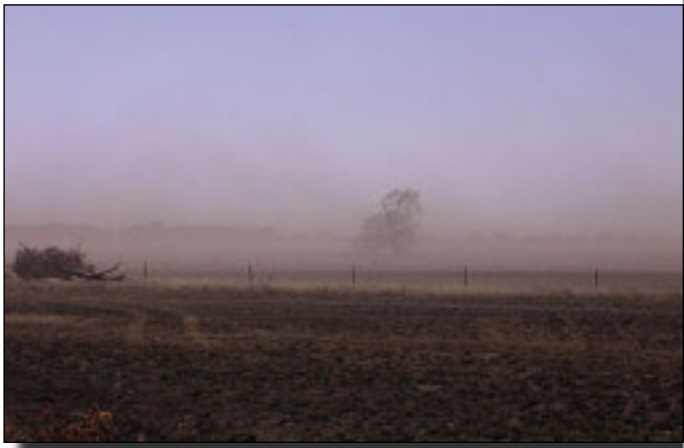
Figure A14: Wind erosion in fallowed paddock

Wind erosion is mostly seen across the Basalt Plains, the Central Highlands and at points along the coastline. Wind erosion generally occurs on fallowed areas in cropping country and exposed sand dunes along the coast (Fig. A14).

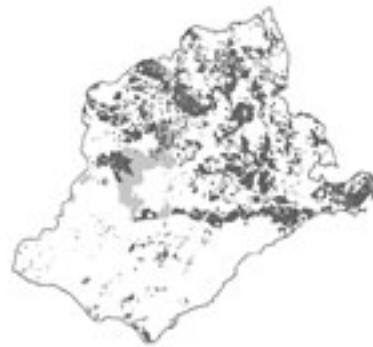
Figure A15: Areas of high to very high wind erosion susceptibility in the Corangamite region

Wind erosion of sand dunes is most dynamic along south-west to south-facing shorelines in response to prevailing and strong winds. However, detailed dune position, extent and dynamics are determined by several variables including the beach slope and offshore profile, the geometry of the coastline and the availability of sand (partly a function of shoreline geology). High to very high susceptibility areas for wind erosion are illustrated in Figure A15.
