a.s.miner
Geotechnical
Consulting Engineers

**CCMA Erosion and Landslide
Trend Mapping Project Using
Aerial Photo Interpretation.**

Part A - Methodology

Report No: 356.1/01/07

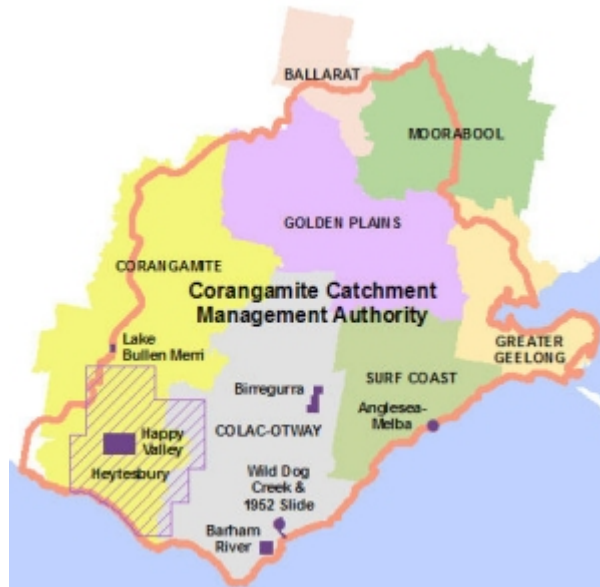
Figure 1 Location of Landslide trend mapping study sites

A series of other temporal analyses were also available through other studies and researchers. These are described in the later sections. Locations of all study sites are shown in Figures 1 and 2.

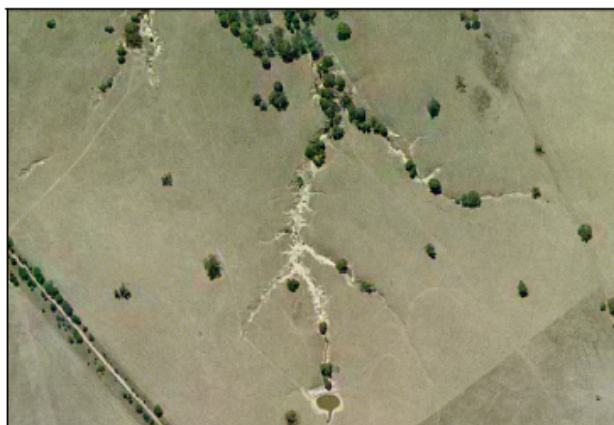
Figure 3.2 Feature WF58. Aerial Photo Mapping of gully erosion

Gully and sheet erosion features that were not obscured by vegetation were particularly well defined on the aerial photographs (Figure 3.2). Landslide features that had occurred recently were relatively easy to identify, whereas landslides that had occurred some time ago and had undergone the effects of weathering and revegetation were difficult to identify.
