## Corangamite Catchment Management Authority and the City of Greater Geelong

### **Case Study for Erosion and Landslides.**

Lal Lal Reserve

Report No: 356.3/25/06

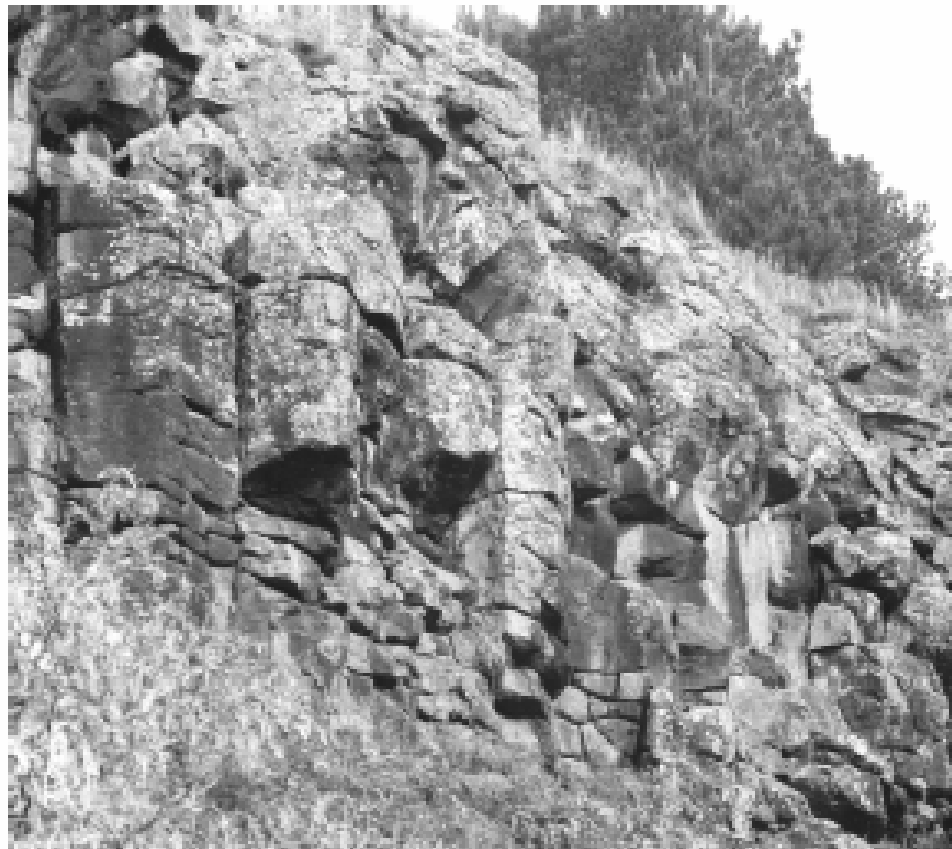
Figure 6. Undercut columns with open joints.

The walls of the Lal Lal gorge expose two layers of basalt both exhibiting well formed columnar jointing. As such the main hazard exist below the columnar basalt although ongoing retrogressive degradation of the gorge is occurring but at geological rates.
