Tunnel Erosion

An early identification guide for East Gippsland

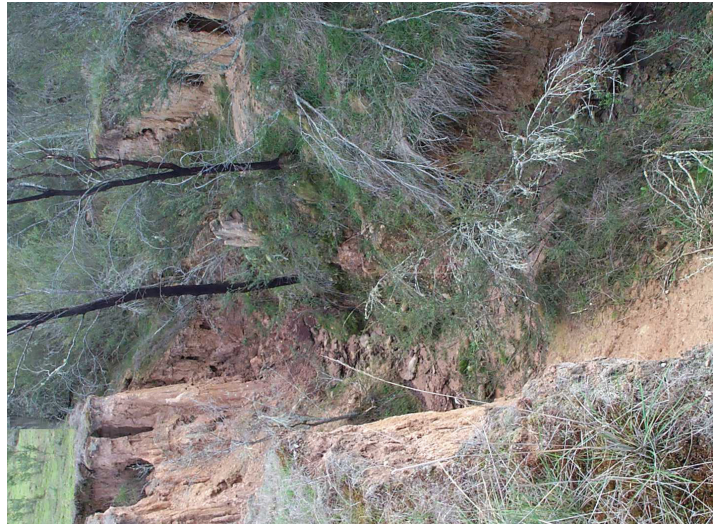
Figure 5: Illustrating potential damage of tunnel erosion.

- reduced productivity
- soil and nutrient loss from property
- injury to livestock
- damage to farm equipment
- harbor for rabbits and wombats
- sedimentation of dams and waterways
- the potential to turn into highly active gully erosion (Figures 3 & 5)
- negative impact on the Gippsland Lakes' water quality.

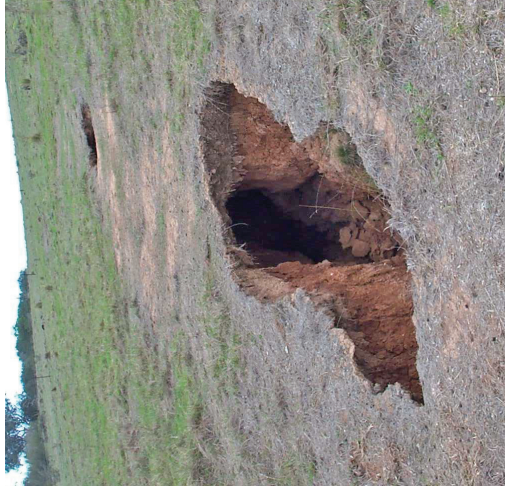
Figure 1: Clay deposits rising to the surface through an outlet, creating a 'fan' shape.

Identifying tunnel erosion in the early stages is difficult as indications are small areas of clay deposits and/or holes in the surface soil on lower slopes. As more subsoil is washed down through the 'tunnels' fan shaped clay deposits or flumes form as shown in Figure 1.

- Small holes and/or indents appearing in the pasture.
- Water 'spouting' from small holes in the ground following heavy rain.
- Clay particles deposited in a fan shape on the paddock surface (Figure 1).
- 'Drying off' lines in pasture caused by shallow soil depth (Figure 2).
- Collapsing surface soil creating elongated ditches, usually running down a slope (Figure 3).

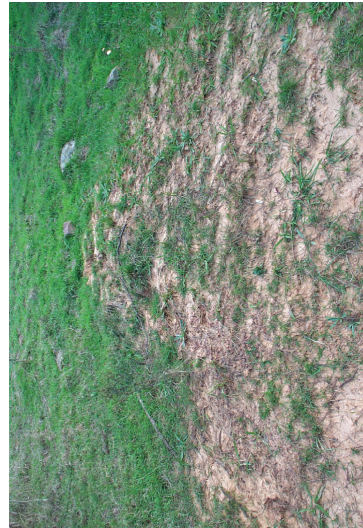
Figure 2: Partial collapse of tunnel with drying off lines visible.

As more subsoil is washed away, the tunnels deepen and widen until the roof of the tunnel cannot support its own weight and collapses forming holes. At this stage the erosion is already well advanced. Eventually more tunnels collapse forming an active gully (Figure 2, 3 and 4).

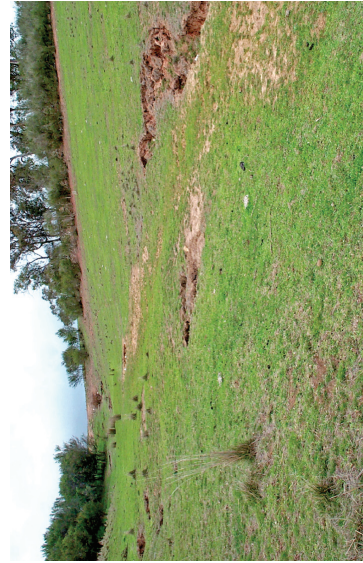
Figure 3: Tunnel collapse and surface clay deposits.

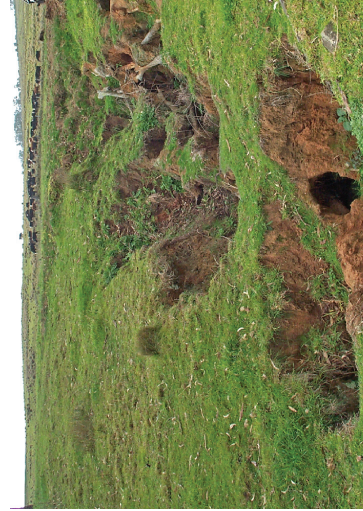
Figure 4: Start of gully formation.

A process where the subsoil is eroded by water forming underground tunnels. It is often associated with soils that have a hard-setting top soil over a subsoil (clay) which may be stable when dry but readily disperses when wet (Figure 4).
