Tunnel erosion in East Gippsland

Published by: Department of Primary Industries,
Bairnsdale, Victoria 3953, Australia
April 2010

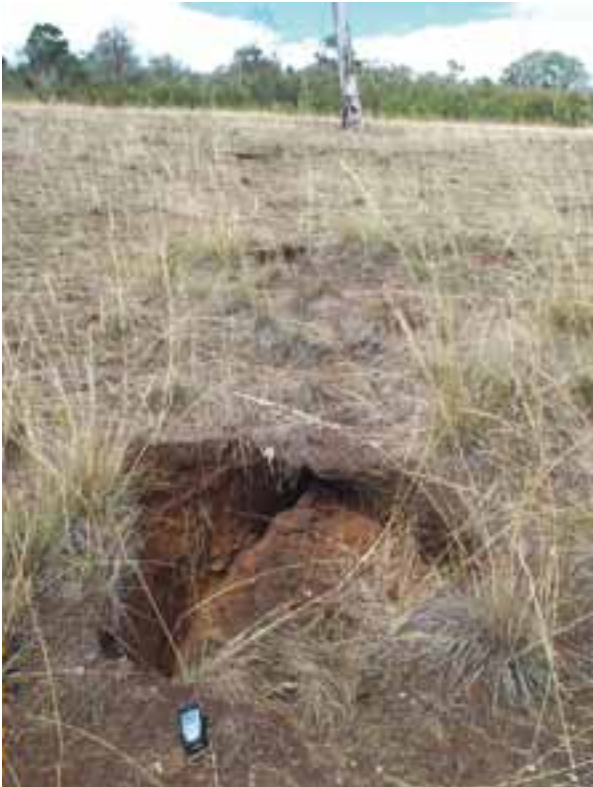
Holes in the paddocks of the catchment that are caused by tunnel erosion.

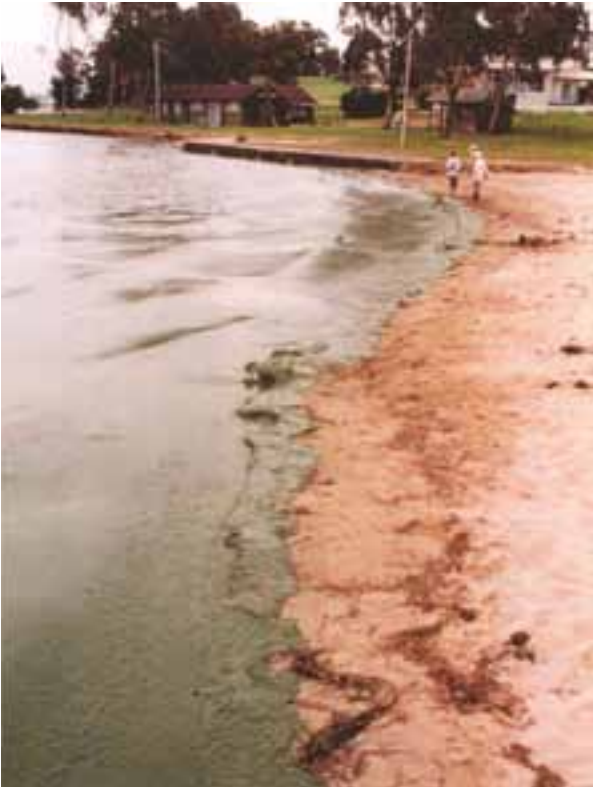
Algal bloom at Paynesville attributed to the nutrients washed from the catchments due to erosion.

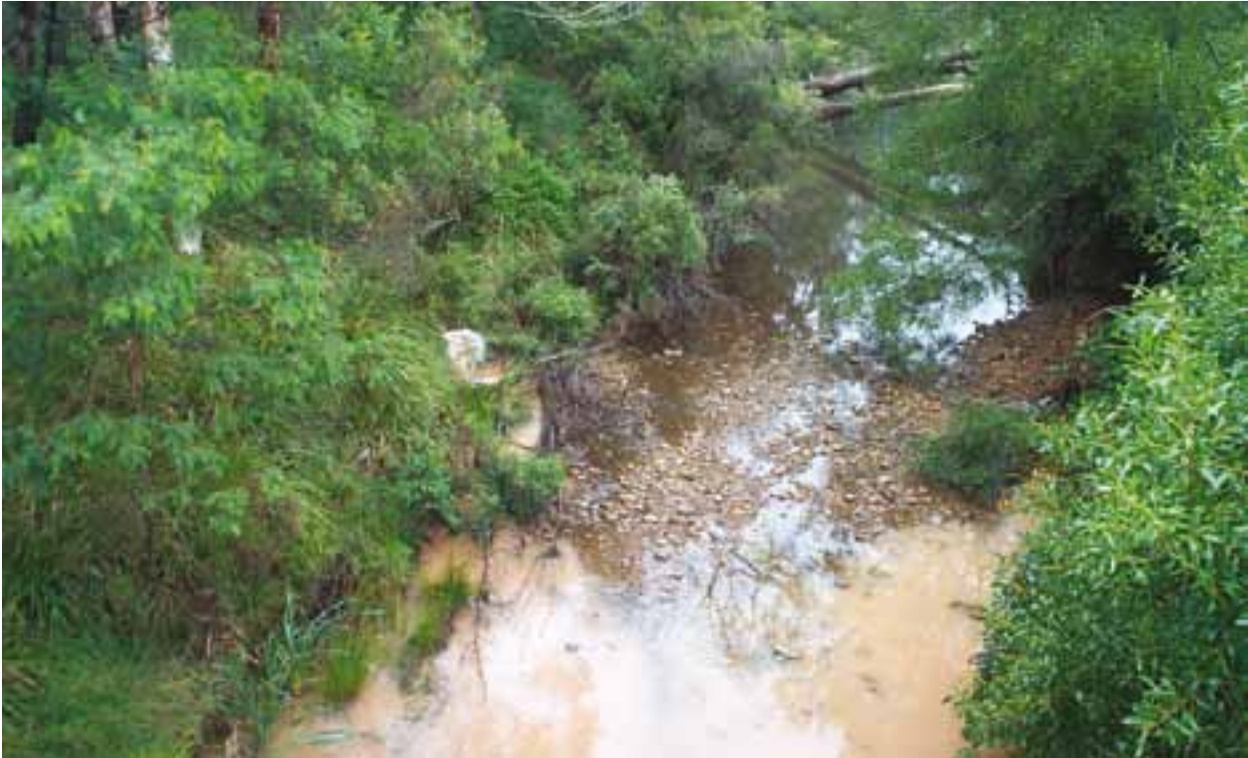
The transport of the sediment and nutrients via gullies, creeks and rivers.

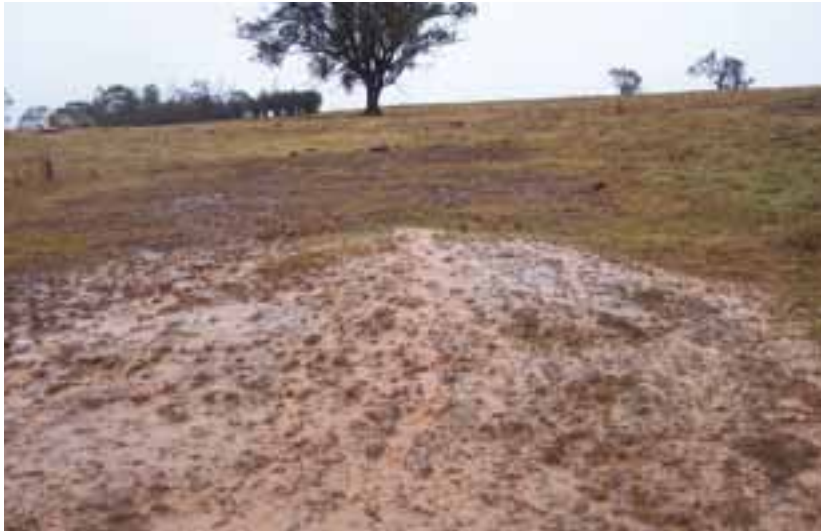
Tunnel erosion can appear innocuously as a small hole that flows water and suspended sediments.

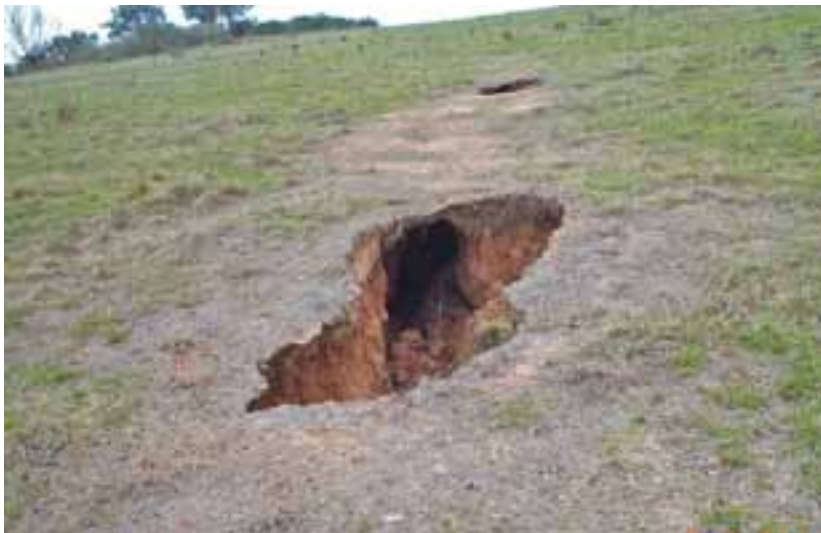
As the tunnel develops under the ground, the top profile collapses and holes form in the paddock. Note the lack of vegetation that depicts the location of the erosion between the holes.

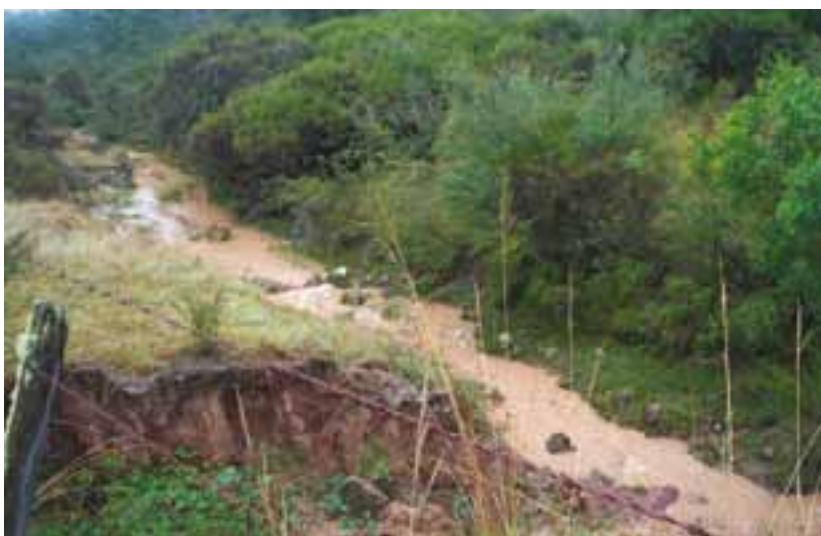
The highly dispersive sediments are transported with the water from the paddock during rainfall events to the gullies, creeks and rivers.

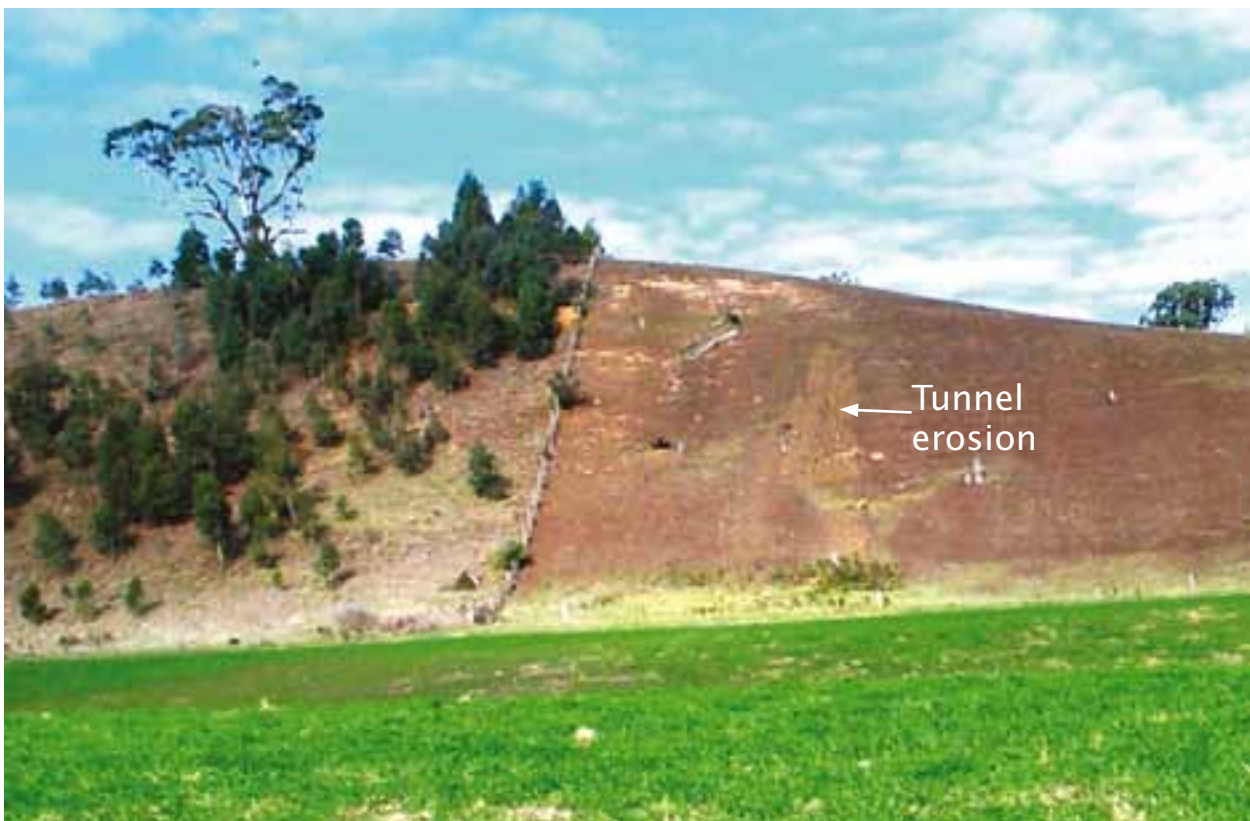
Left of the fence has been revegetated with indigenous species and right of the fence has not been rehabilitated. Note the lines of sediment from the working tunnel erosion on the right.

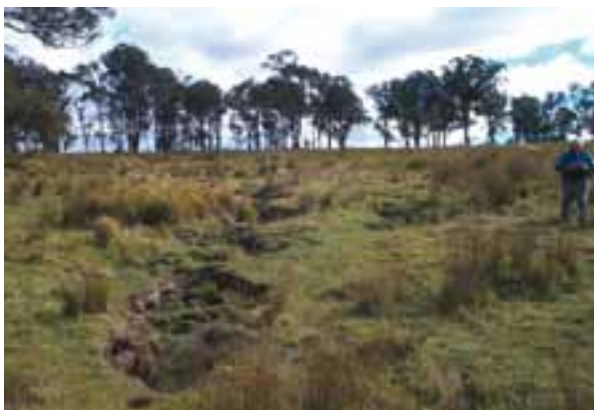
6a Collapsed tunnel erosion in the gully line of the divisional line of the plots indicating medium rated tunnel erosion

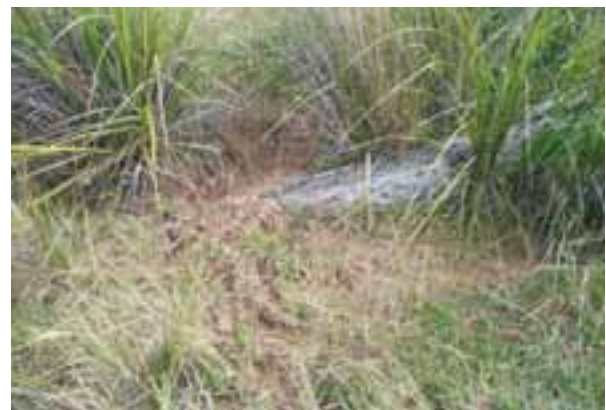
6b Sediment from a tunnel outlet in plot D near the central gully

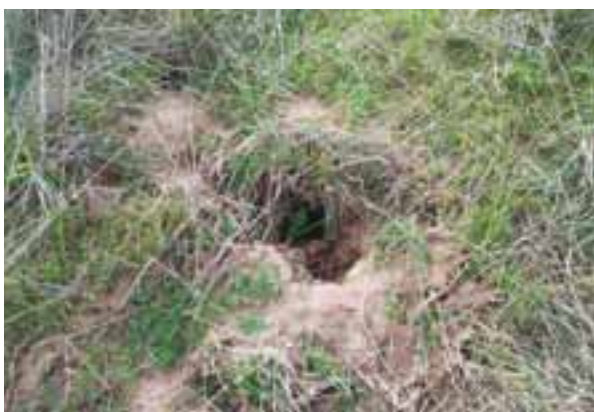
6c Tunnel outlet in Plot E

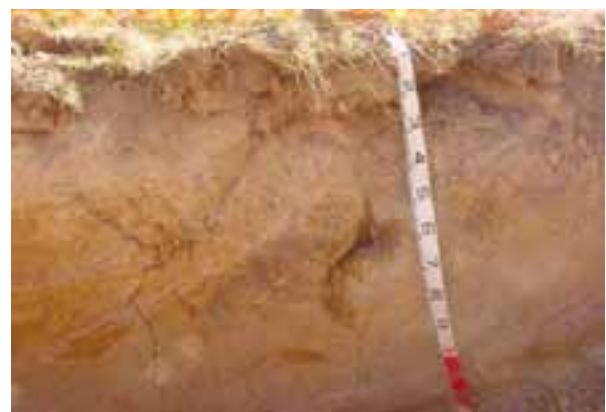
6d Soil pit in plot F showing average depth of tunnel erosion in the paddock

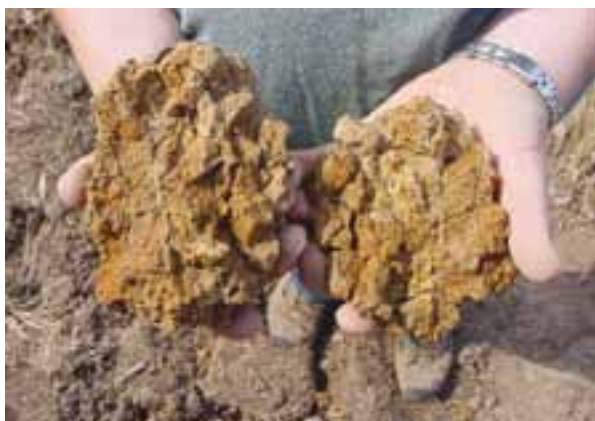
Above is an example of how water and soil move through the soil aggregates with the lighter coloured veins of soil against the darker coloured clay ped illustrating how also the very fine sediment is washed through the soil profile with the water as a result of the erosion process occurring.

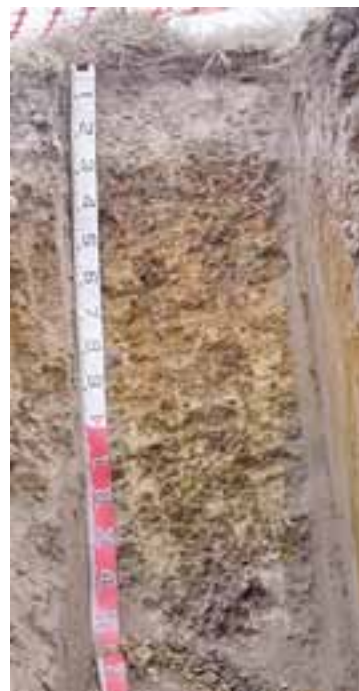
At left is a soil pit photo of a typical Glenaladale soil.

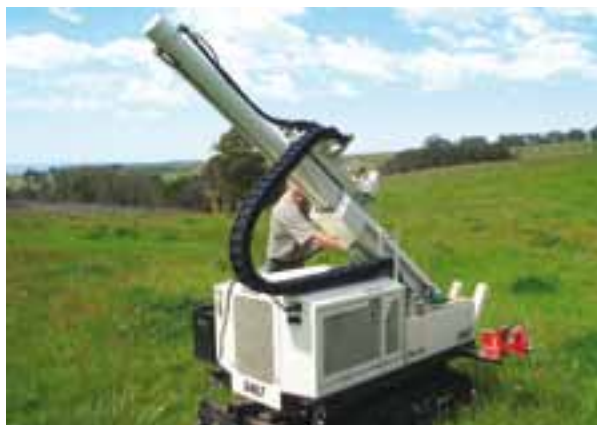
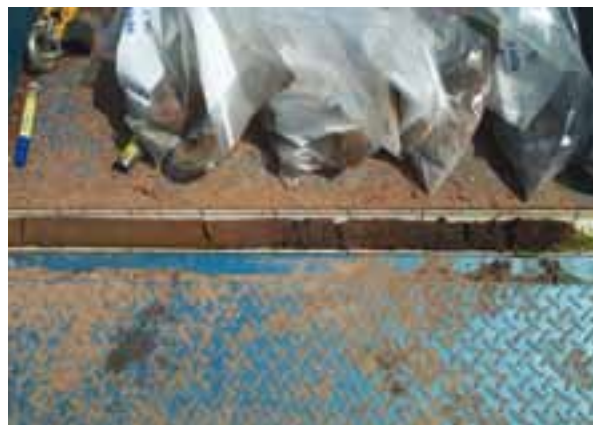
Figure 10: The Intact corer at work (left) and the core sample from plot C showing the sandy subsoil (right).

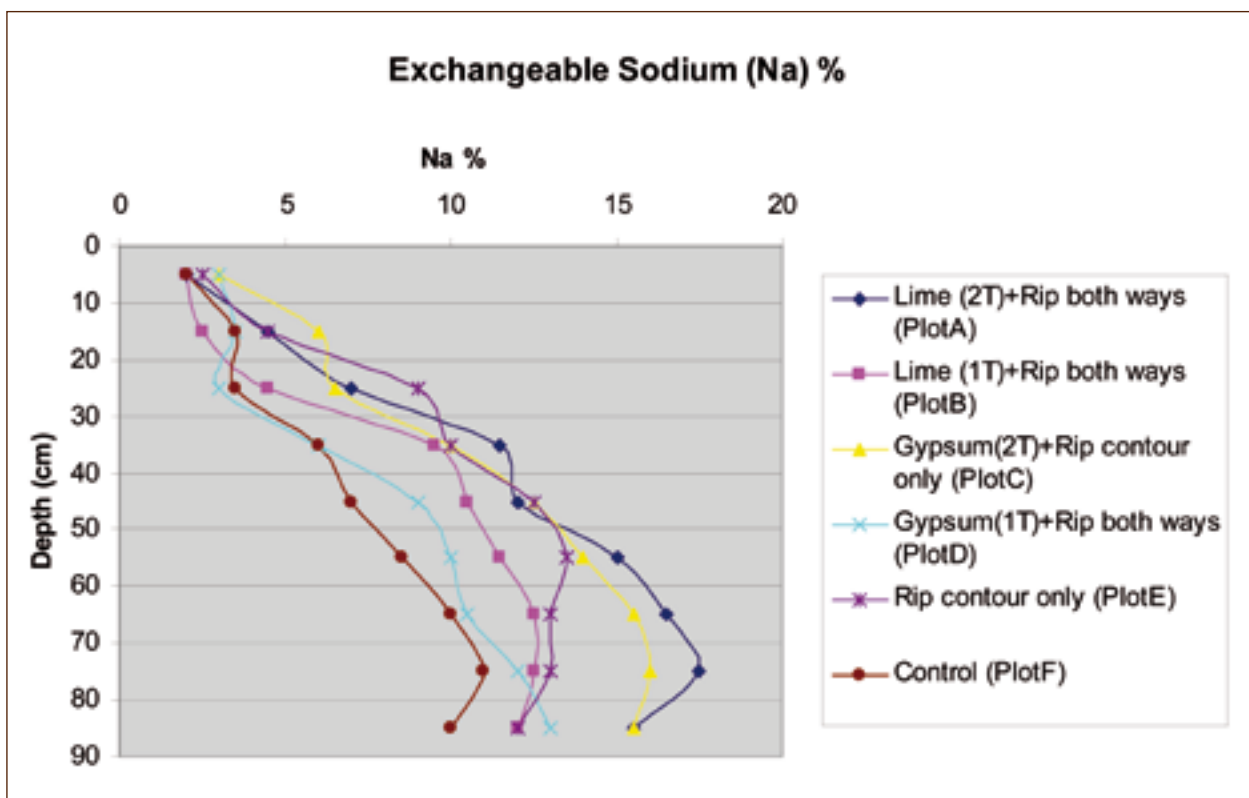
Figure 11: Demonstration site mean exchangeable sodium percentage across treatment plots.

A possible explanation for these results is that sodium is being displaced by the calcium from the gypsum or lime, resulting in the leaching of sodium from the shallower depths to depths deeper in the soil profile. This typically leads to an increase in Exch Na and a decrease in the Exch Ca in the lower depths of the soil profile (Lines-Kelly, 2000). Exch Mg was also less in the soil samples from top of the soil of the control plot compared to those from the treated plots.

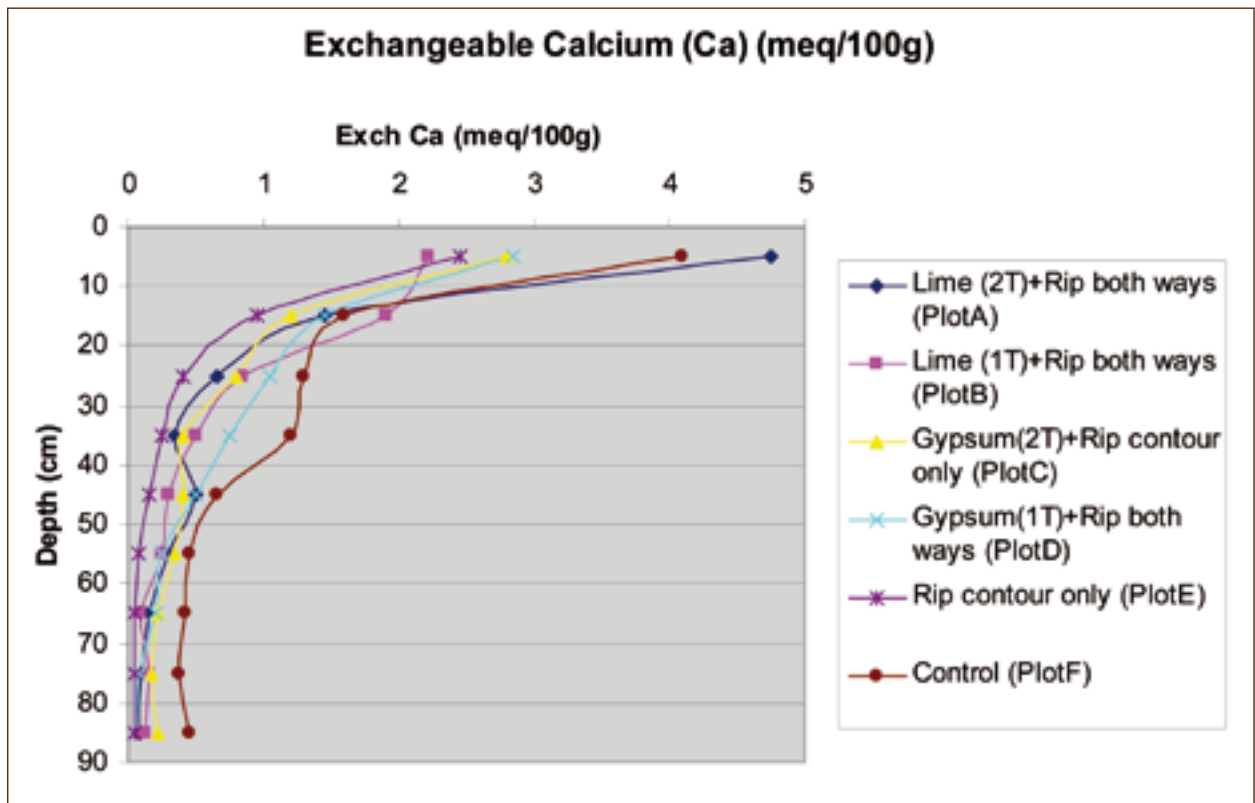
Figure 12: Demonstration site mean calcium content across treatment plots.

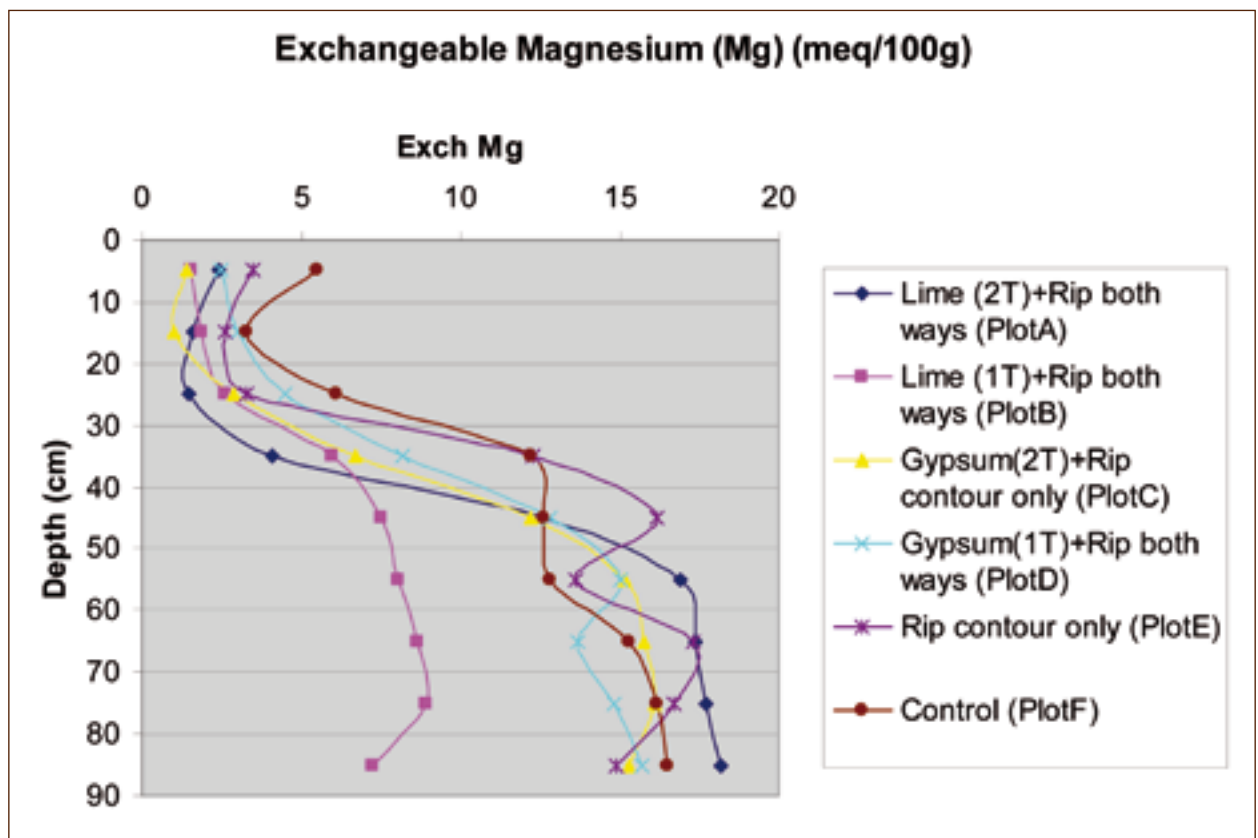
Figure 13: Demonstration site mean Exchangeable Magnesium (Mg) content across treatment plots.

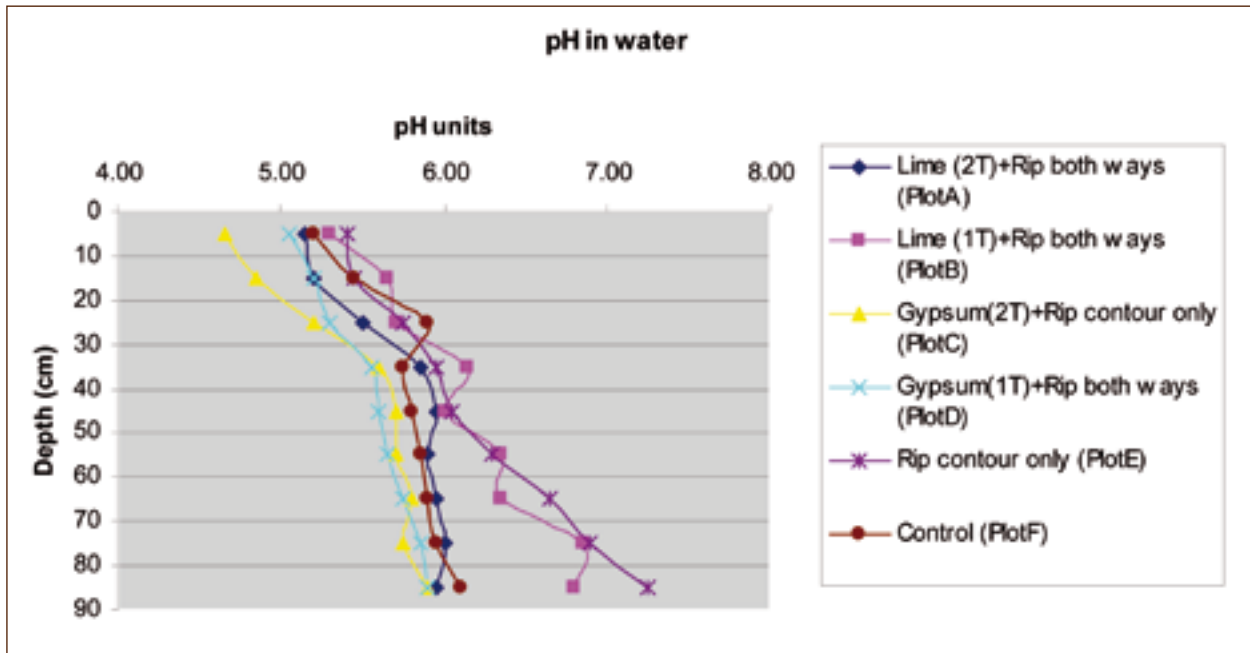
Figure 14: Demonstration site mean pH (in water) across treatment plots.

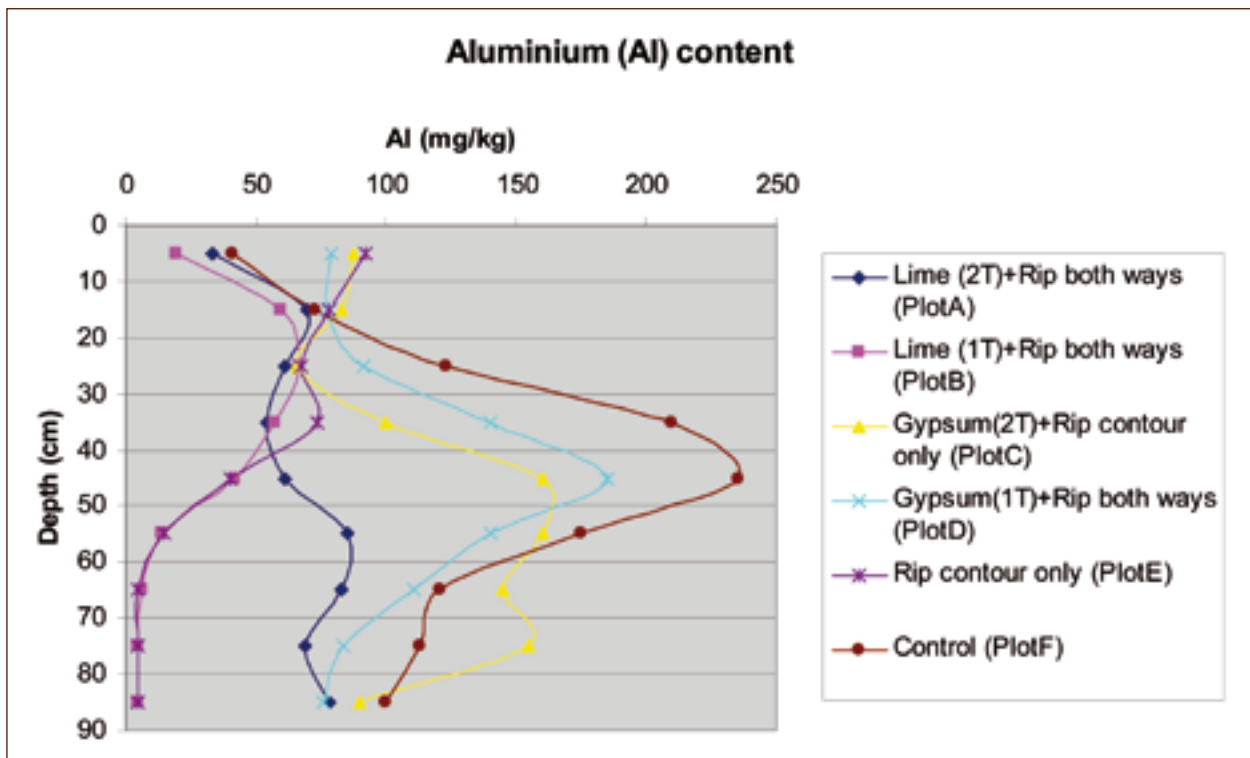
Figure 15: Demonstration site mean Aluminium (Al) content across treatment plots.

As the rehabilitation method uses perennial pasture establishment as part of the rehabilitation process, toxic concentrations of aluminium in the soil solutions of sub-soils, as indicated by extractable aluminium values > 50 mg/kg, impacts on the choice of pasture species that are able to be planted after earthworks are completed. However, this did not appear to reduce the establishment of pasture on the demonstration site (Figure 16).

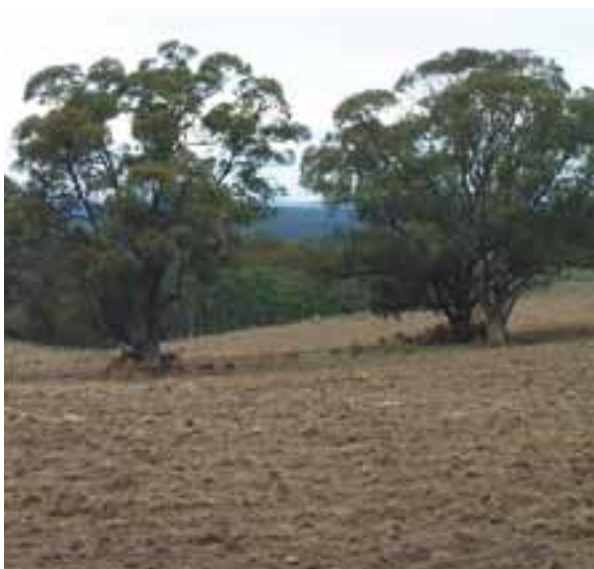
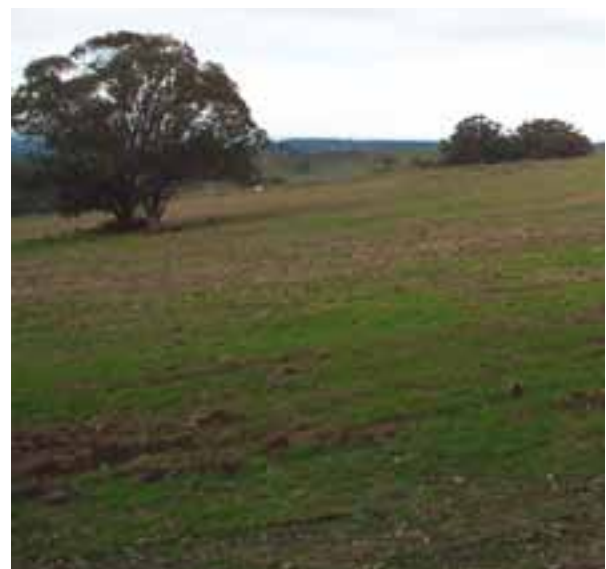
Figure 16: Monitoring photographic points of demonstration site.

April 2003 after ripping treatments completed and pasture sown.

May 2003 one month after rehabilitation completed.

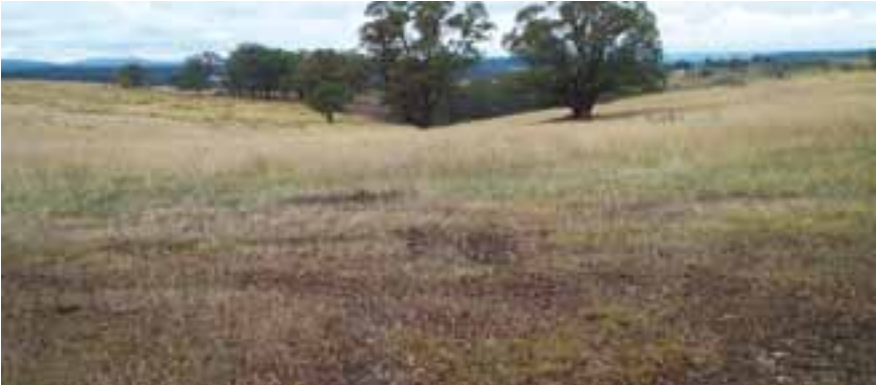
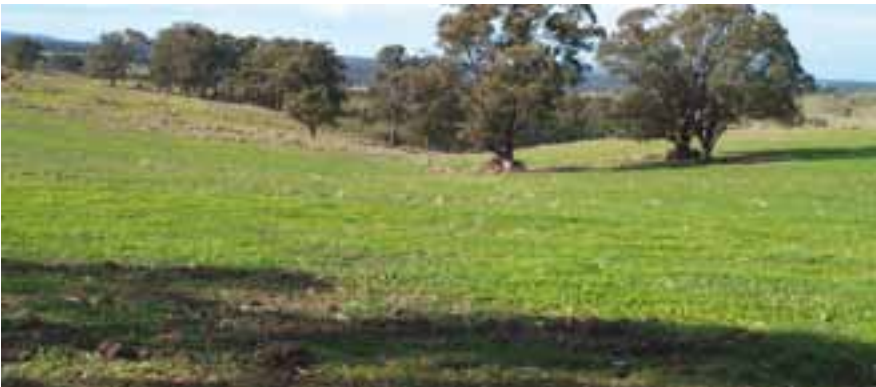
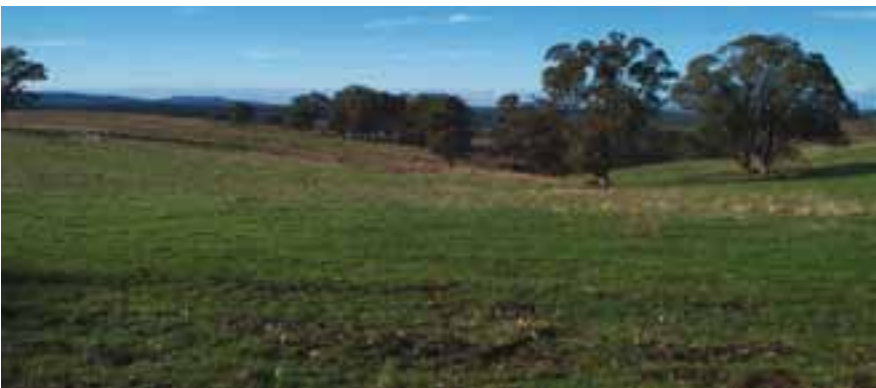
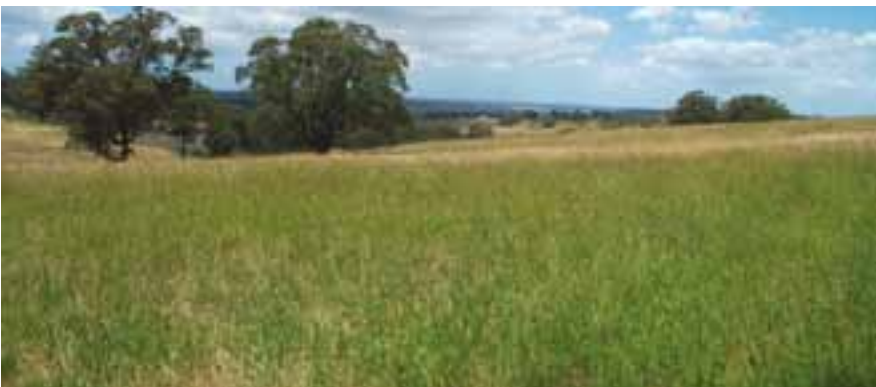
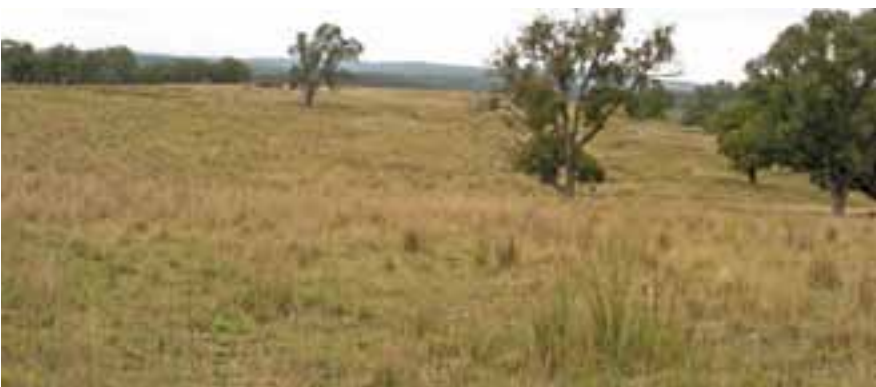
January 2004

May 2004

June 2004

December 2004

May 2009

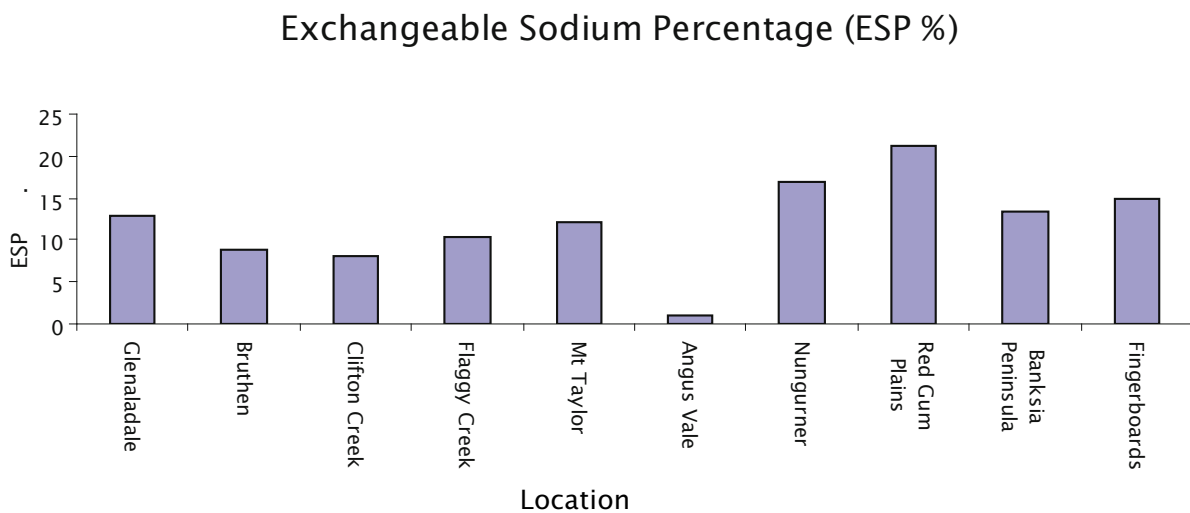
Figure 18: Mean exchangeable sodium percentage results for the whole soil profile across the 15 soil pit sites sampled in the Bairnsdale region.

All but one soil pit had an ESP % of above eight. This means that nine areas in the region have sodic soils present. Sodic soils are likely to be dispersive and are also structurally unstable and therefore when coming in contact with water break down into their basic soil particles (Sargeant I and Sargant J 2005). Angus Vale was the only location that did not have sodic soils present based on this definition (Figure 18).

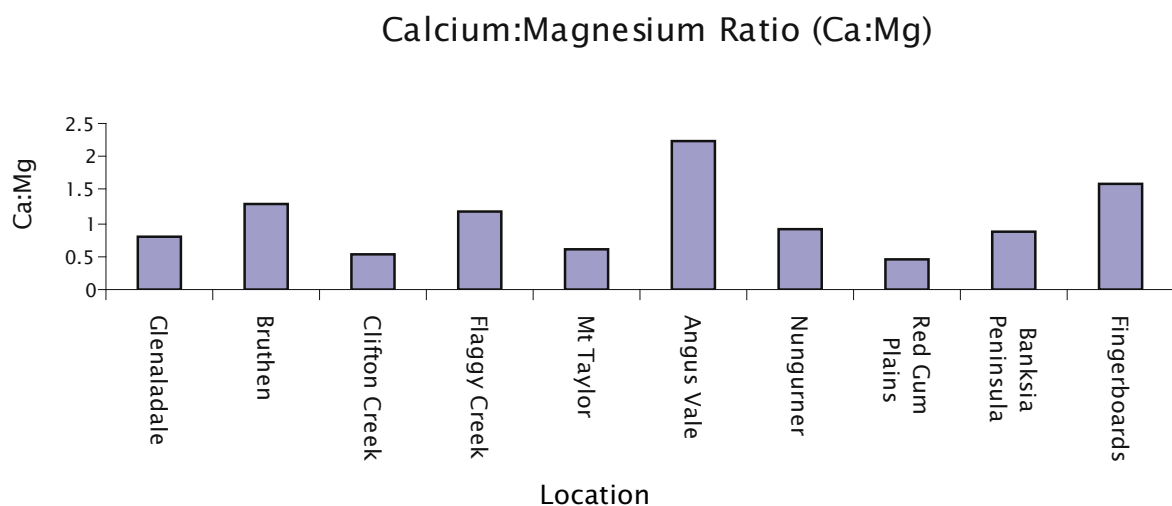
Figure 19: Mean Calcium:Magnesium ratio results for the whole soil profile across the 15 soil pit sites sampled in the Bairnsdale region.

There were six locations (Glenaladale, Clifton Creek, Mt Taylor, Nungurner, Red Gum Plains and Banksia Peninsula) that have an Ca:Mg ratio below one indicating a calcium deficiency. The other locations (Bruthen, Flaggy Creek, Angus Vale and Fingerboards) have ratios between one and four and are therefore low in calcium (Sargeant I and Sargeant J 2005) (Figure 19).

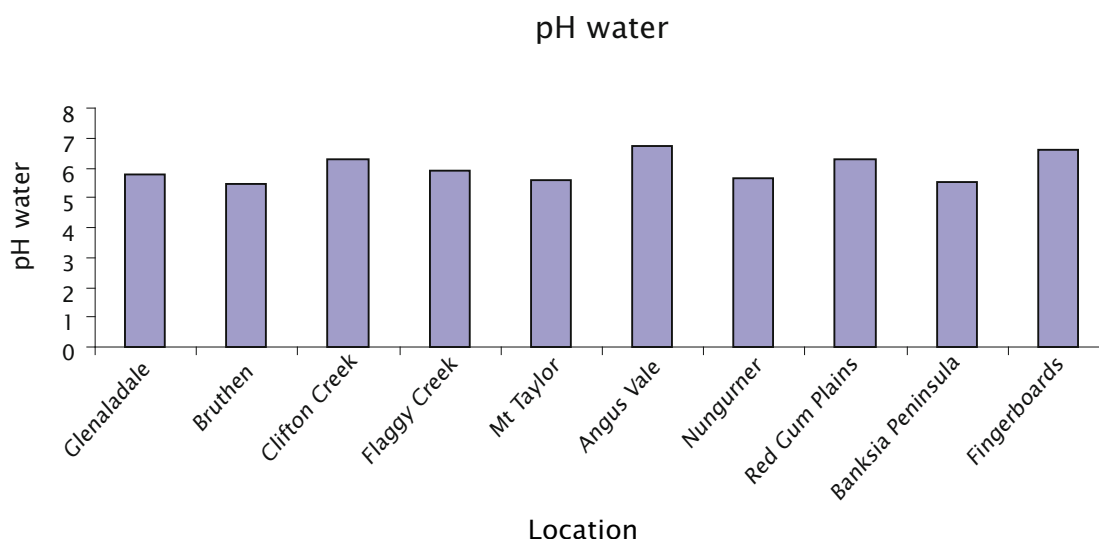
Figure 20: Mean pH in water results for the whole soil profile across the 15 soil pit sites sampled in the Bairnsdale region.

Overall the pH of these soils is within the ranges that are conducive to plant growth (between 5.5 and 8.0). The samples (Figure 20) range between 5.5 and 7.0 while on the acidic side are within acceptable ranges for pasture production (Sargeant I and Sargant J 2005).

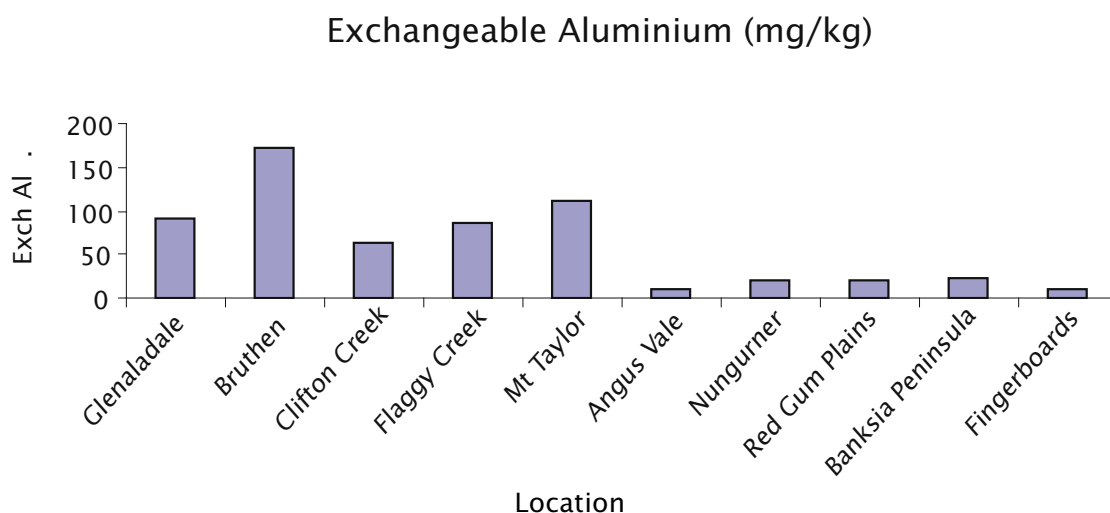
Figure 21: Mean Exchangeable Aluminium results for the whole soil profile across the 15 soil pit sites sampled in the Bairnsdale region.

There were five locations where aluminium (Al) was detected in above normal ranges (Glenaladale, Bruthen, Clifton Creek, Flaggy Creek and Mount Taylor). Whilst aluminium has no known direct effect on causing erosion in the soil profile it does have an impact on the plant species that are grown in the soil and thus has the potential to cause issues for perennial pasture and revegetation as part of the rehabilitation techniques used to remediate the tunnel erosion affected land (Figure 21).

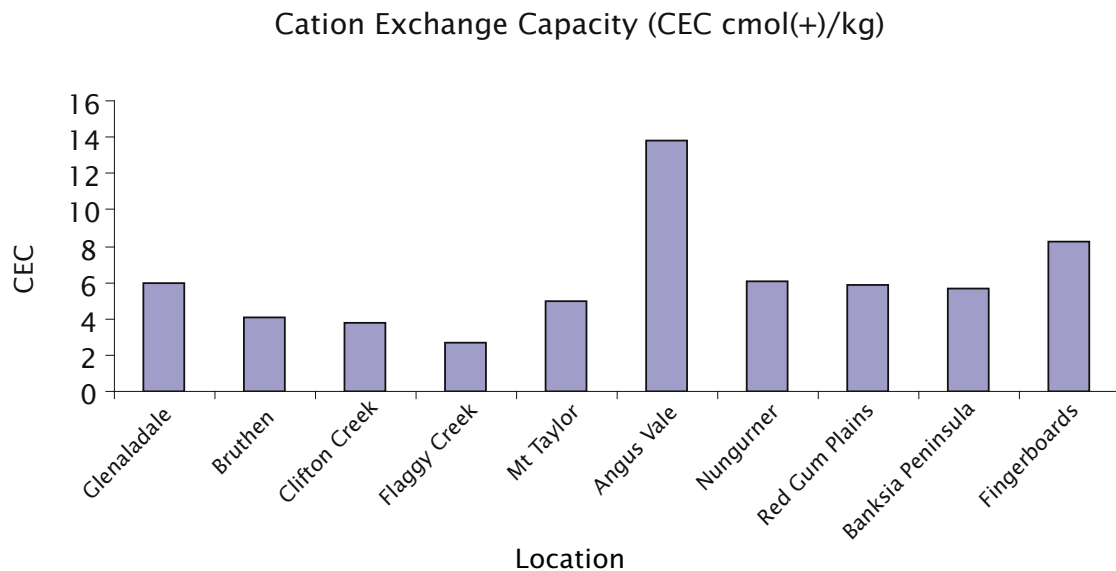
Figure 22: Mean Cation Exchange Capacity results for the whole soil profile across the 15 soil pit sites sampled in the Bairnsdale region.

Thus low CEC soils have reduced ability to support plant growth and when combined with sodic and dispersive characteristics this has severe implications for the increased potential of soil erosion in these locations of the Bairnsdale region.

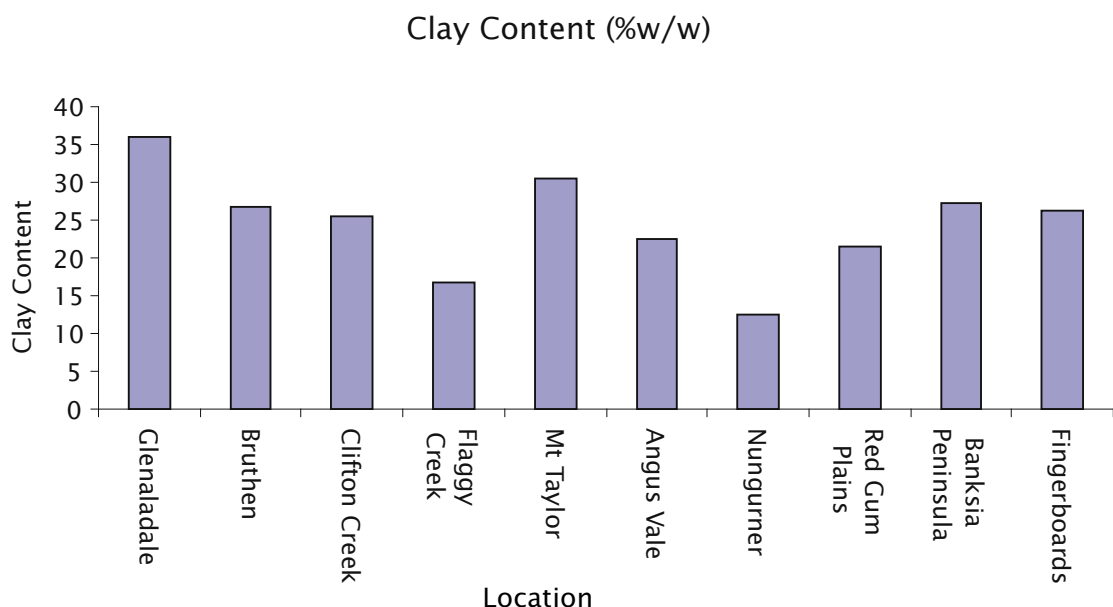
Figure 23: Mean Clay Content (%w/w) results for the whole soil profile across the 15 soil pit sites sampled in the Bairnsdale region.

The highest clay content from the samples taken was found in the Glenaladale, Bruthen, Clifton Creek, Mt Taylor, Banksia Peninsula and Fingerboards and the majority have been characterised as “very fine sandy clay loam” (Figure 23).

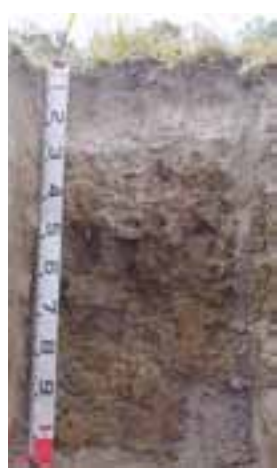
Table 5: Glenaladale soil pit near Den of Nargan
Easting 550529590 Northing 5827027.

Depth cm	ESP %	Ca:Mg ratio	pH-H ₂ O	Exch Al mg/kg	CEC cmol(+)/kg
0-12	2	2.3	5.8	18	6
12-26	4	1.2	6	20	3
26-60	16	0.1	6.2	26	10
60-80	18	0.1	6.3	10	9.4
80-100	21	0.1	6.2	14	7.4

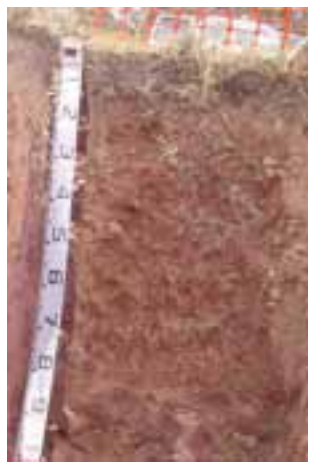
Table 6: Glenaladale soil pit Bairnsdale-Dargo Road
Easting 550527696 Northing 5826027.

Depth cm	ESP %	Ca:Mg ratio	pH-H ₂ O	Exch Al mg/kg	CEC cmol(+)/kg
0-10	3	2.5	5	130	4.4
10-30	5	1.2	5.2	120	2.1
30-50	4	0.2	5.3	270	3.2
50-100	12	0.1	5.6	140	5.2

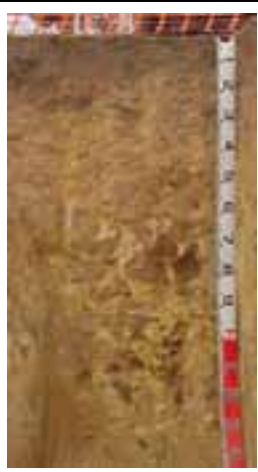
Table 7: Bruthen soil pit
Easting 550573478 Northing 5824969.

Depth cm	ESP %	Ca:Mg ratio	pH-H ₂ O	Exch Al mg/kg	CEC cmol(+)/kg
0-12	1	4	5.4	71	9.4
12-26	4	1.1	5.2	200	3.1
26-60	4	0.5	5.3	190	3

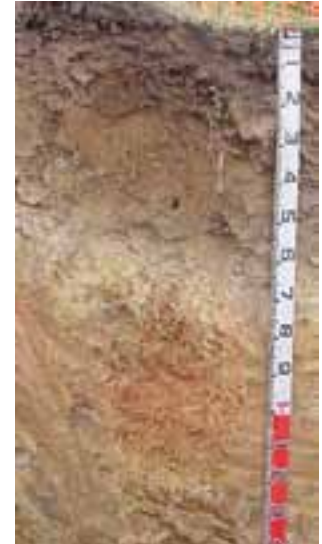
Table 8: Wiseleigh soil pit
Easting 550570572 Northing 5826277.

Depth cm	ESP %	Ca:Mg ratio	pH-H ₂ O	Exch Al mg/kg	CEC cmol(+)/kg
0-8	2	1.1	4.9	360	7.6
8-35	9	0.3	5	460	1.2
35-50	9	0.2	5.8	140	1.1
50-70	10	0.2	5.8	82	1
70-100	12	0.1	6	55	1.8

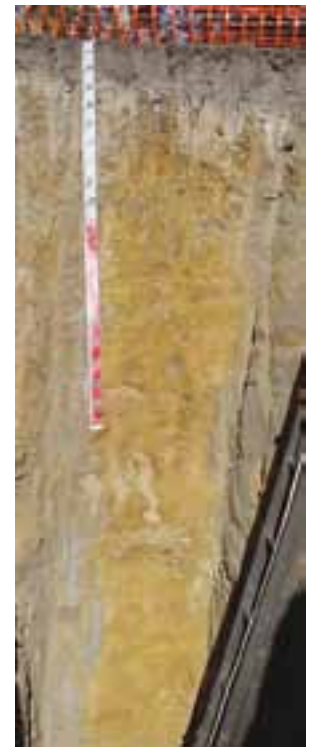
Table 9: Nungurner soil pit
Easting 550581940 Northing 5808051.

Depth cm	ESP %	Ca:Mg ratio	pH-H ₂ O	Exch Al mg/kg	CEC cmol(+)/kg
0-8	2	3.8	5.5	6	8.9
8-16	3	3	5.8	14	4.2
16-25	5	1.6	6.2	<5	2
25-60	12	0.2	5.9	32	8.5
60-115	12	0.2	5.9	32	8.5
115-170	27	0.1	5.5	19	8.4
170-230	33	0.1	5.3	23	8.4
230-270	34	0.1	5.5	28	5.3
270-320	34	0.1	5.6	17	4.5
320-390	34	0.1	5.6	15	3.6
390-440	35	0.1	5.3	32	6.4

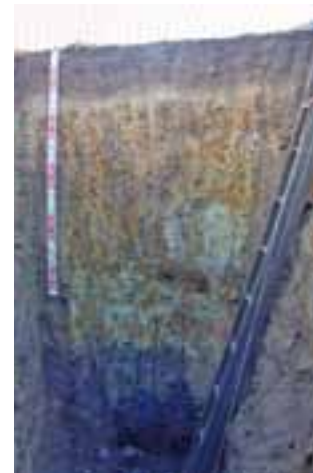
Table 10: Banksia Peninsula soil pit
Easting 550559578 Northing 580319.

Depth cm	ESP %	Ca:Mg ratio	pH-H ₂ O	Exch Al mg/kg	CEC cmol(+)/kg
0-10	2	4.4	5.2	45	6.4
10-35	3	1.1	5.6	56	3.3
35-52	8	0.3	6	16	2.6
52-110	19	0.1	5.6	8	4.2
110-180	24	0.1	5.4	13	4.2
180-240	29	0.1	5.5	14	10
240-330	31	0.1	5.4	8	9.2

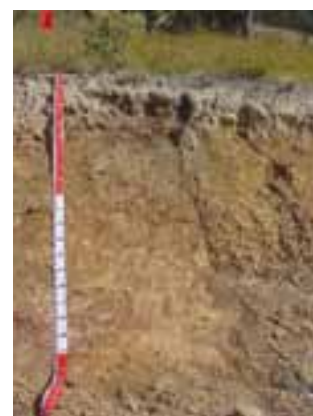
Table 11: Mount Taylor soil pit
Easting 550547821 Northing 5820575.

Depth cm	ESP %	Ca:Mg ratio	pH-H ₂ O	Exch Al mg/kg	CEC cmol(+)/kg
0-10	3	1.9	5.6	56	3.8
10-45	9	0.8	5.7	45	1.1
45-90	10	0.1	5.5	220	5.1
90-120	14	0.1	5.3	160	7.2
120-170	17	0.1	5.7	76	7.8

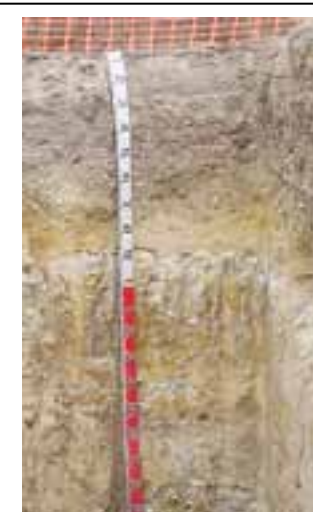
Table 12: Red Gum Plains at Fernbank soil pit
Easting 550531877 Northing 5804143.

Depth cm	ESP %	Ca:Mg ratio	pH-H ₂ O	Exch Al mg/kg	CEC cmol(+)/kg
0-30	10	1.7	5.1	14	1
30-60	13	0.5	5.2	36	0.8
60-90	25	1	5.4	7	0.4
90-100	9	0.2	5.9	6	1.1
100-110	18	0.1	5.7	110	6.3
110-180	22	0.1	5.8	15	3.7
180-270	22	0.1	5.9	<5	3.3

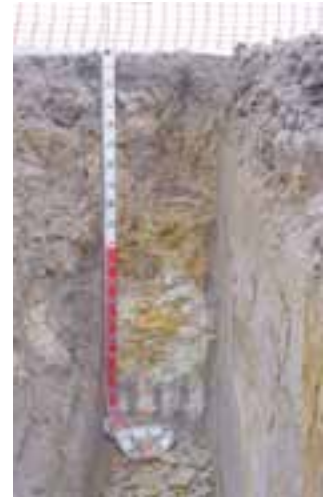
Table 13: Red Gum Plains at Nicholson soil pit
Easting 550566088 Northing 5810863.

Depth cm	ESP %	Ca:Mg ratio	pH-H ₂ O	Exch Al mg/kg	CEC cmol(+)/kg
0-15	4	1.6	5.4	25	3
15-40	11	0.3	5.9	42	11
40-90	22	0.1	7.8	<5	11
90-120	32	0.1	7.9	<5	14
120-170	27	0.1	7.7	<5	9.3
170+	28	0.2	7.6	<5	8.2

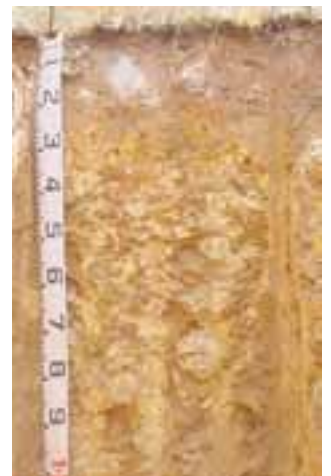
Table 14: Clifton Creek soil pit
Easting 550556591 Northing 5828027.

Depth cm	ESP %	Ca:Mg ratio	pH-H ₂ O	Exch Al mg/kg	CEC cmol(+)/kg
0-5	4	1.6	5.1	140	5.8
5-20	20	0.3	5.7	100	2
20-30	18	0.1	6.7	13	3.4
30-70	8	0.1	7.6	<5	3.9

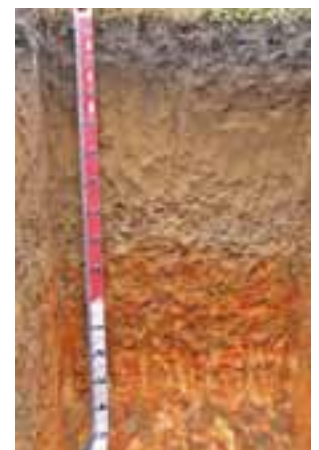
Table 15: Flaggy Creek soil pit
Easting 550542400 Northing 582100.

Depth cm	ESP %	Ca:Mg Ratio	pH-H ₂ O	Exch Al mg/kg	CEC cmol(+)/kg
0-25	7	2.3	5.5	43	2.1
25-65	8	2.4	6	27	1.2
65-85	11	0.9	6.5	NS	1.4
85-120	12	0.1	6	120	5.9
120-150+	22	0.1	5.6	150	2.6

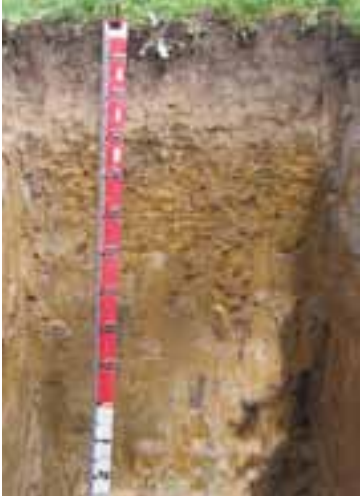
Table 16: Fingerboards soil pit
Easting 550528900 Northing 5817000.

Depth cm	ESP %	Ca:Mg ratio	pH-H ₂ O	Exch Al mg/kg	CEC cmol(+)/kg
0-15	7	3.6	5.7	<10	7.2
15-27	7	2.4	6.0	<10	1.6
27-90	15	0.2	6.6	NS	12
90-120+	23	0.1	8.0	<10	12

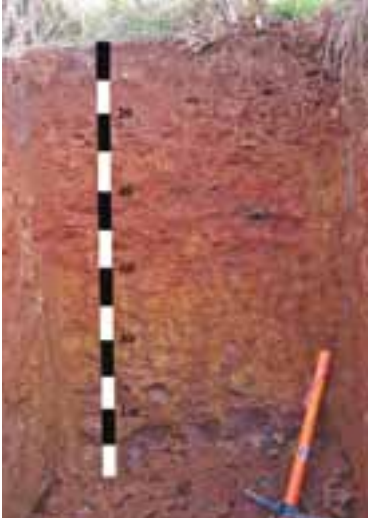
Table 17: Angus Vale soil pit
Easting 550531400 Northing 5840400.

Depth cm	ESP %	Ca:Mg ratio	pH-H ₂ O	Exch Al mg/kg	CEC cmol(+)/kg
0-15	3	2.8	5.9	<10	6.8
15-30	2	2.8	6.5	NS	7.4
30-55	1	1.5	7.3	NS	21
55-90	1	1.8	7.1	NS	20

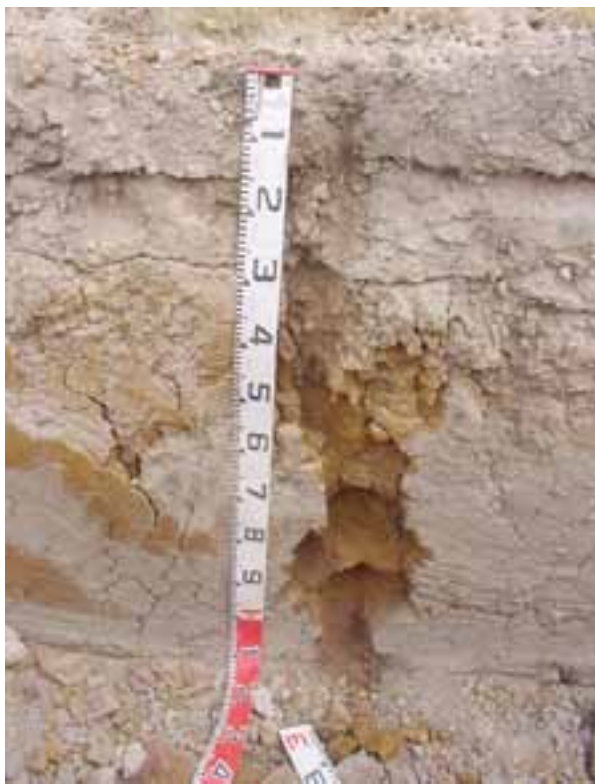
Figure 24: Cracks in the soil that lead to tunnel erosion.

This “Paddock tunnelling” (a typical example of which is depicted in Figure 2) was the subject of the demonstration site at Glenaladale, investigating cost effective rehabilitation methods. Overall when soil pits were excavated large cracks were observed when the soil was dry in the tunnel

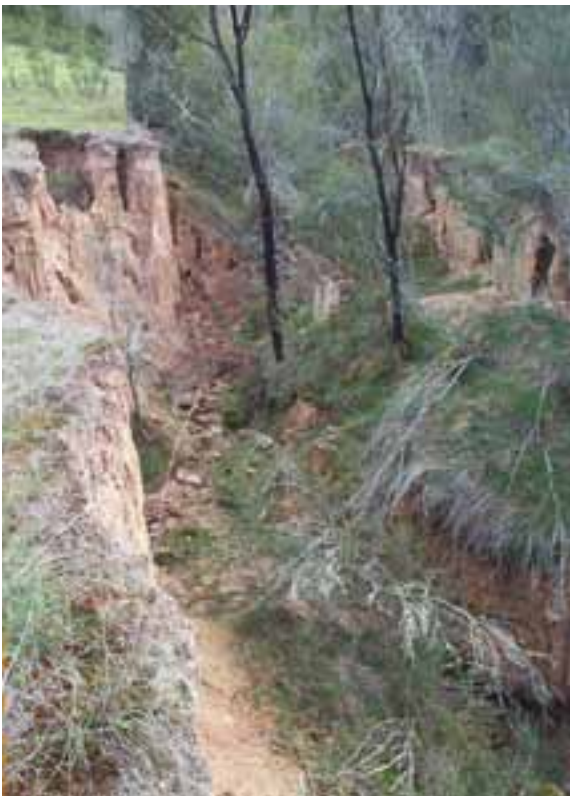
The photo above shows severe erosion that started as tunnel erosion and has collapsed to form an actively eroding gully line that other tunnels from the paddock feed into, increasing the hydraulic pressure that accelerates the erosive potential. The depth of this gully was six metres.
