Tunnel erosion in East Gippsland

Published by: Department of Primary Industries,
Bairnsdale, Victoria 3953, Australia
April 2010

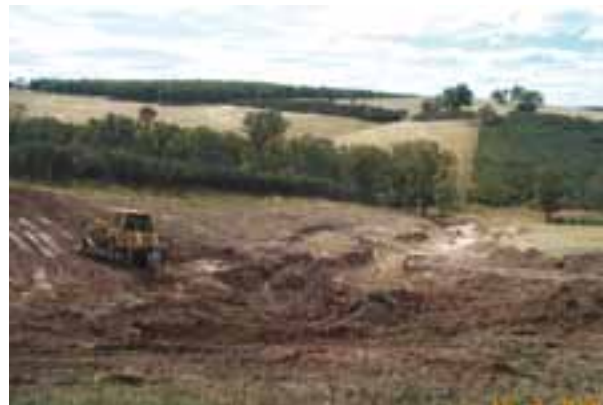
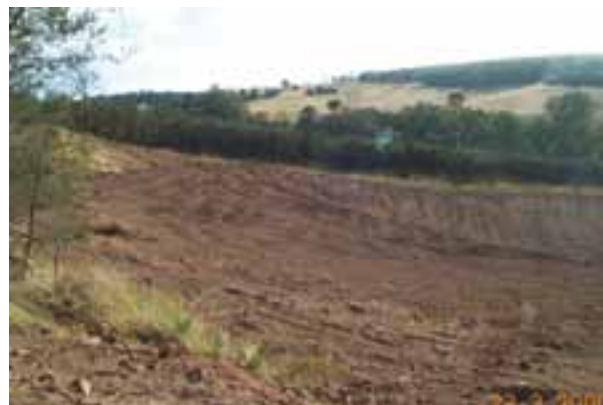
These two photos show the rehabilitation works in progress (above) and when completed with the area ready for seeding by the landholder (below).

Figure 25: Rehabilitation of severe tunnel erosion.

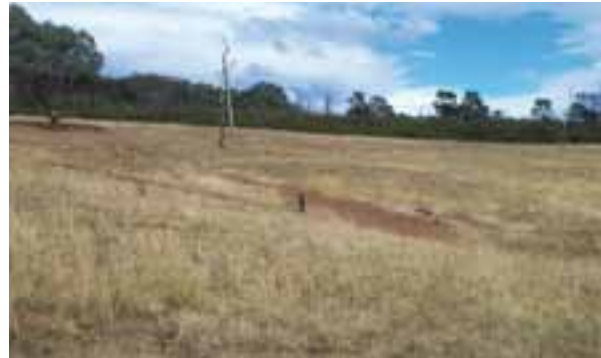
26a Tunnel erosion in a paddock at Glenaladale before treatment.

Figure 26: Cost effective rehabilitation processes of tunnel erosion in East Gippsland.

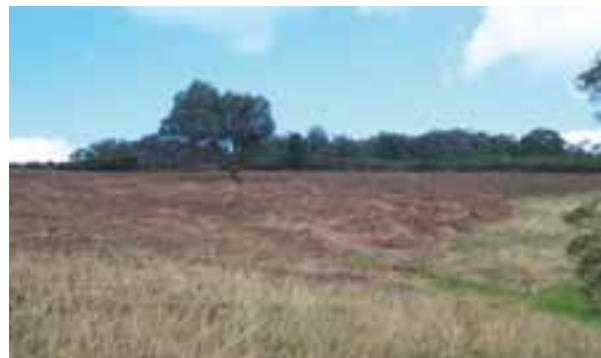
26b Glenaladale paddock during treatment with heavy machinery.

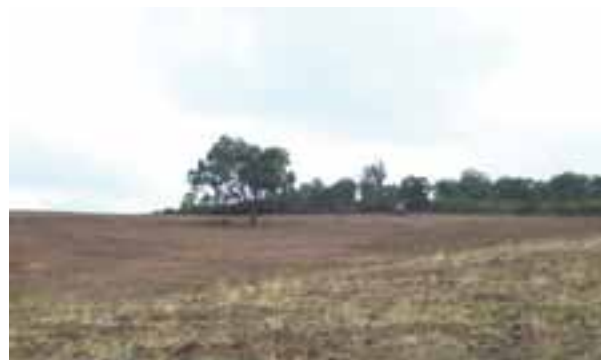
26c Glenaladale paddock after sowing.

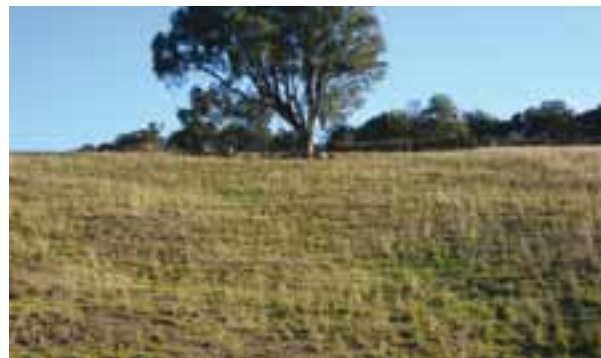
26d Glenaladale paddock pasture established.

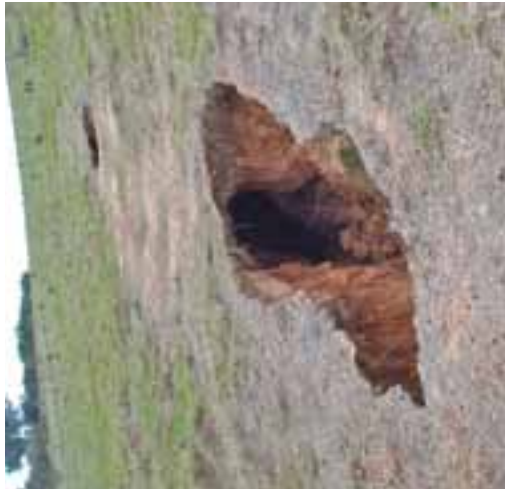
Figure 1: Clay deposits rising to the surface through an outlet, creating a 'fan' shape.

- Small holes and/or indents appearing in the pasture.
- Water 'spouting' from small holes in the ground following heavy rain.
- Clay particles deposited in a fan shape on the paddock surface (Figure 1).
- 'Drying off' lines in pasture caused by shallow soil depth (Figure 2).
- Collapsing surface soil creating elongated ditches, usually running down a slope (Figure 3).

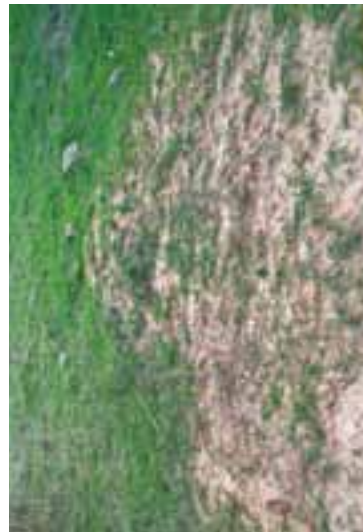
Figure 2: Partial collapse of tunnel with drying off lines visible.

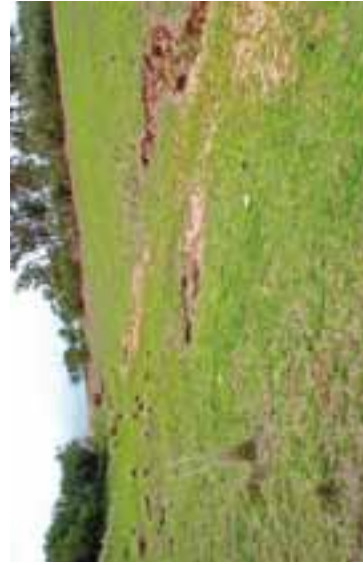
Figure 3: Tunnel collapse and surface clay deposits.

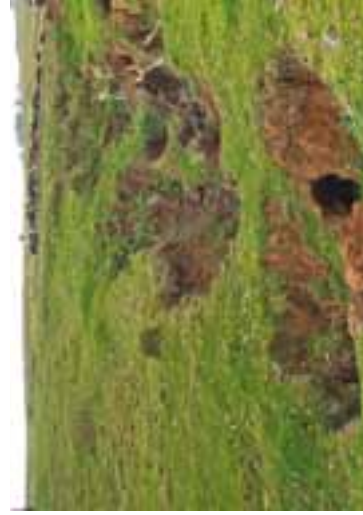
Figure 4: Start of gully formation.
