Corangamite Catchment Management Authority and the City of Greater Geelong

# Case Study for Erosion and Landslides.

Great Ocean Road (1949)

Report No: 356.3/32/06

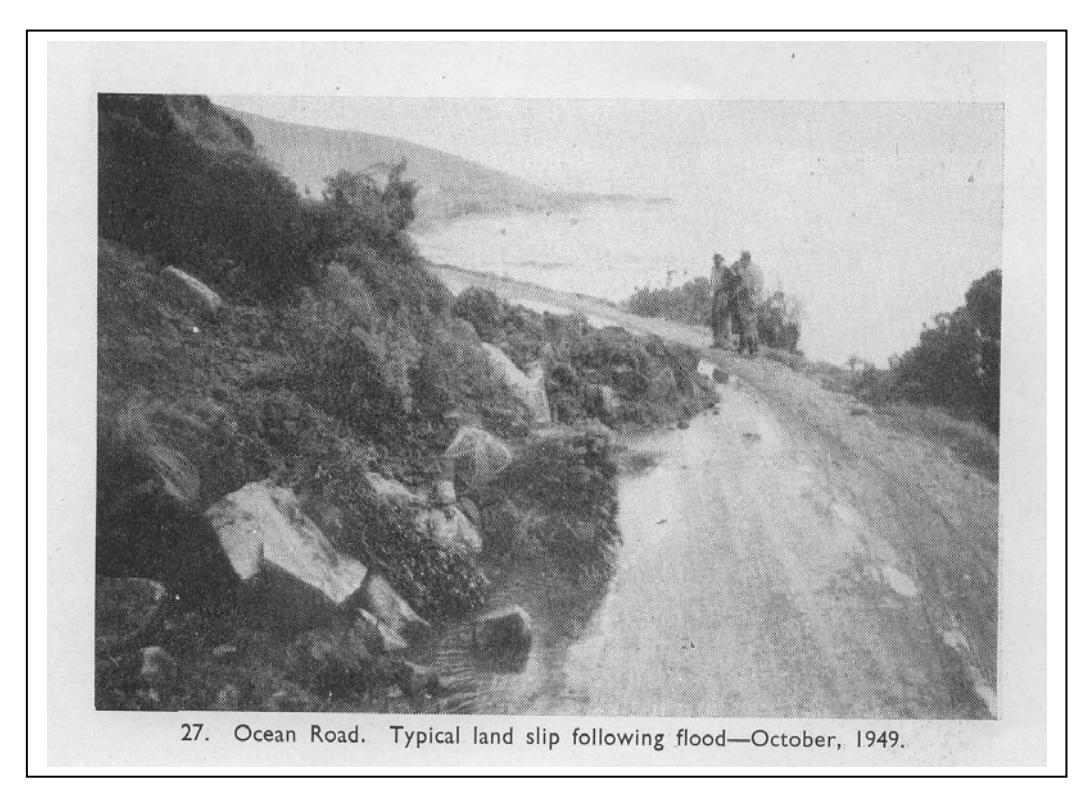
Photo 1

Rockfalls slides and collapses of bridges occurred during heavy flooding in October 1949 (see attached photos). The result was traffic was blocked between Lorne and Apollo Bay with a section between Lorne and Anglesea also closed but for a shorter period. Principal damage derived from slips from the high side of the road but more serious slips also occurred on the low side which involved the provision of retaining walls. The slide at Cape Patton (see Photos) is a good example of a low side slide.

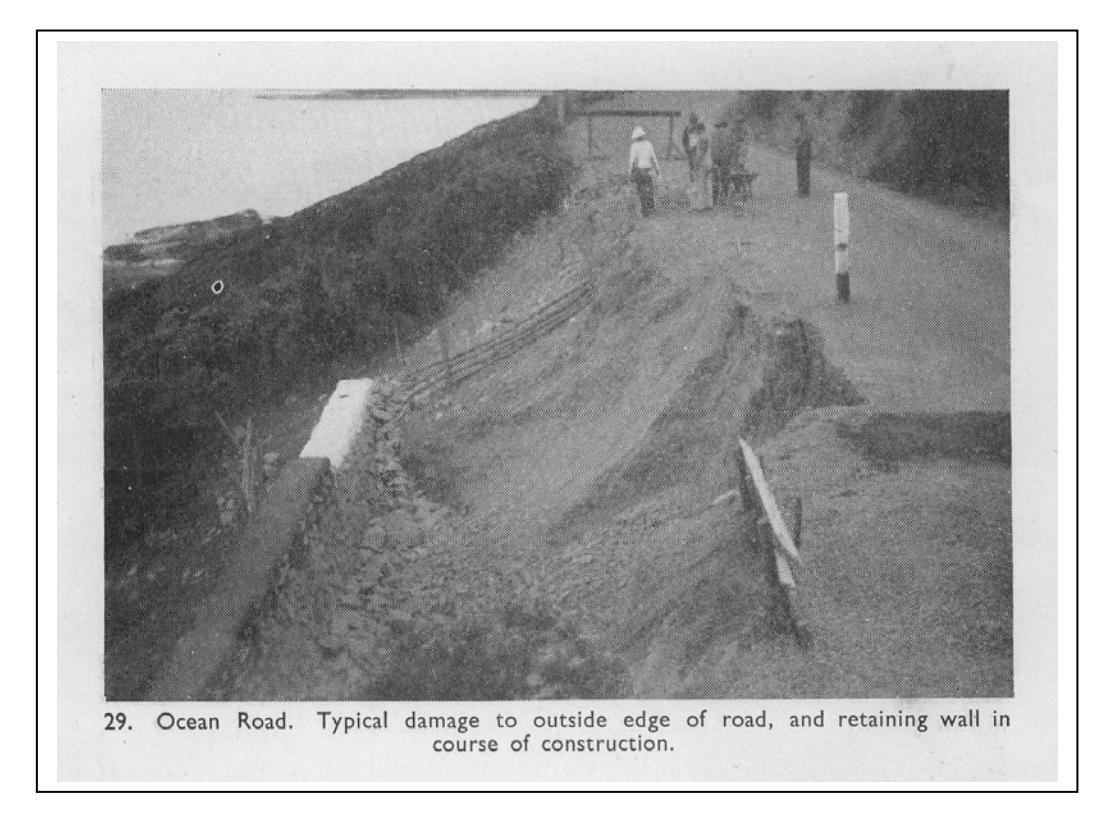
Photo 3

In all, damage occurred at 38 points between Lorne and Apollo Bay as well as damage to a culvert and filling at Chapman's Creek (see Photo) and the loss of a bridge near Apollo Bay (see Photo).
